AN ALTERNATIVES ANALYSIS

**For Improving Fish Passage Conditions
at Four Road-Stream Crossings within
San Francisquito Creek Watershed, California**

February 13, 2004

The San Francisquito Watershed Council

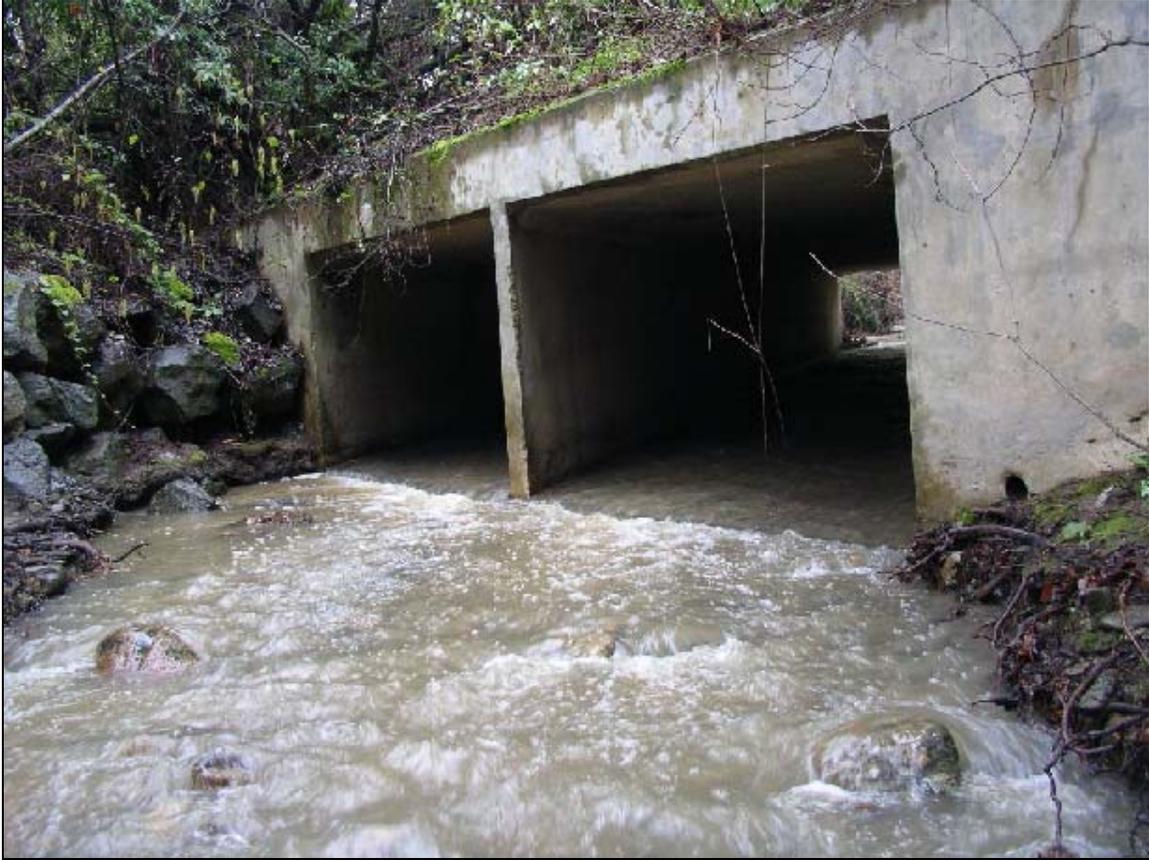
A distinctive knick point (interruption in a stream's longitudinal profile), indicative of head cutting and channel incision, was identified approximately 80 feet downstream of the culvert. The knick point, which can be identified in the surveyed channel profile, consisted of a short oversteepened section of channel with matching channel slopes immediately upstream and downstream of the knick point. This is a common indicator that the channel bed downstream of the knick point has recently lowered, or incised. Large scale channel incision can have numerous causes, including removal of large wood from streams, increases in peak flows due to urbanization or recent fires, or constriction of the historic channel through armoring of channel bed and banks. If left to its own accord, a knick point tends to move upstream resulting in head cutting.

If the knick point in Los Trancos Creek continues moving upstream, the culvert outlet will become perched by as much as three feet, making it a severe barrier to upstream migrating steelhead. The rate at which a knick point will move upstream is largely dependent on its composition and the extent to which it resists erosion. The knick point identified in Los Trancos Creek consists of moderately resistant materials, including numerous large scoured roots and large cobbles. Matt Stoecker with the San Francisquito Watershed Council Steelhead Task Force noted that he has observed very little change in the knick point over the last several years. It would be advisable to monitor the location of the knick point by taking measurements from the culvert outlet to the knick point at regular intervals (at least annually). This information would be helpful to estimate how soon the knick point could reach the culvert and help determine if action should be taken to slow or halt the knick point from migrating upstream before it reaches the culvert.

Los Trancos Creek double bay box culvert outlet on Los Trancos Creek (photo by Matt Stoecker)

Baffles are commonly used to increase water depths and decrease velocities in culverts that have slopes less than 3.5%. Since the Los Trancos Road culvert primarily lacks sufficient water depths for passage and has a slope of only 1.8%, using baffles appears to be a feasible alternative. Baffles used in double bay box culverts are typically only placed in one of the bays. To concentrate low flows into the baffled bay, a low flow cut-off sill is typically placed into the other bay.

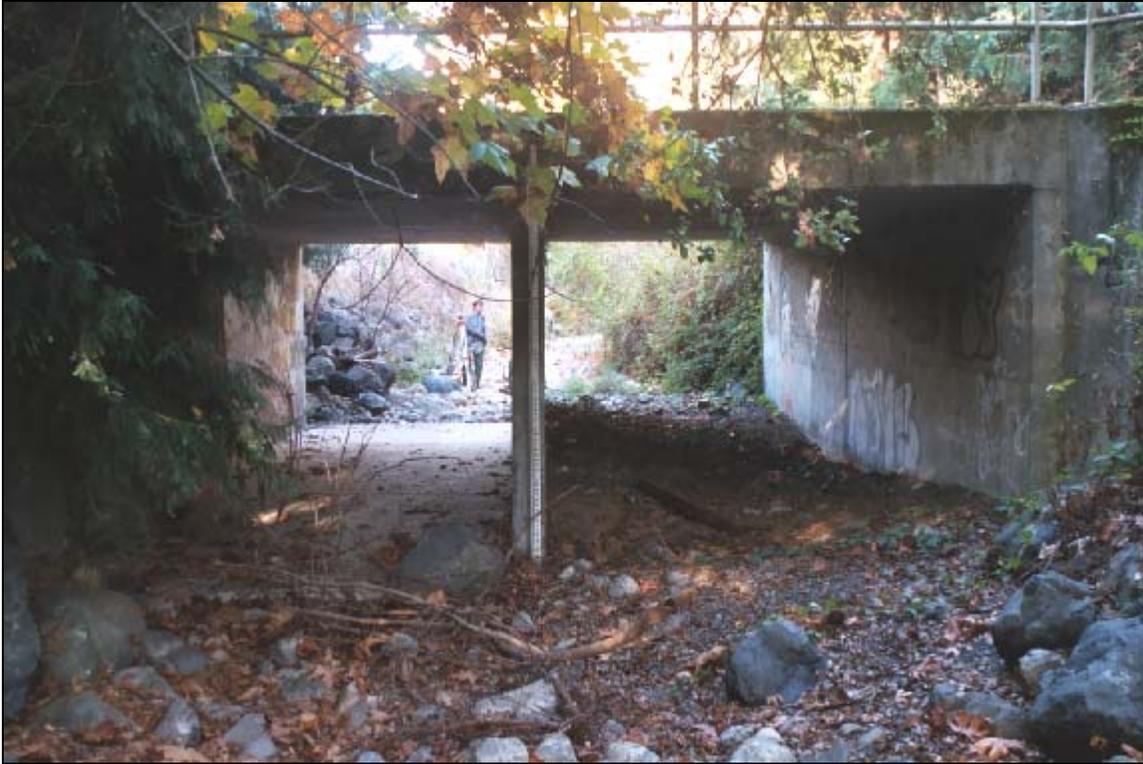
Preliminary evaluation of the culvert hydraulics, stream morphology, and fish passage conditions identified insufficient water depth for fish migration as the primary area of concern. Additional issues needing to be addressed at the site are the small drop at the outlet and excessive velocities for juvenile salmonids.

Inlet of the double bay box culvert at the Fire Access Road Crossing.

Installing four to five bed retention sills, including one across the outlet, would greatly improve fish passage and also reduce outlet velocities and related scour of the downstream channel. Along the left wall of the left bay is a series of three weep holes, with their inverts set between 0.5 and 0.6 feet above the culvert floor. To avoid having them be covered by sediment, the sills should be no more than 0.5 feet in height. The sills could be constructed of either redwood beams, formed concrete, or prefabricated steel sills (preferably using stainless steel). The top of the sill would likely slope down towards the center of the culvert to help form a low flow channel. If part or all of the sills are unable to retain bedload for unforeseen reasons, they will still function as baffles, increasing depth and decreasing velocities for fish passage.

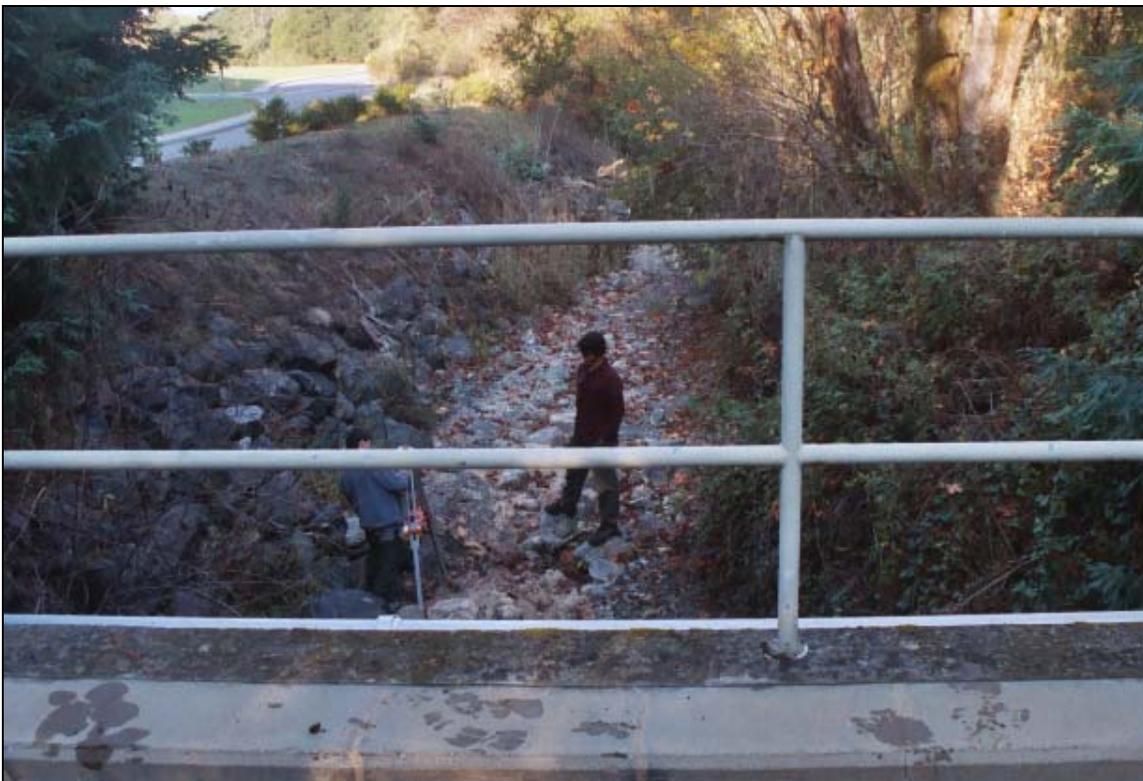
Channel bed downstream of the culvert outlet. Note the levee along the left bank that protects Valley Oak Road from flooding.

profile. The magnitude of the outlet drop is relatively small and there is only a small outlet scour pool, making the site ideal for raising the channel bed by adding large roughness elements at the outlet. This could be achieved through strategic placement of large angular rock immediately below the outlet, likely being within the existing right-of-way of the road crossing. The extra roughness created by placement of large rock below the outlet would slow water velocities, dissipate energy, and result in the deposition of smaller substrate. The intent would be to cause a small rise in the channel bed at the outlet, creating a smooth transition from the substrate retained within the culvert to the downstream channel.

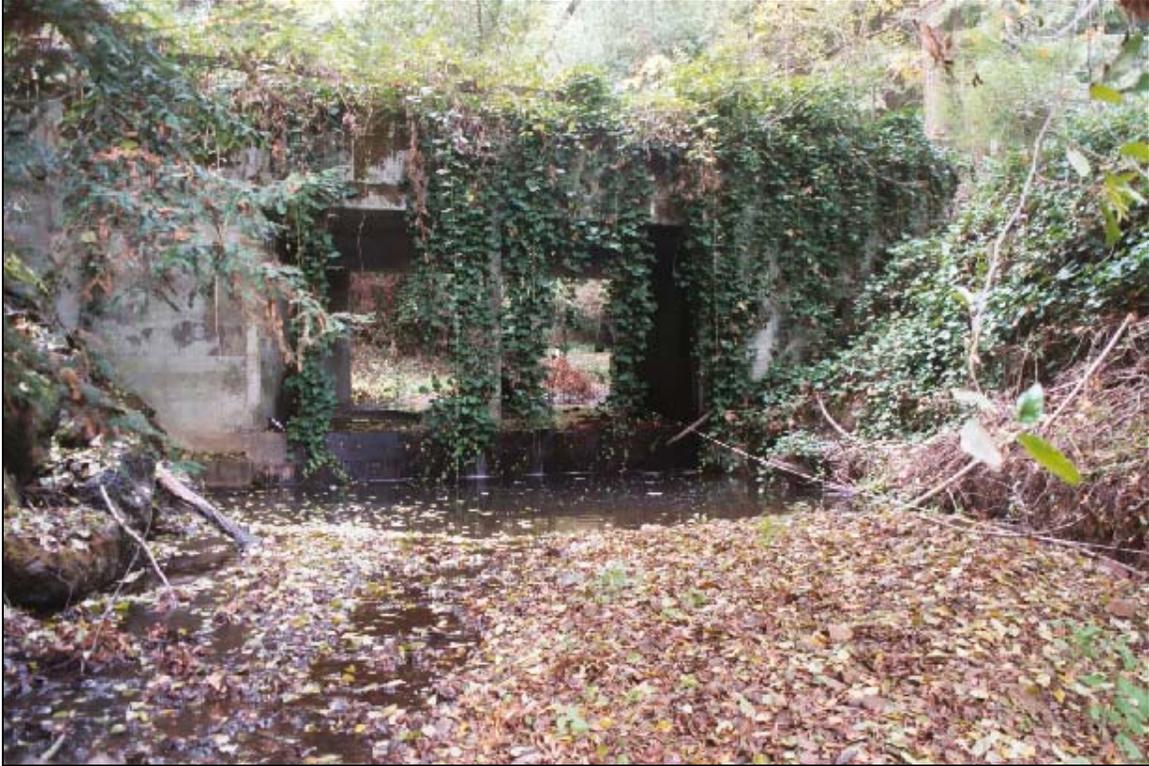
Preliminary evaluation of the culvert hydraulics, stream morphology, and fish passage conditions identified the outlet drop as creating a relatively severe barrier to migrating adult steelhead. Additionally, the culvert fails to provide sufficient water depths for fish to swim through at all migration flows.

The assessment of fish passage conditions at the Fox Hollow Road crossing indicates the outlet drop is excessive and water depths are insufficient at all migration flows for all salmonids at all life stages.

Culvert outlet at Fox Hollow Road on Bear Gulch Creek.

The natural-looking roughened channel design is an innovative approach to addressing differences in grade. Although use of this design technique is relatively new in the United States, it has been used extensively in Europe. Sometimes referred to as a rock-ramp, the technique involves building-up and oversteepening the channel with various sized rock. To ensure its stability and to keep conditions acceptable for fish passage, a roughened channel is composed of a mixture of various sediment sizes, including large rock that increases roughness and fine grain sediments to prevent flows from going subsurface. The recommended maximum steepness of a roughened channel is 5.0%.

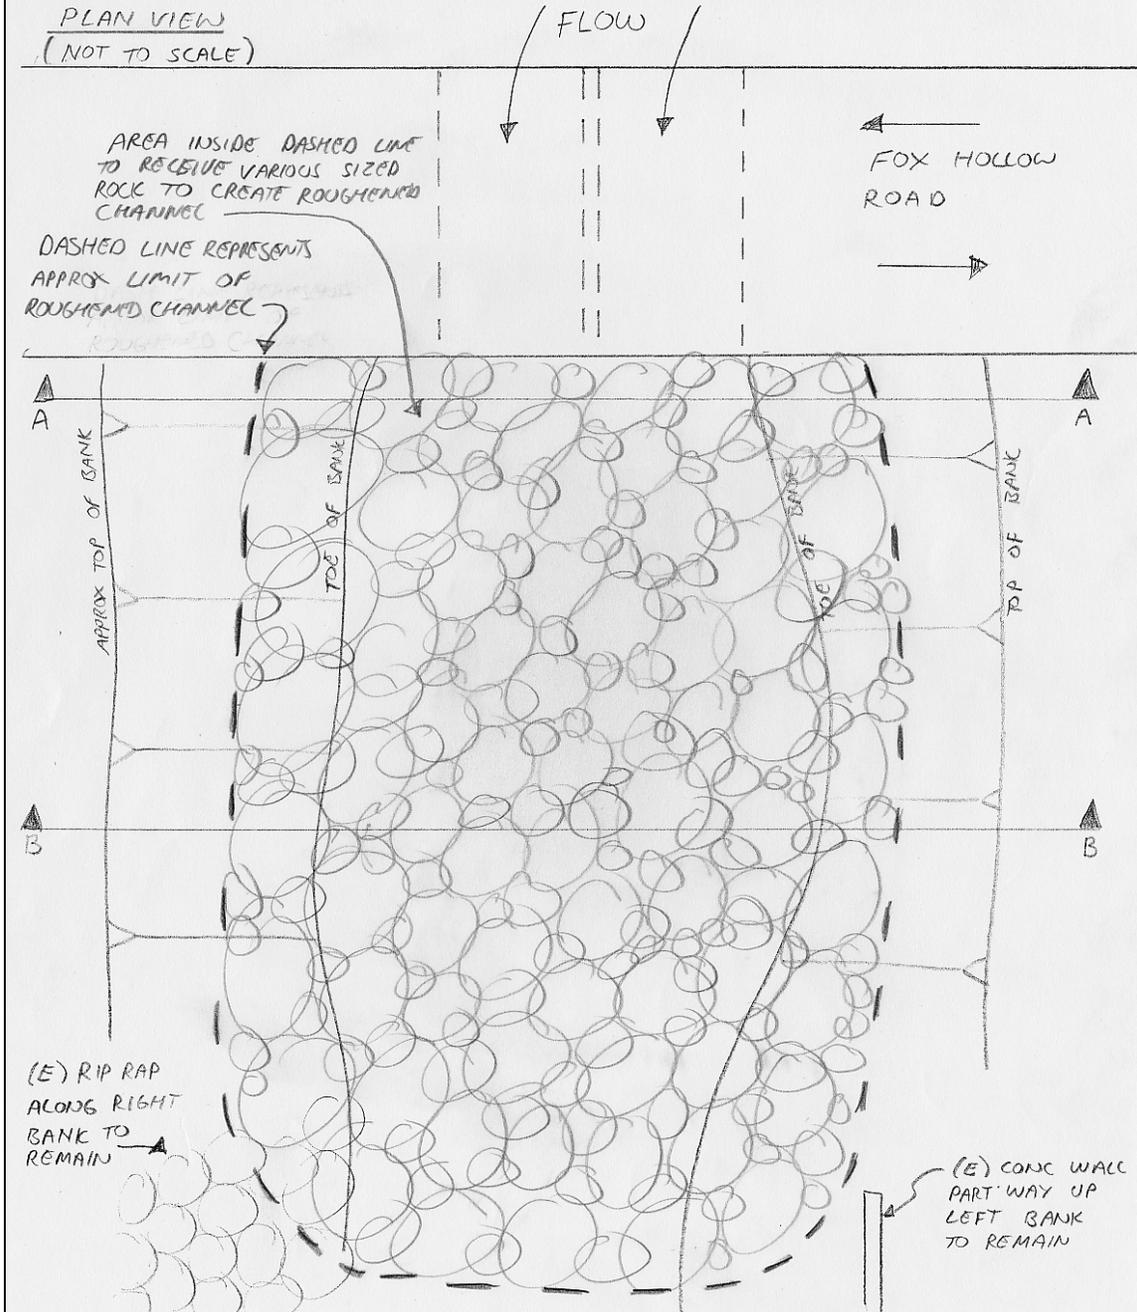
Site sketch (Plan View) of proposed roughened channel design at Fox Hollow Road.

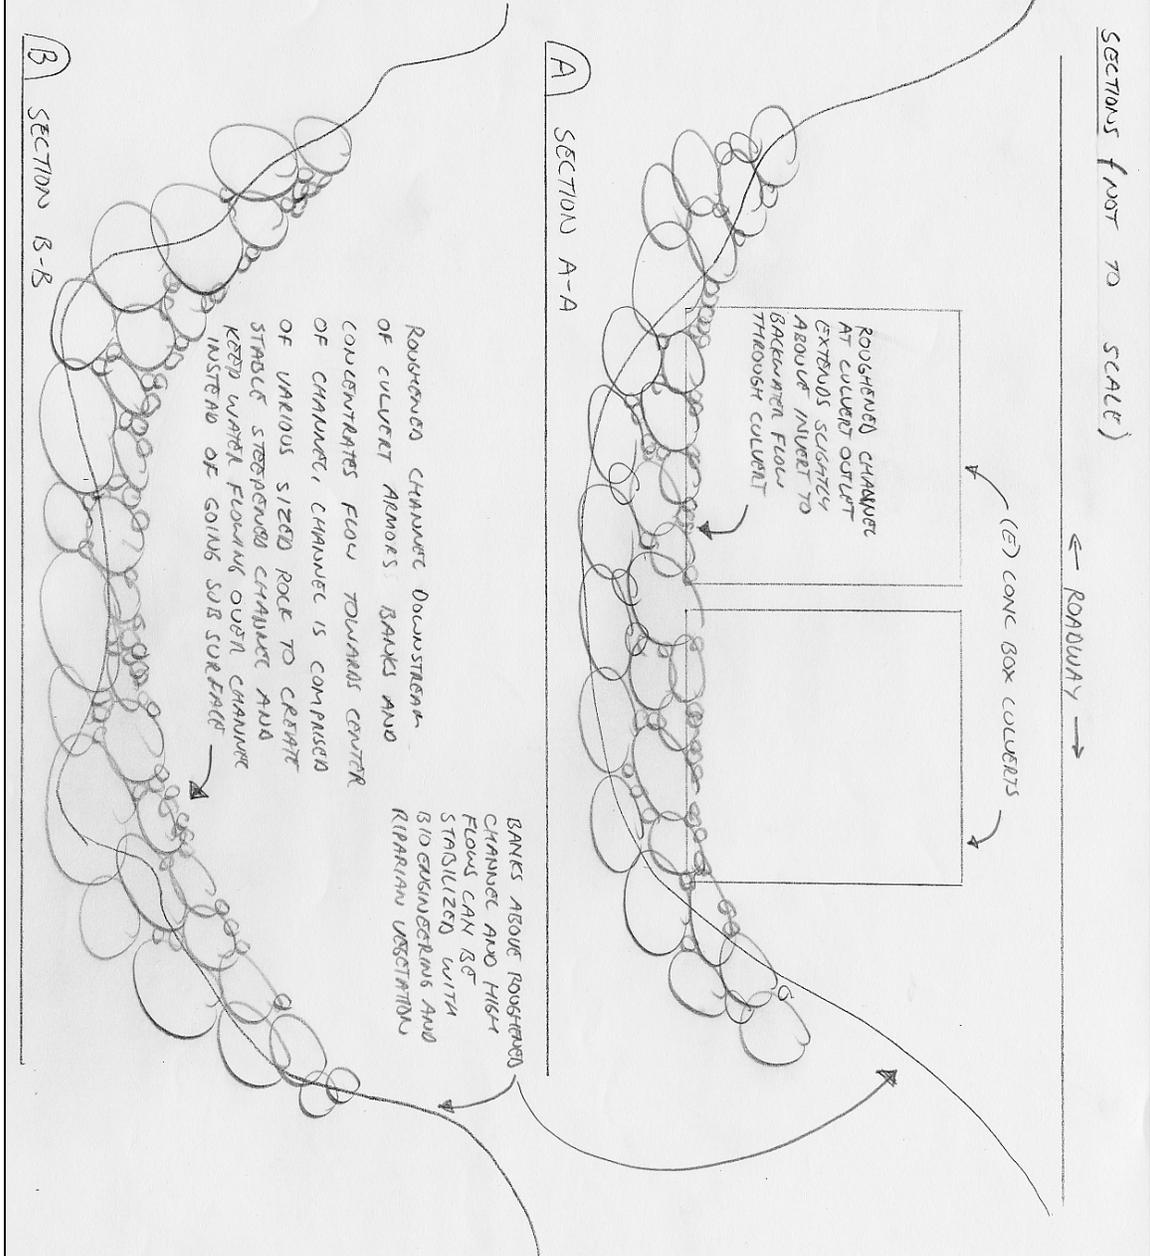
Site sketch (Section Views) of proposed roughened channel design at Fox Hollow Road.

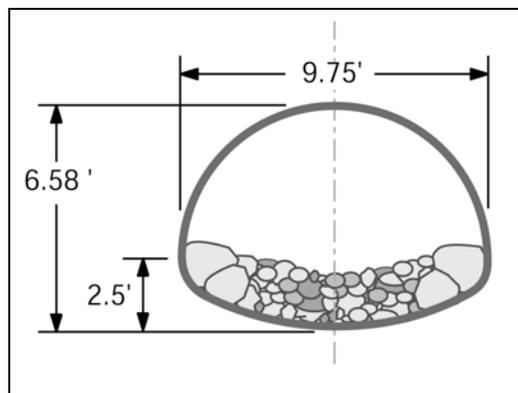
Section view of proposed pipe arch culvert with constructed streambed.

Using the FishXing 2 software, several different culvert sizes and configurations were analyzed. Because of the low profile of the road, a pipe arch was selected over a circular culvert. The preferred design alternative involves using a pipe arch with a span of 9.75-feet and a rise of 6.58-feet. The culvert would be placed at a 3.5% slope and embedded 2.5-feet (38% of the rise) into the channel bottom. This would place the constructed streambed at the widest portion of the pipe arch. Assuming the new culvert inlet is mitered instead of having a headwall, the analysis found this design able to accommodate the 100-year peak flow of 150 cfs with the headwater below the top of the culvert inlet per NOAA Fisheries guidelines.

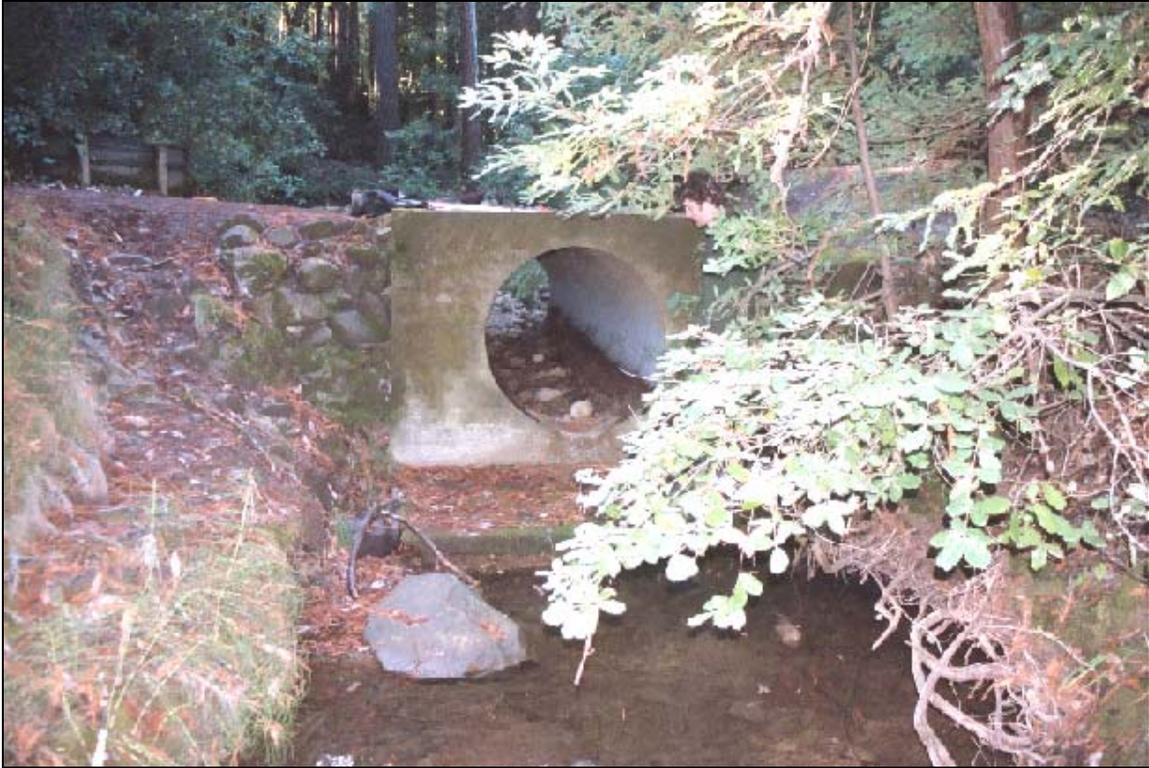
Culvert outlet and apron on McGarvey Gulch at the Richards Road-Trail crossing, Huddard Park.

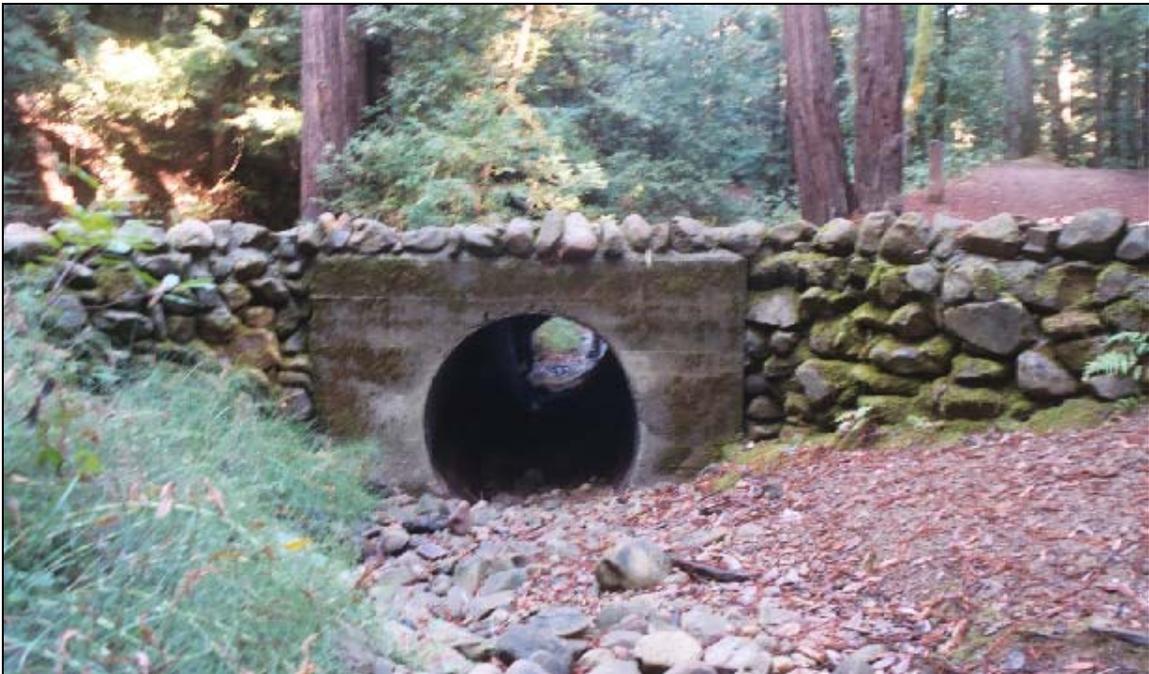
Culvert inlet on McGarvey Gulch. Note the added stone headwall and aggraded channel upstream of the inlet.
