Gaviota Creek

Fish Passage and Geomorphic Assessment

Prepared for
California Department of Fish and Game
And
Pacific States Marine Fisheries Commission

Prepared by
Michael Love and Associates
PO Box 4477
Arcata CA 95518

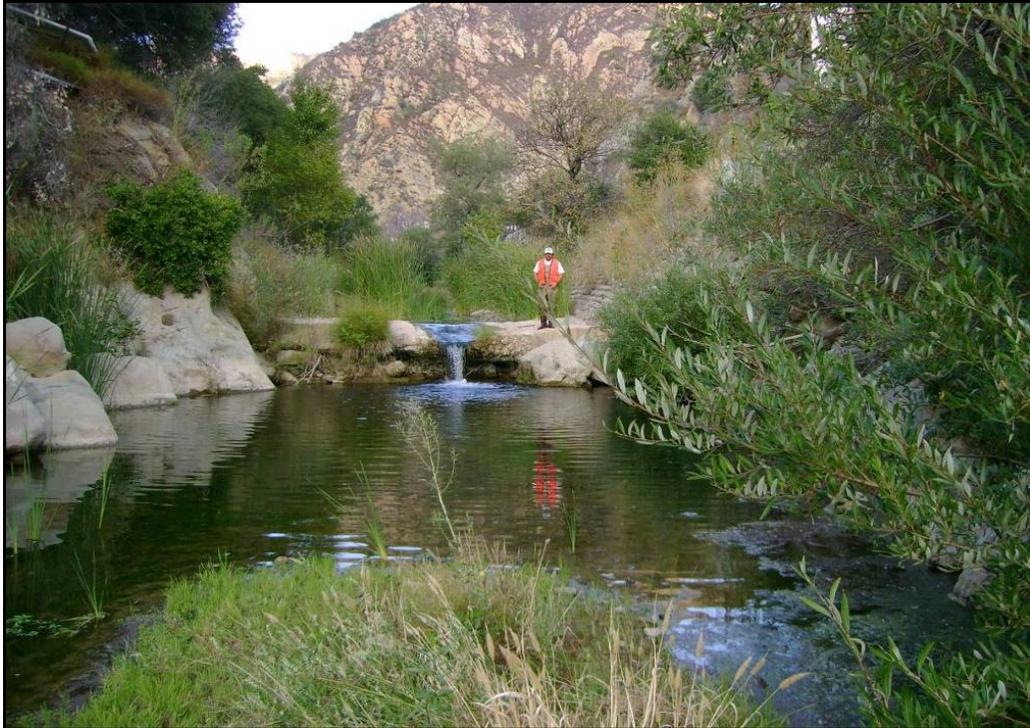
Model results predict the water surface drop over each grade control weir at typical adult steelhead passage flows and at the no-flow condition (Table 4.1). From 8.1 cfs to 115 cfs GA2 creates a drop of 4.7 ft. At these same flows the drop over GA3 ranges between 2.9 and 3.3 feet. Since the drop height over GA3 is directly influenced by GA2 (Figure 4.6), rising flows reduce the drop height.

CDFG and NOAA requirements for water surface drops over grade control structures is 1 foot maximum for adult steelhead and 0.5 feet for resident trout and juvenile salmonids. Under all flow conditions, GA2 and GA3 have substantially greater drop heights. These structures are categorized as RED (impeding passage for all fish) under the CDFG assessment protocol and present a substantial impediment to migrating adult steelhead.

Figure 4.2 – Looking upstream at grade control GA2. The structure is anchored to the concrete revetment wall (right side of photo) and to exposed bedrock on the other side. The tailwater pool was one of four large pools found in the study reach.

An alternative approach would be to remove the existing grade controls, GA2 and GA3, and construct new grade control in the form of boulder step-pools. The regraded channel section could begin at the existing downstream end of GA2's scour pool and end near Sta. 71+50 (Figure 6.1), where the channel begins to move away from the highway embankment. Similar to the previous option, the boulder steps should have drops of 6 inches or less and the design should follow typical roughened channel construction techniques. This reach would have an average channel slope of only 2.2%, which would provide an average spacing of 22 feet between boulder steps. Since the slope would only be 2.2%, the stability and fish passage through the regrade channel could be better than the previous option that would require a 4% slope. The stability of the concrete revetment along the highway embankment could likely be maintained since the channel thalweg (flow-line) would be close to its current elevation.

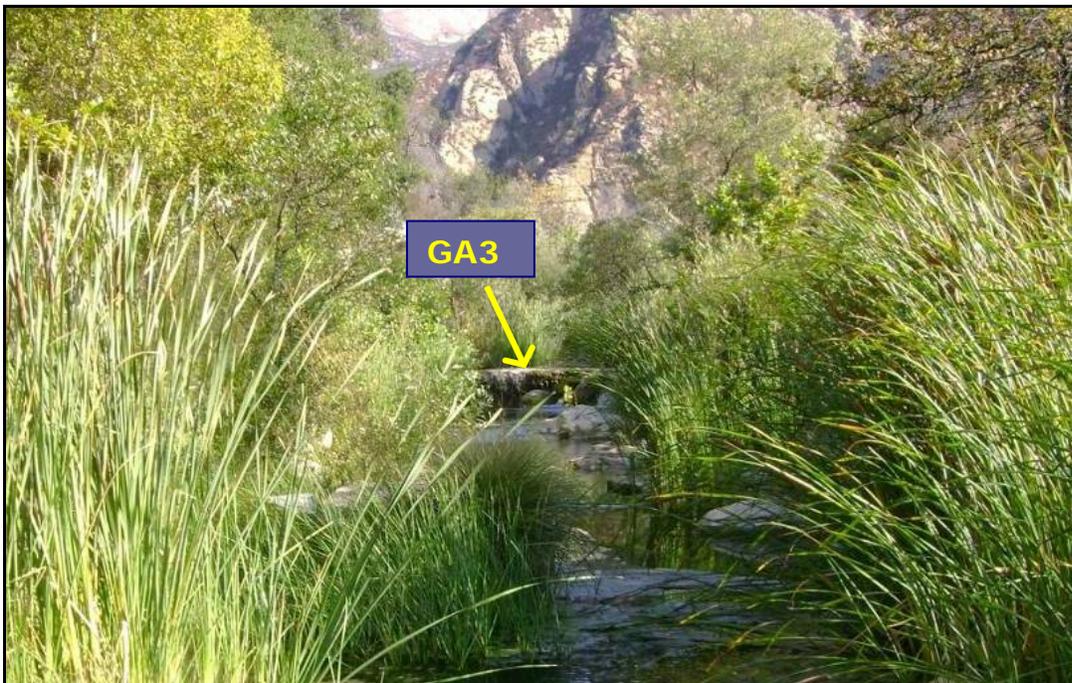
Figure 4.3 – Looking upstream to GA3. Long shallow pool controlled by GA2 gives rise to dense growth of cattails.

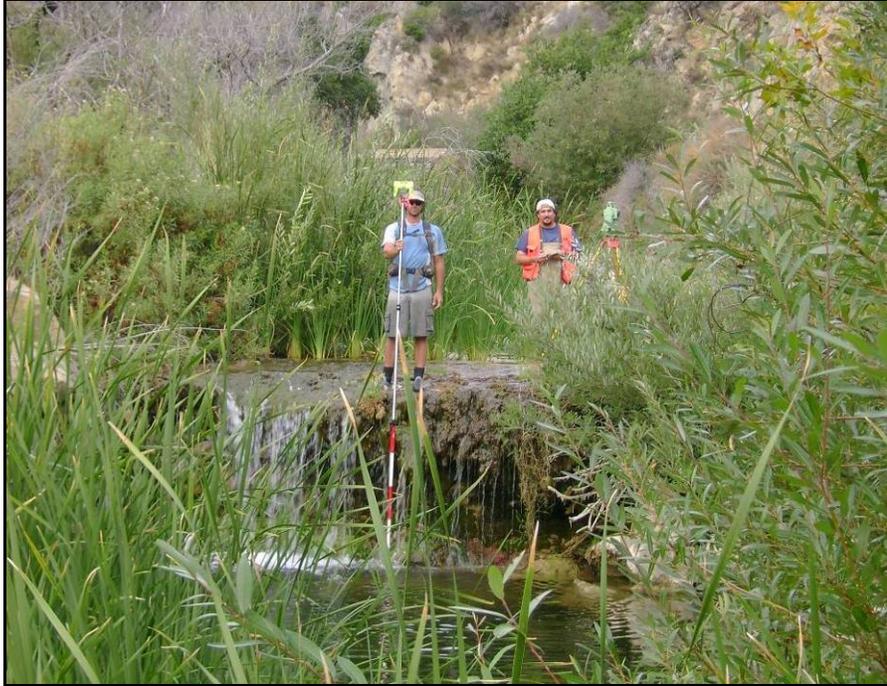
GA 4 (Sta 79+40) constructed from concrete and anchored on the left bank into a long sacrete revetment wall along the highway. The weir spans 27 feet across the channel and is 8 feet wide. The spillway has been retrofit with railroad ties to act as baffles. The thickness of the structure is 2 feet with 3 feet undercut. On the right bank, the structure has been formed around a large boulder/bedrock outcrop. The tailwater pool is one of the largest found in the study reach and is heavily armored on both banks with 2 to 4 ton RSP. It maintains a residual pool depth of at least 7.4 feet.

Figure 4.7 – Looking upstream at GA4, which is controlled by a boulder weir constructed by CA State parks. GA4 is undercut approximately 3 ft and the banks and pool are scoured and have been reinforced by large rock placed along the highway revetment.

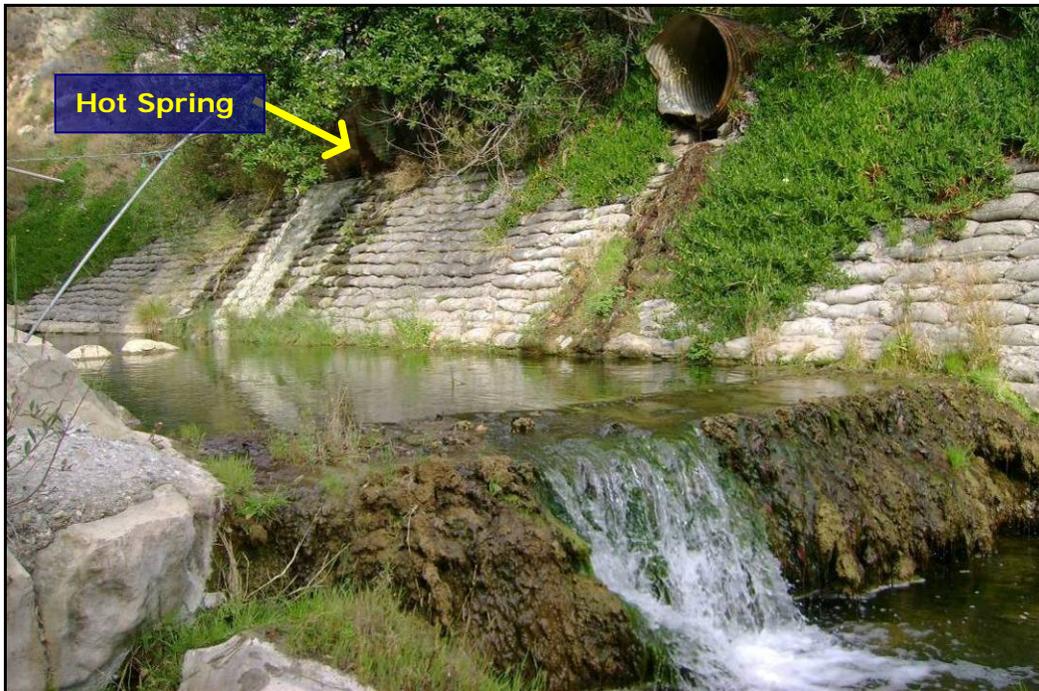
Figure 4.8 – Grade control GA5 located 80 ft upstream of GA4. Note the 36-inch highway drainage culvert and hot spring outlet located at the top of sacrete revetment wall.

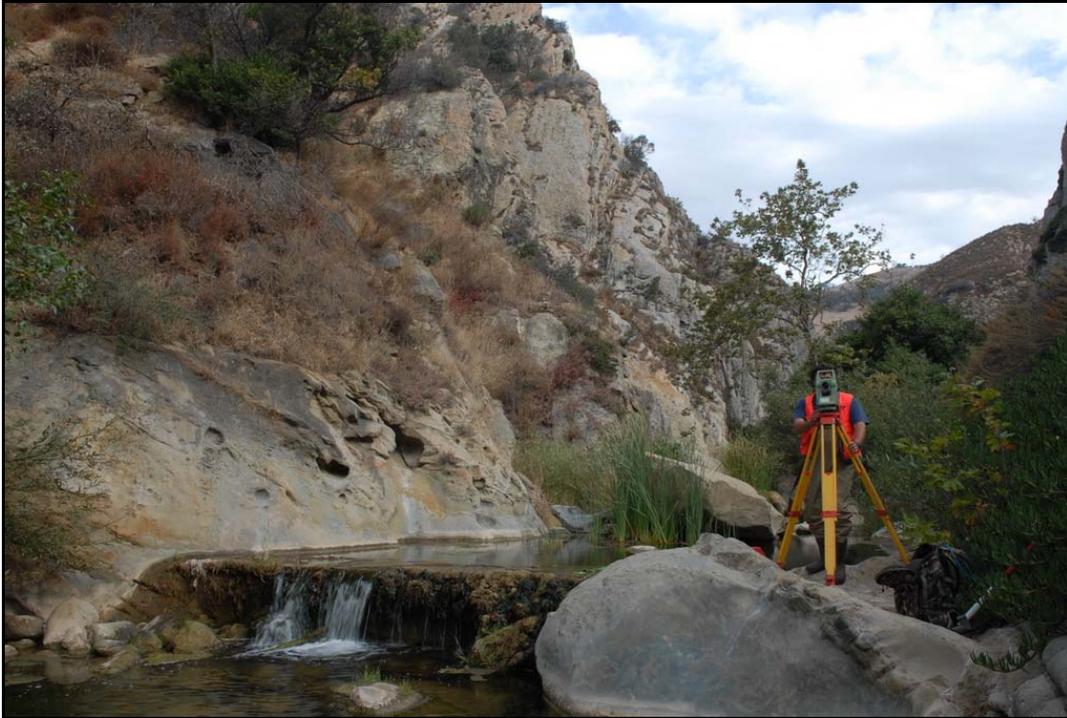
Figure 4.9 – Grade control GA6 located 90 ft upstream of GA5.

GA6 appears to be a natural constriction point in the channel, with bedrock along the right bank and either bedrock or a very large boulder along the left bank (Figure 4.9). Fish passage could be improved by removing and reshaping the concrete in GA6 to make for a more natural type of step. Making the drop more complex would help eliminate the sheeting flow over the weir and make it hydraulically resemble the numerous boulder and bedrock steps that are immediately upstream.

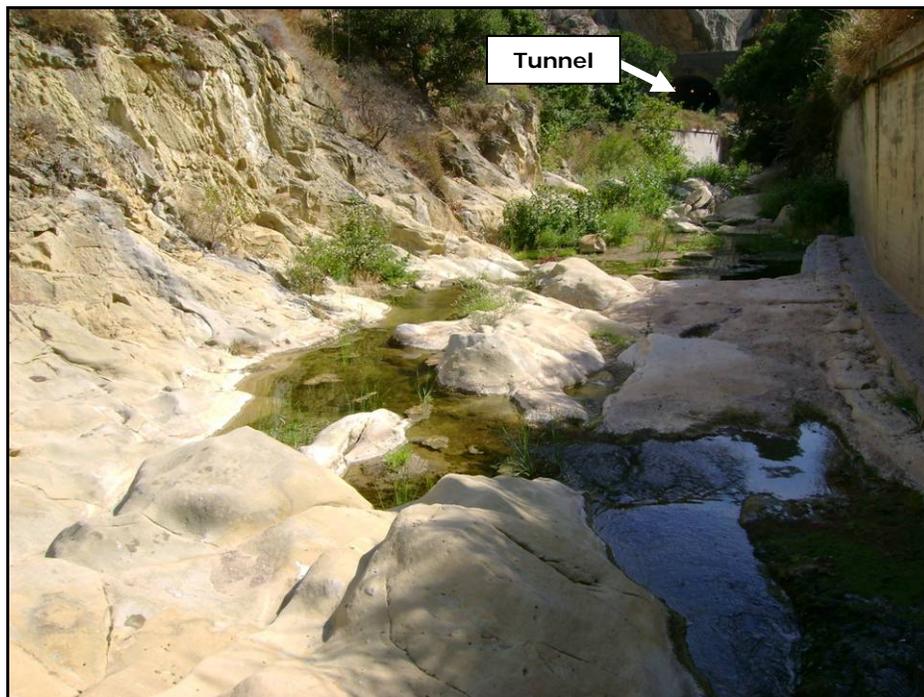
Figure 4.13 – Looking downstream at bedrock chute (BR_CHUTE), with tunnel of northbound Highway 101 in background. Note the bedrock banks on left and vertical concrete retaining wall forming right bank.

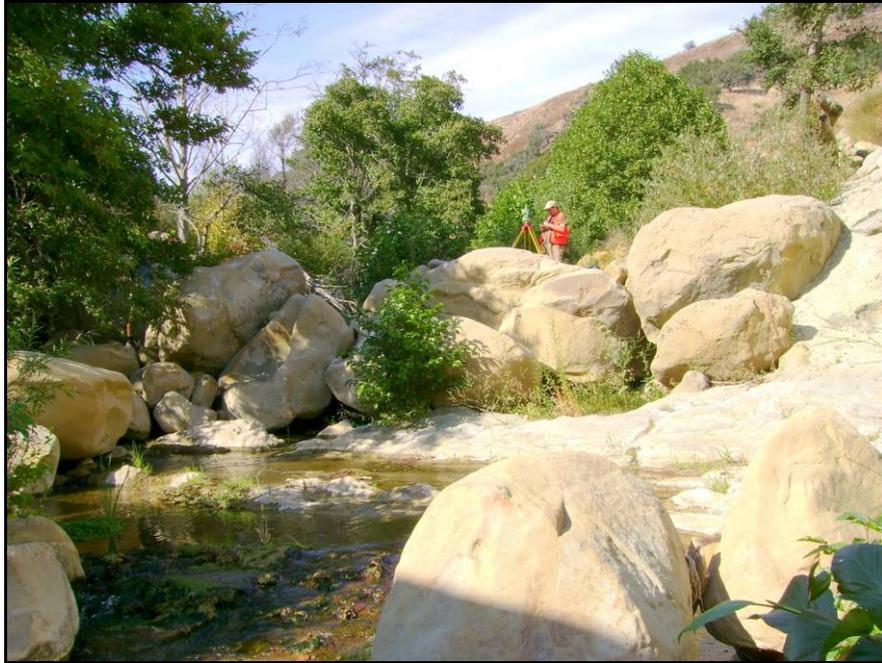
Figure 4.14 – Looking upstream at boulder jam (BLDR_JAM), located at upstream end of bedrock chute. The right boulder is secured to concrete retaining wall with rebar. There is a small channel around the jam on the left side of photo that adult steelhead can likely ascend during moderate to high flows. Lack of a leap pool at the base of the side channel makes it a barrier at low flows.

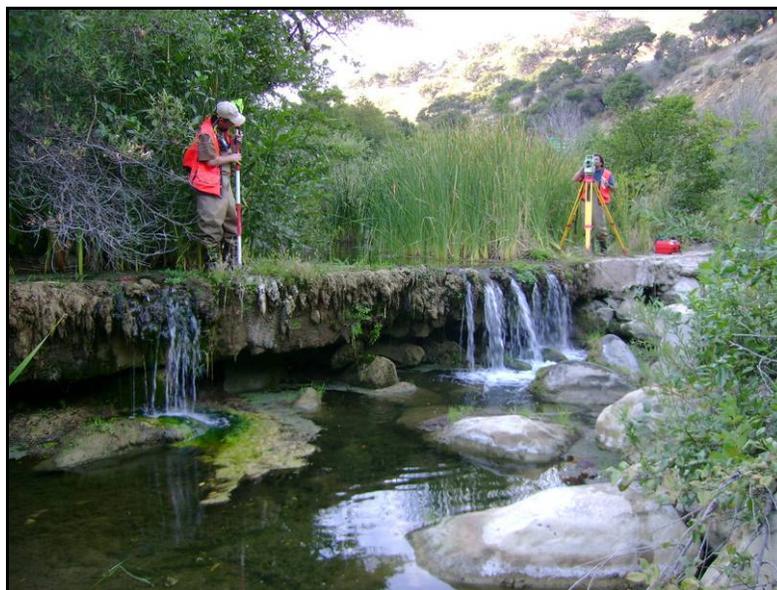
Figure 4.15 – GA 7 is skewed at a 45-degree angle with the centerline of the channel. It is likely that this structure was built to protect a now- abandoned pipe that is visible in parts of the structure.

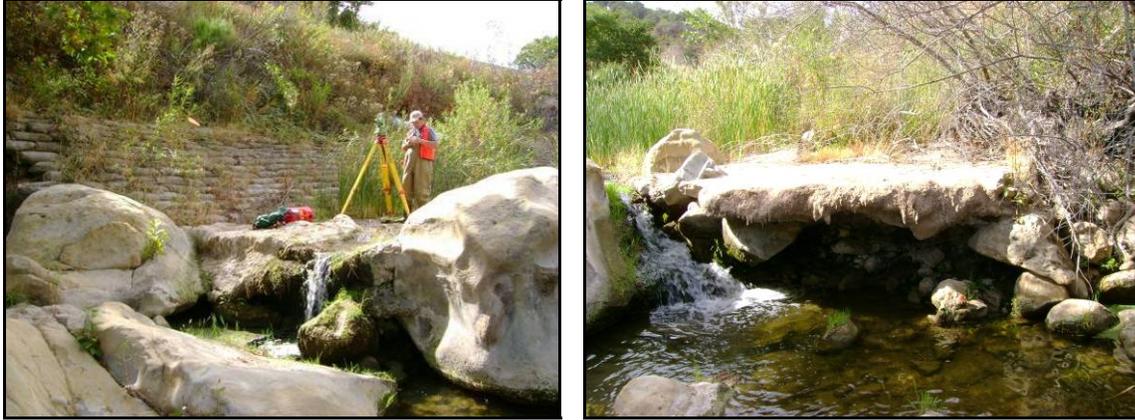
Figure 4.18 – GA8 appears to be a concrete apron less than 1 foot thick, poured over an existing boulder cluster. It is undercut approximately 4 ft and failing around the large mid channel boulder.

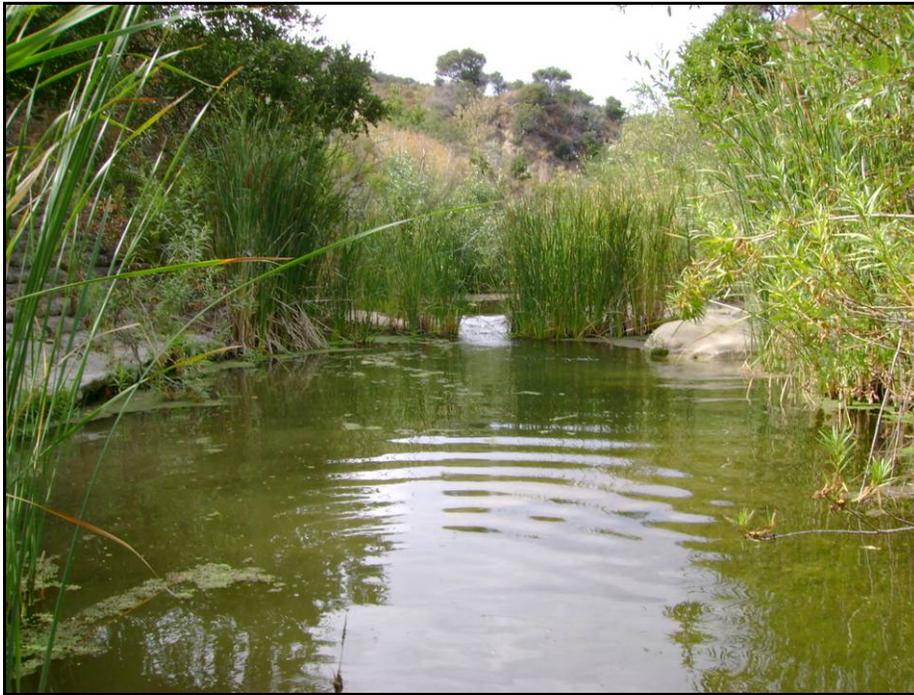
Figure 4.19 – GA9 has the smallest residual drop and backwatered during fish passage flows.

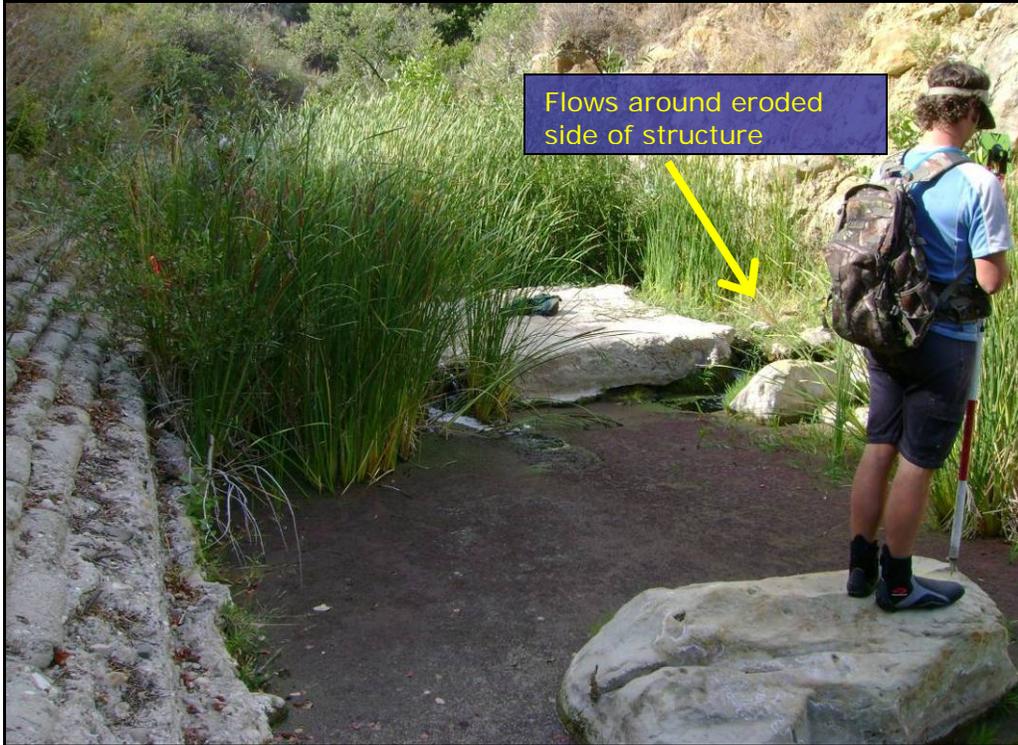
Figure 4.20 –GA10 is failing along the river-left bank from flanking that has eroded the native material along the steep right bank.

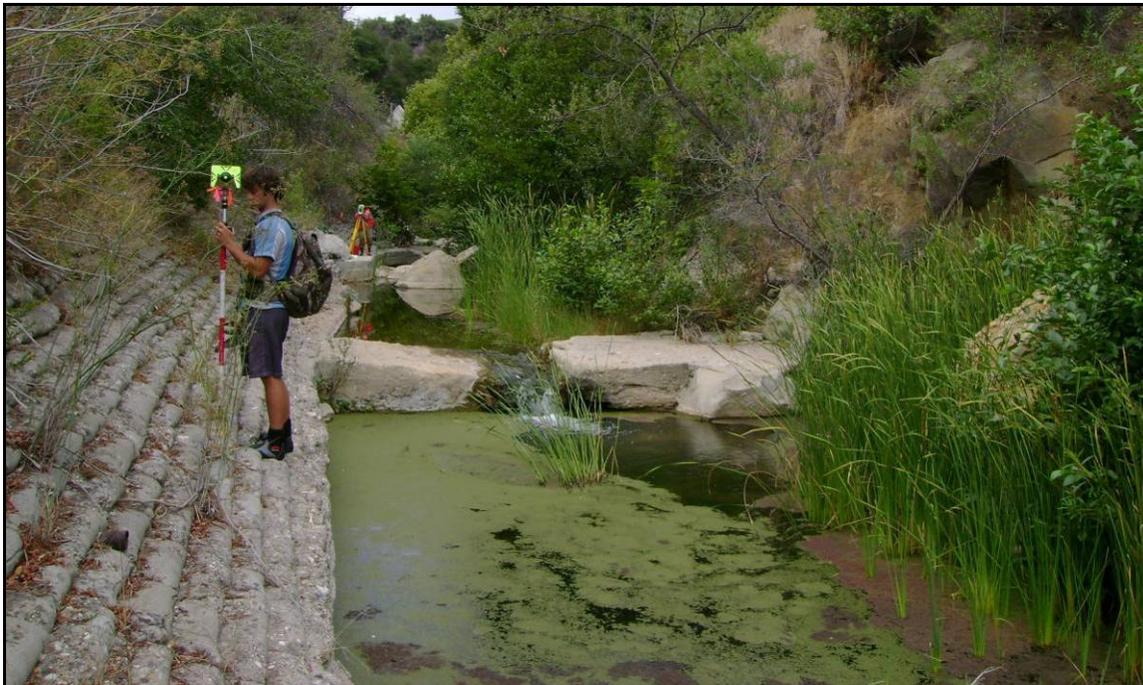
Figure 4.21 – GA11 and GA12 are keyed to sacrete and large boulders.

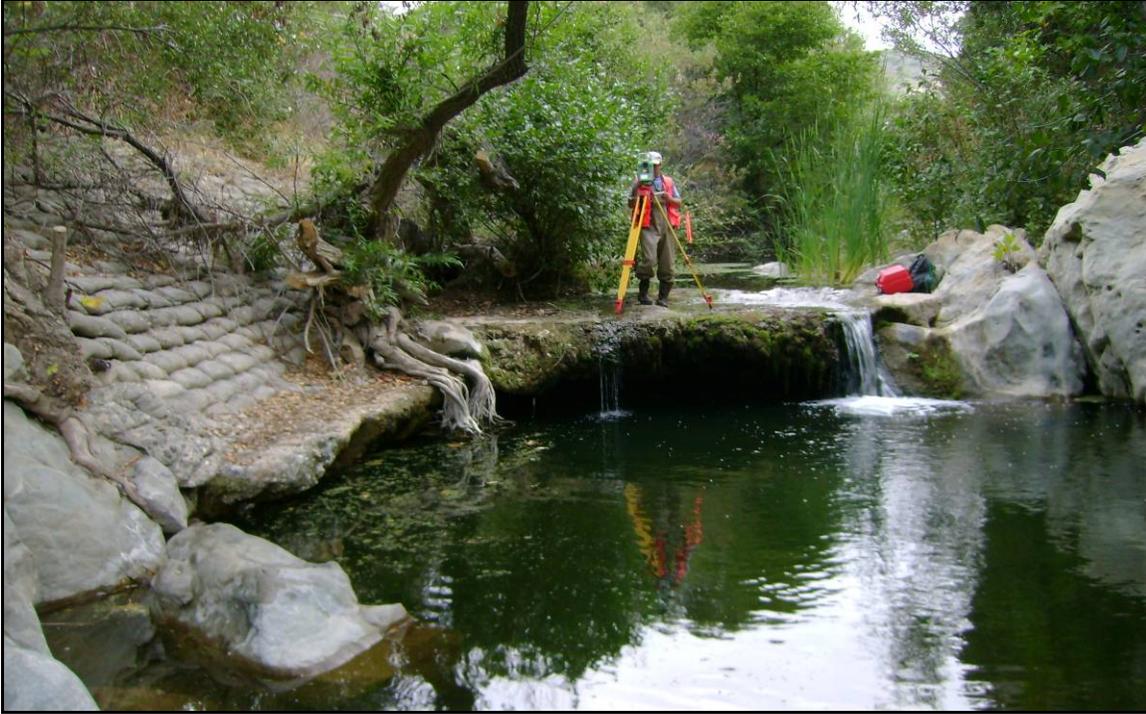
Figure 4.22 - GA13 is keyed into the sacrete wall and large boulders and exposed bedrock. There is ample evidence of scour along the undercut wall and GA13 is undercut approximately 5 ft. The pool elevation is controlled by a bedrock chute the spans the entire width of the downstream channel.

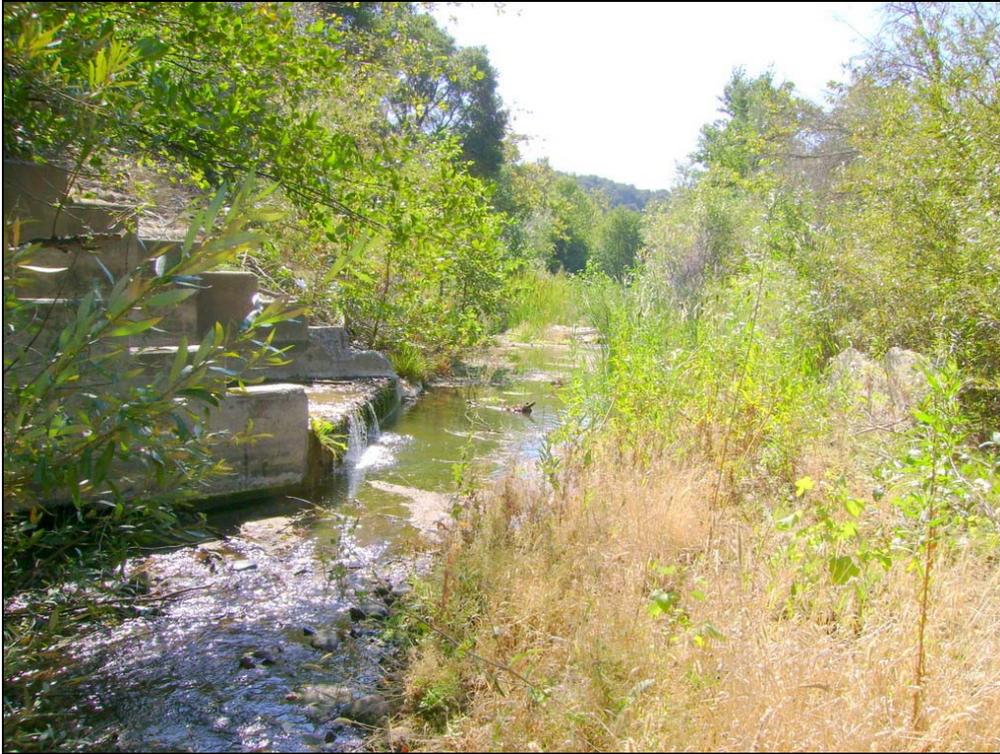
Figure 3 – Outlet of Las Canovas Creek culvert, at the confluence with Gaviota Creek. Looking downstream towards tailwater control in Gaviota Creek.

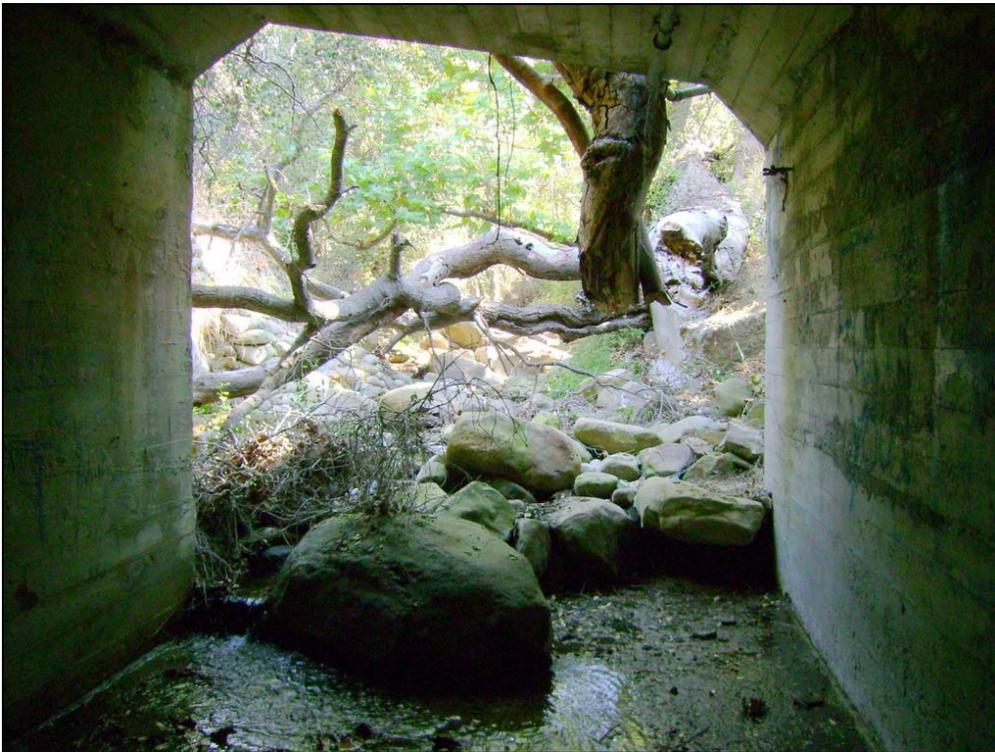
Figure 4 - Looking upstream through the inlet of the Highway 101 Las Canovas Creek culvert. The crossing is a 10 ft x 10 ft box culvert, with 3 turns and four distinct breaks in slope. There is substantial aggradation of boulders and cobbles at the inlet.
