Technology &
Development
Program

Response of Road- Stream Crossings to Large Flood Events in Washington, Oregon, and Northern California

**USDA Forest Service
Six Rivers National Forest
Pacific Southwest Region**

September 1998

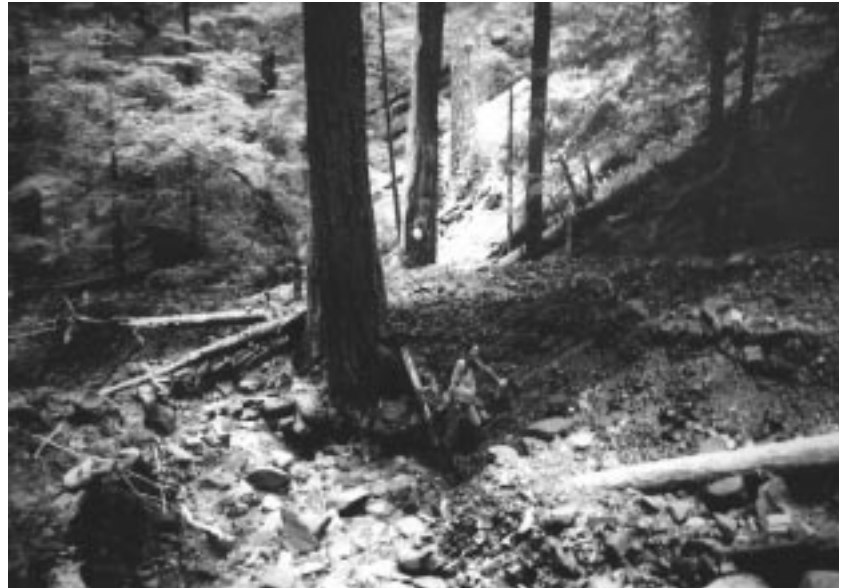
R9800127

Figure 3—Debris flows were relatively easy to identify. Evidence consisted of either evacuated channels upstream of the crossing or, as in this photo, large, poorly stratified deposits where the flow was impounded against the road fill.
