# **Stonybrook Creek Watershed**

## **A Strategic Plan for Eliminating Barriers to Steelhead Migration**

June 4, 2010

**Michael Love & Associates**

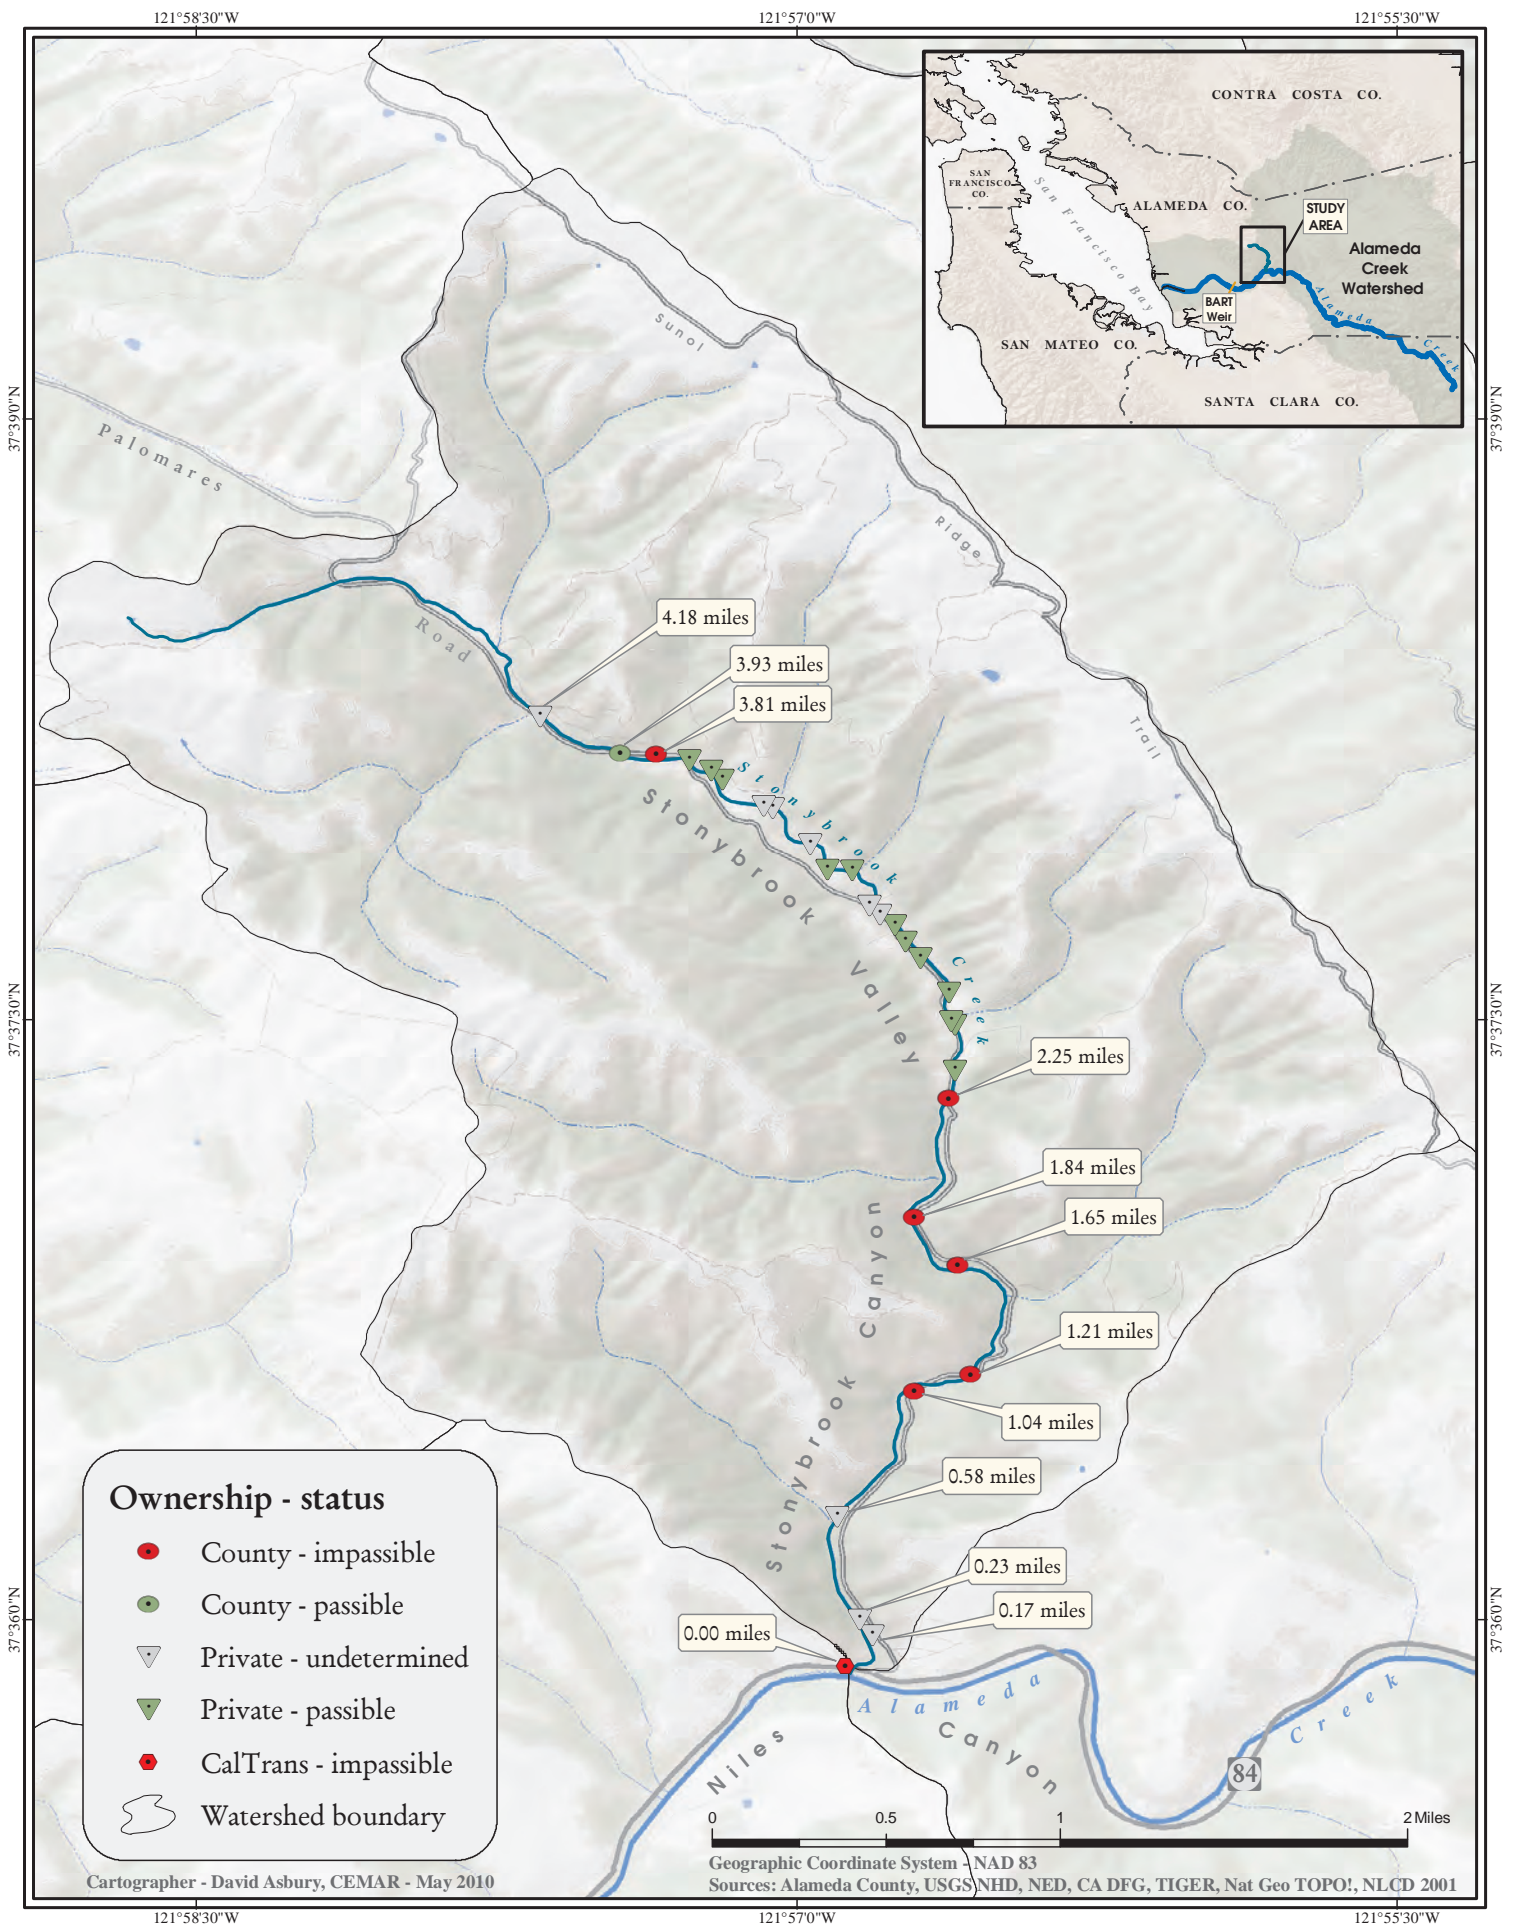
Figure 1. Location of known road-stream crossings within the Stonybrook Creek watershed and their fish passage status.

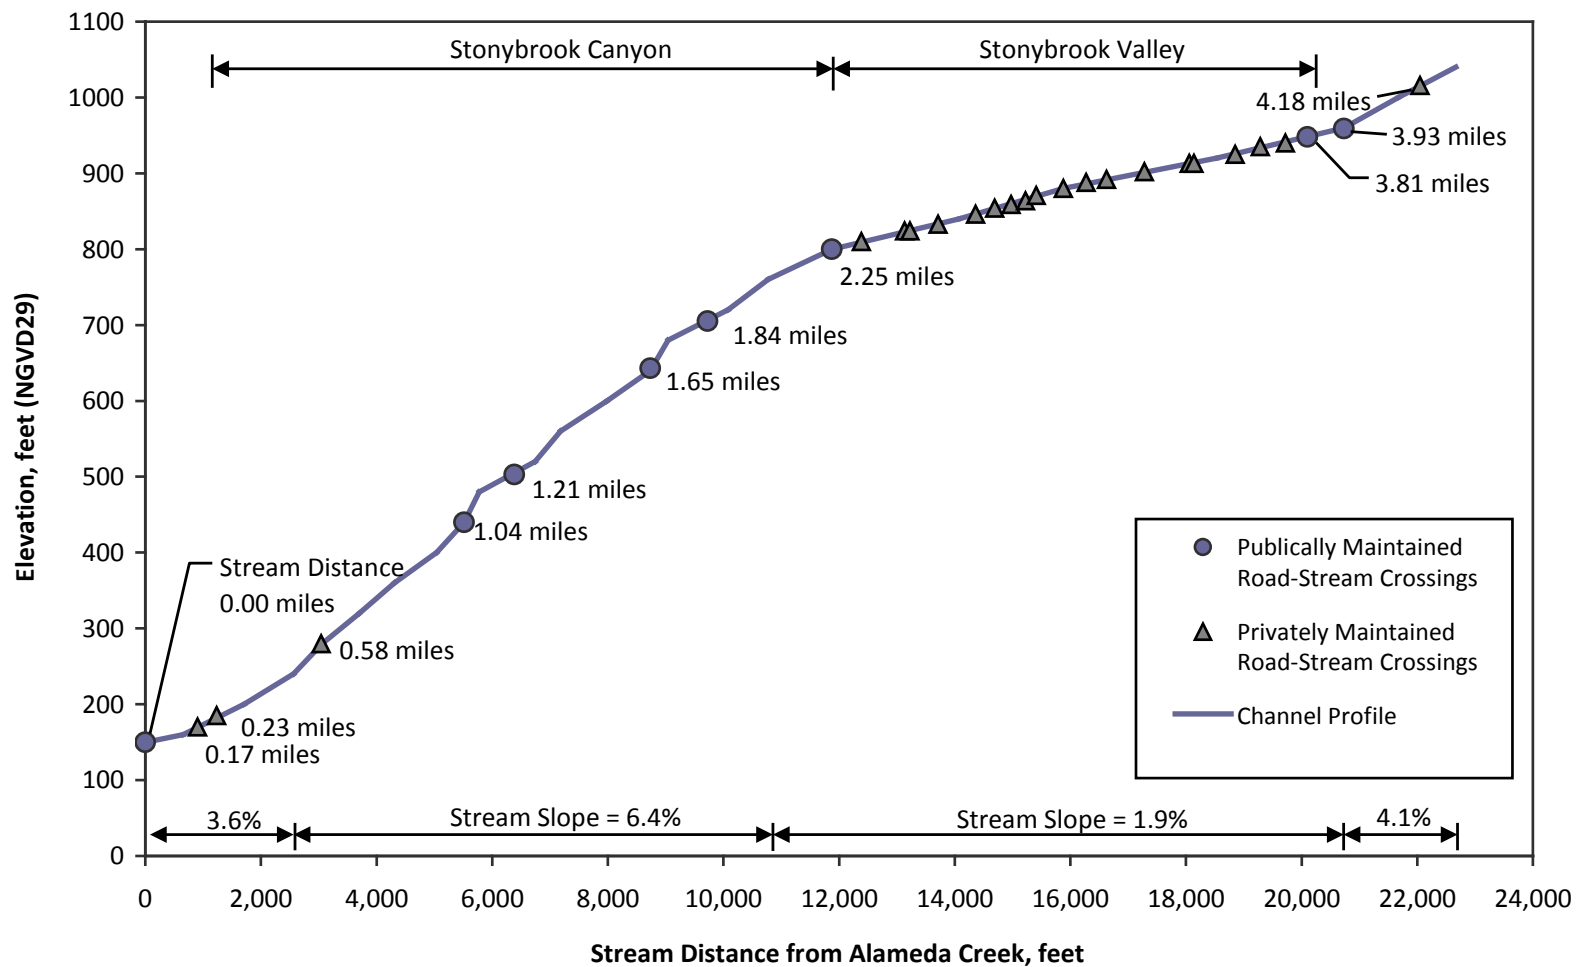
Figure 2. Longitudinal profile of Stonybrook Creek based from the USGS Niles and Dublin Quadrangles with 40-foot contour spacing. Location of public and privately maintained road-stream crossings, given in Stream Miles, is based on hip-chain distance measured by ACPW (2002).
