# **Stonybrook Creek Watershed**

# A Strategic Plan for Eliminating Barriers to Steelhead Migration

June 4, 2010

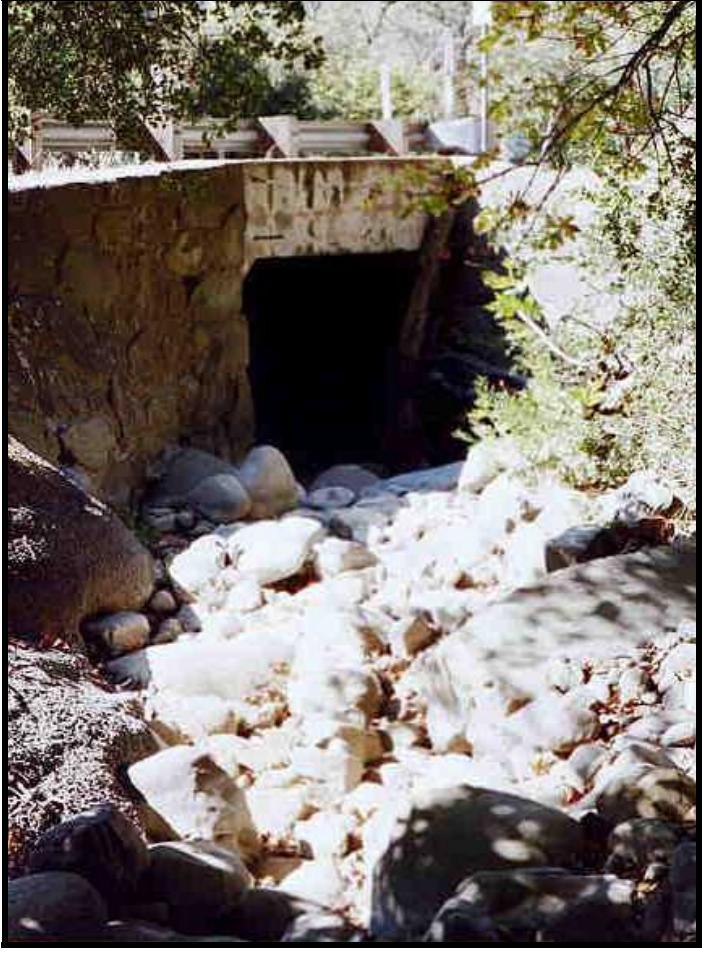
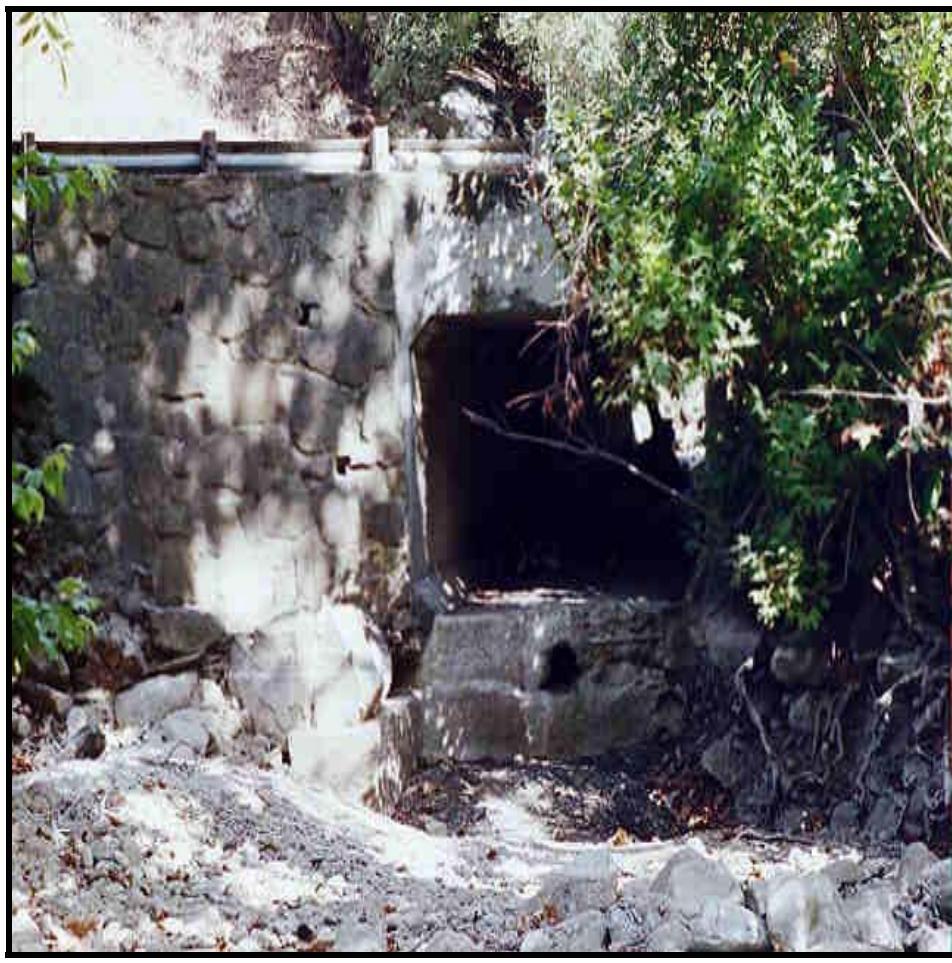
# Stream Mile 0.00 (Stobk#1): Highway 84 CalTrans Culvert (Niles Canyon Road), Milepost 12.90

CalTrans is aware of the fish passage problems at this site and is planning to replace the crossing. Replacement should address the aggraded stream channel immediately upstream of the crossing and the poor alignment of the channel with the culvert inlet. Because this is the most downstream barrier on Stonybrook Creek, it should be given a high priority for replacement. The preferred crossing type, schedule for implementation, and cost for replacement is unknown at this time.

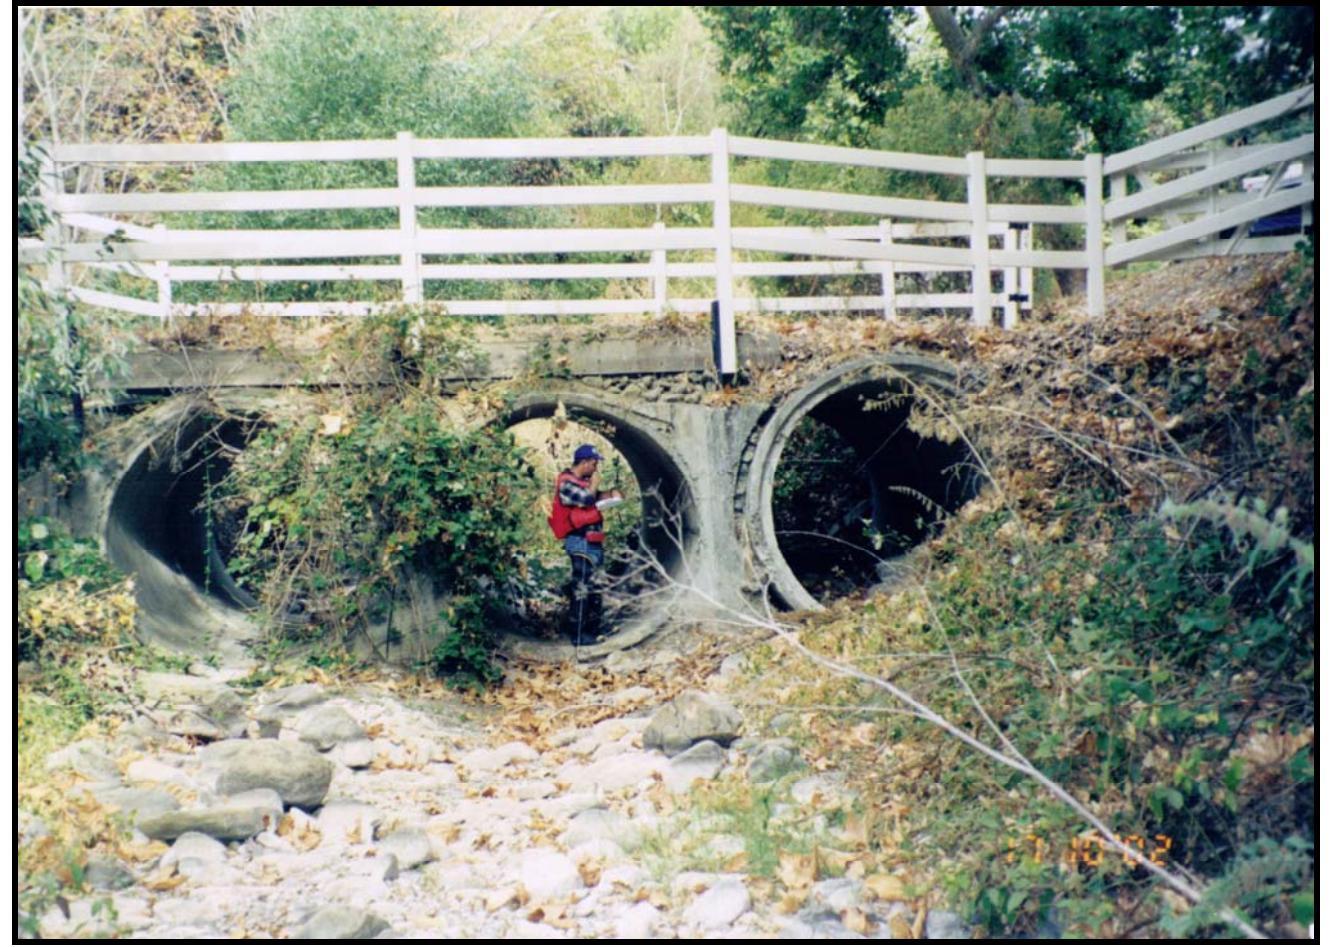
**Stream Mile 0.17 Private Culvert**

The crossing fails to meet CDFG fish passage assessment criteria for juvenile and resident trout at all flows, and is a barrier for adult steelhead 54% for of the migration flows. The radio tagged adult steelhead released into Alameda Creek in 1999 were able to pass through this crossing.

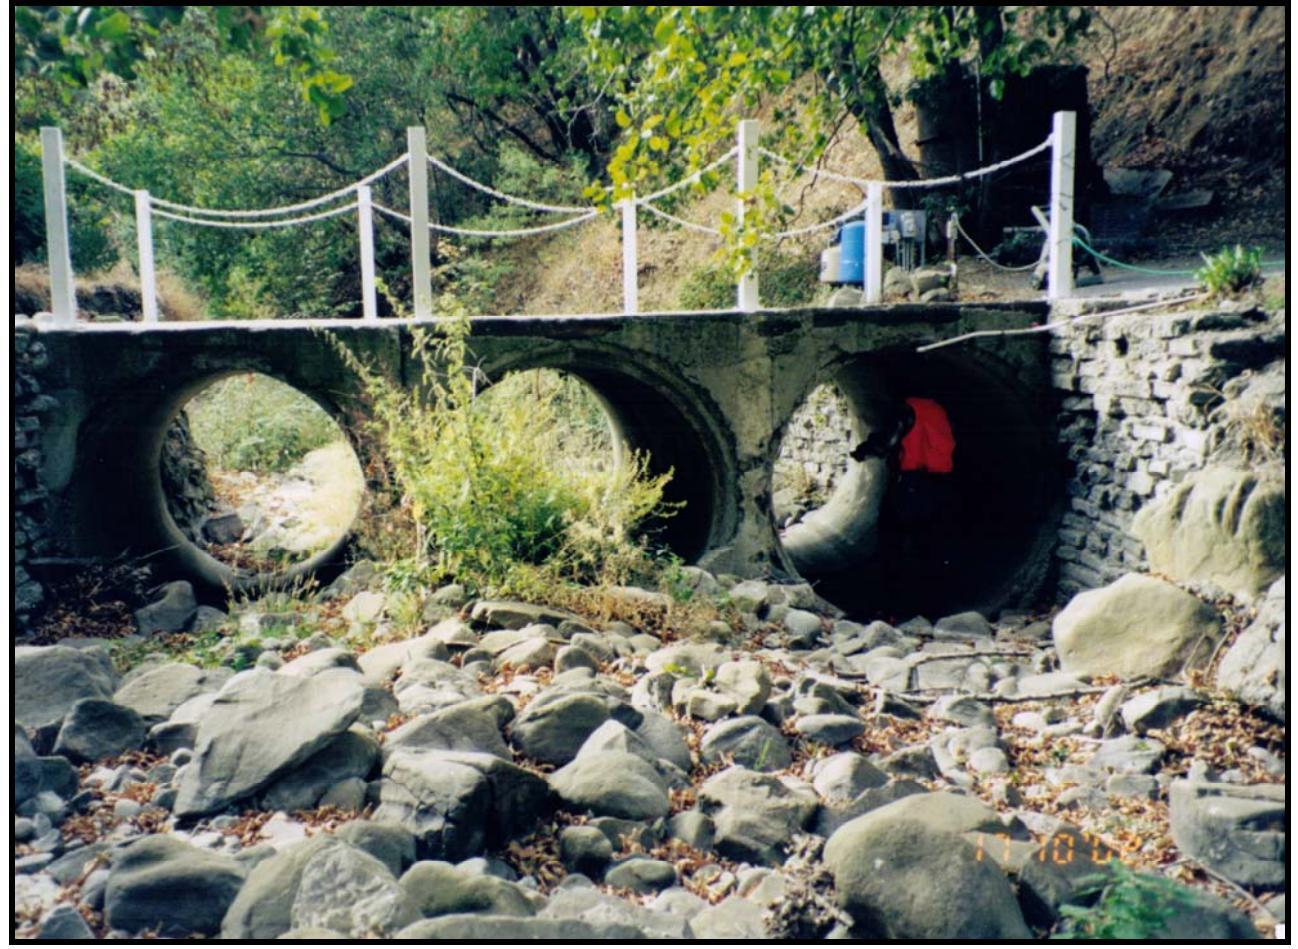
# Stream Mile 0.23 Private Culvert

The crossing fails to meet CDFG fish passage assessment criteria for juvenile and resident trout at all flows, and is a barrier for adult steelhead for 45% of migration flows. The pair of radio tagged adult steelhead released into Alameda Creek in 1999 were able to pass through this crossing.

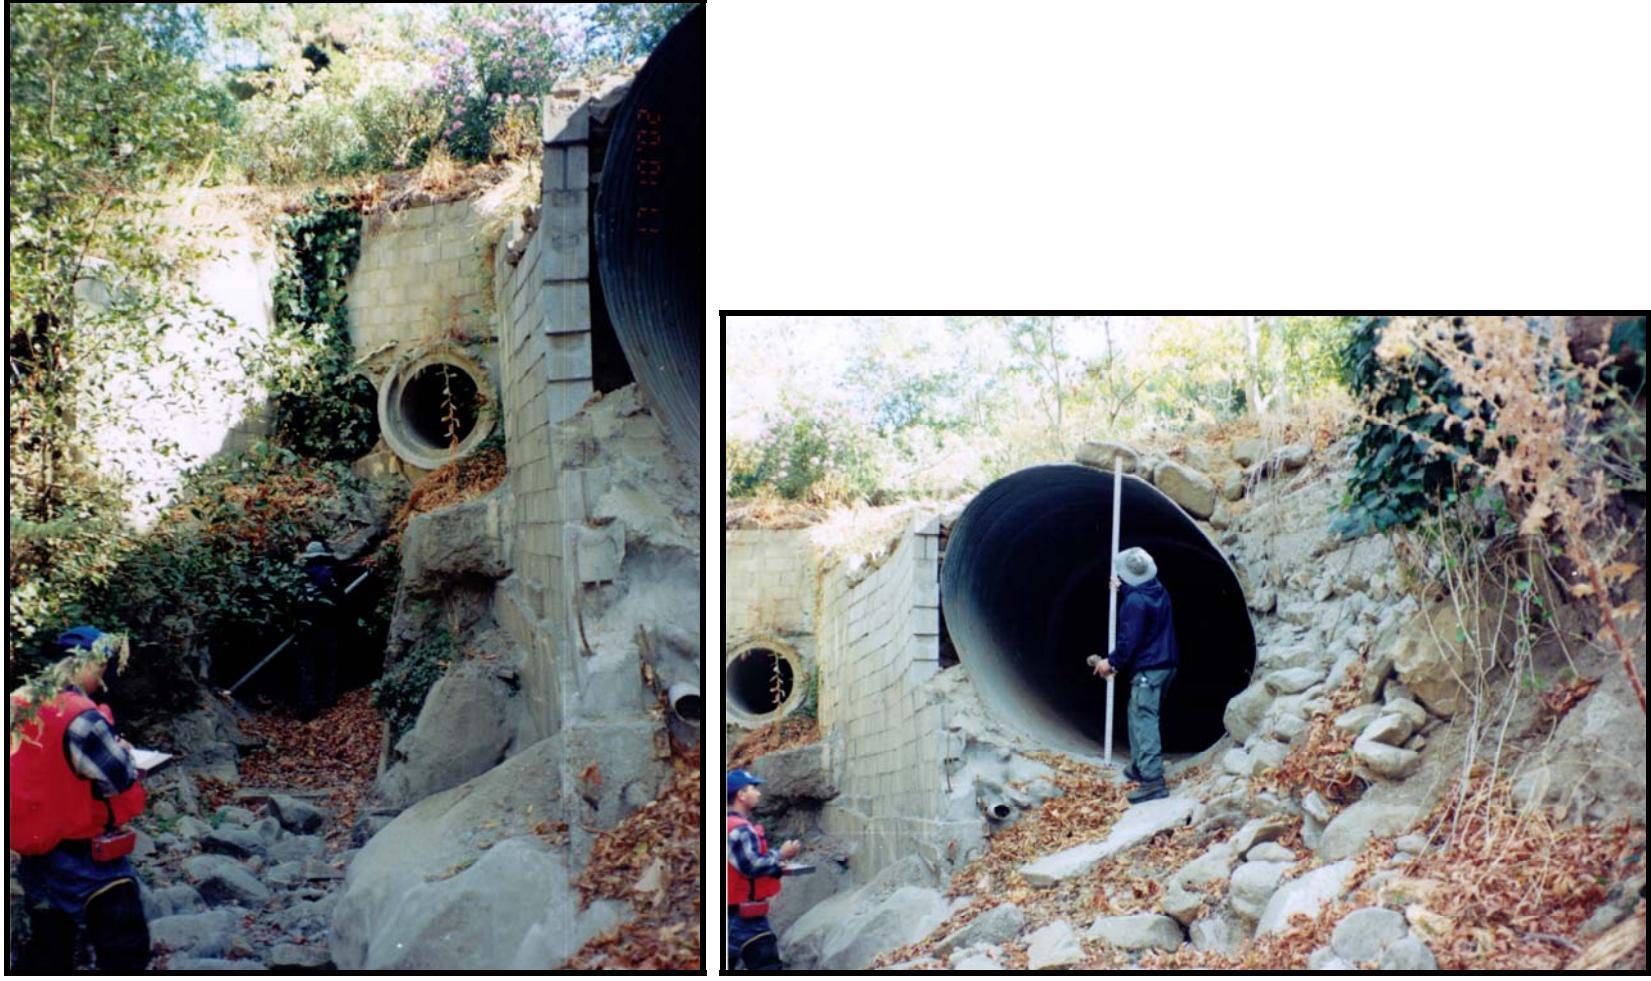
# **Stream Mile 0.58 Private Culvert**

This crossing was only assessed visually for fish passage. It appears passable for adult steelhead at moderate fish passage flows, though water velocities through the single undersized culvert will likely be too great at higher fish passage flows. Accumulated sediment at the upstream end of the crossing may cause an impediment for passage. This crossing is likely not passable for juvenile trout at any flow. The pair of radio tagged adult steelhead released into Alameda Creek in 1999 were able to pass through this crossing.

Because this crossing was not surveyed, developing planning level recommendations and cost estimate was limited to assuming this replacement crossing would be similar to the replacement of

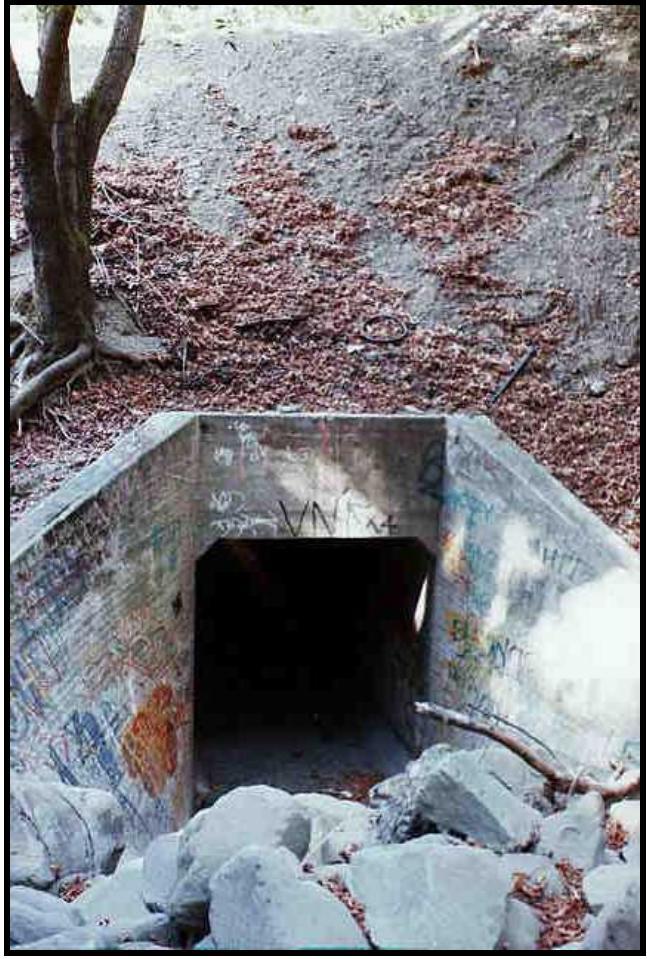
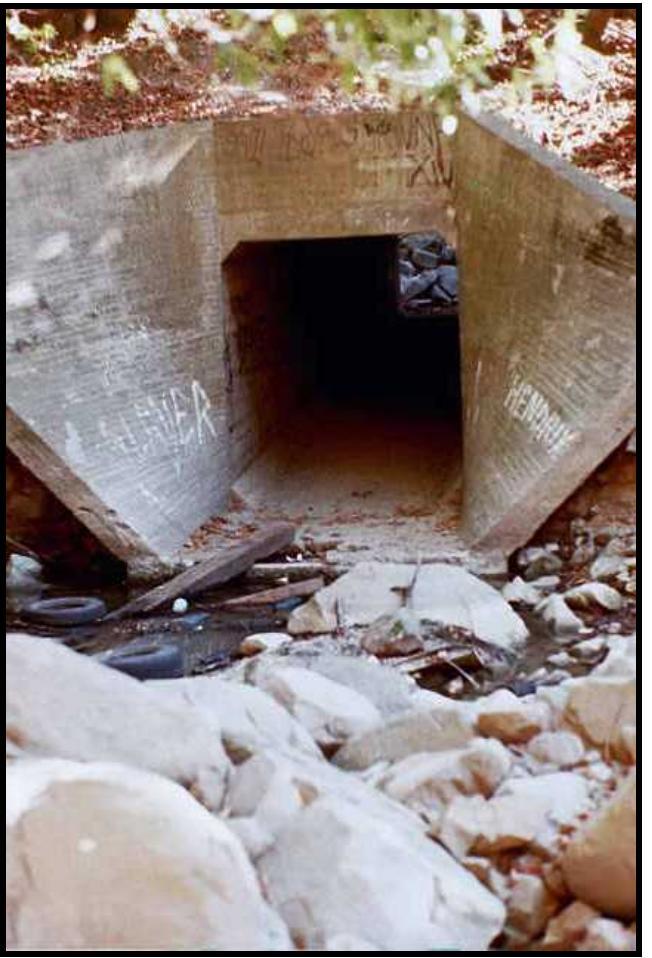
# Stream Mile 1.04 (Stobk#2): Alameda County Culvert Palomares Road, Milepost 8.75

The Palomares Road crossing at Mile Post 8.75 is located approximately 5,500 feet upstream from the confluence with Stonybrook Creek and Alameda Creek. The crossing was surveyed and assessed for fish passage in 2000 (MLA, 2001). The existing crossing consists of an 89-foot long 8-foot by 8-foot concrete box culvert in good condition, and with a large amount of road fill above it. The existing culvert is undersized; able to convey less than the 10-year peak flow before the inlet becomes submerged. The culvert creates a backwater during large flows, which has caused boulders to deposit in front of the culvert inlet, and created an 11-foot drop in the channel profile over a short distance.

Although there has not been a geomorphic assessment of the downstream channel, it appears that the existing culvert may substantially reduce the amount of large boulder-sized bedload transported downstream. There is a concern that replacing this crossing may cause the downstream private crossings, if not replaced, to become overwhelmed by the bedload. The first crossing downstream, at Stream Mile 0.58, is most at risk.

Conceptual designs for this crossing were prepared in 2005 (CEMAR et. al, 2005). The conceptual design includes replacement of the culvert with an 80-foot span pre-fabricated steel bridge with a sheet-pile retaining wall foundation. The conceptual design also included regrading 250 feet of stream channel to a similar slope and morphology as the stable channel upstream and downstream of the crossing. A steel bridge was selected for this site because the roadway elevation is well above the 100-year water-surface elevation, therefore not likely to collect debris. Steel bridges are substantially less expensive than pre-stressed concrete structures.

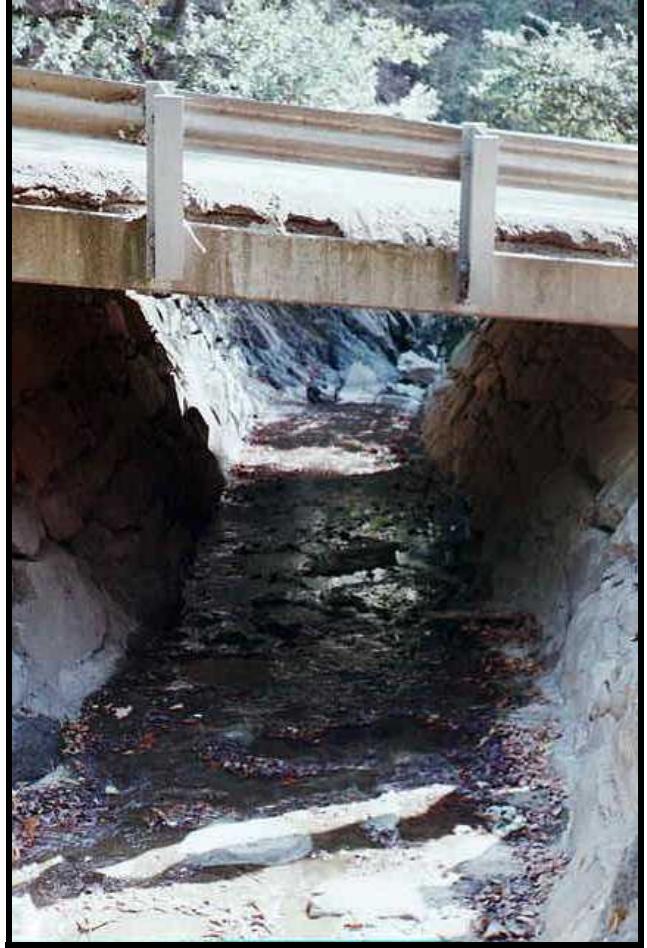
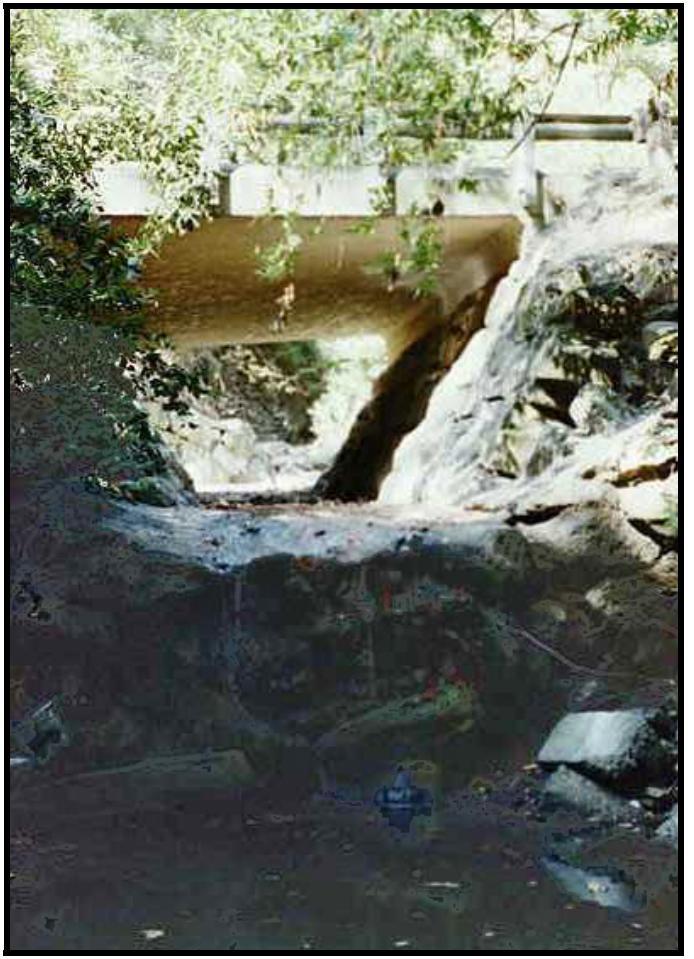
# Stream Mile 1.21 (Stobk#3): Alameda County Bridge Palomares Road, Milepost 8.60

The Palomares Road crossing at Mile Post 8.60 is located approximately 6,400 feet upstream from the confluence of Stonybrook Creek and Alameda Creek. The crossing was surveyed and assessed for fish passage in 2000 (MLA, 2001). The existing crossing consists of grouted masonry channel and a concrete bridge deck in good condition. The masonry channel under the bridge was constructed in the 1930's and has since been grouted. The concrete bridge deck has been more recently replaced. The existing crossing is substantially undersized, conveying less than the 10-year peak flow before the inlet becomes submerged. The road prism for Palomares Road encroaches into the stream channel upstream of the crossing.

Conceptual designs for this crossing were prepared in 2005 (W&K et. al, 2005). The conceptual design includes replacement of the culvert with a 32-foot span pre-fabricated concrete bridge with strip footings keyed into bedrock. The concept plan also included regrading 140 feet of stream channel to a similar slope as the stable channel upstream and downstream of the crossing.

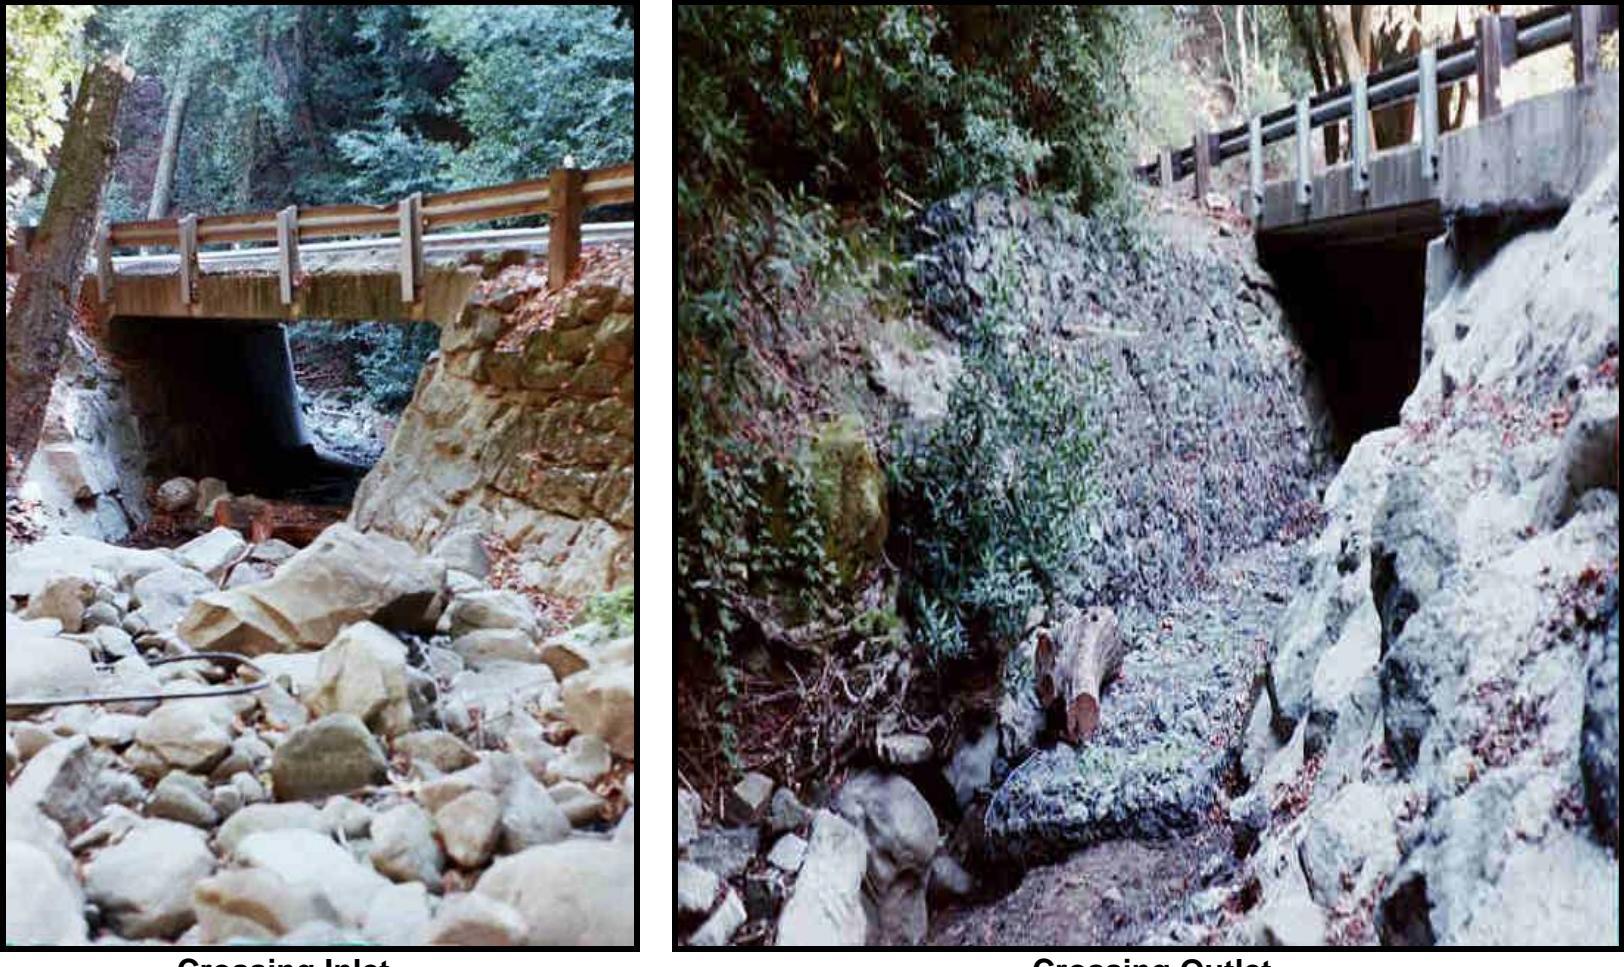
# Stream Mile 1.65 (Stobk#4): Alameda County Bridge Palomares Road, Milepost 8.16

The Palomares Road crossing at Mile Post 8.16 is located approximately 8,700 feet upstream of the confluence of Stonybrook Creek and Alameda Creek. The crossing was surveyed and assessed for fish passage in 2000 (MLA, 2001). The existing crossing consists of grouted masonry channel and a concrete bridge deck. The masonry channel under the bridge was constructed in the 1930's. Since then, the channel has been grouted and rip-rapped, and a gabion apron placed at the outlet. This gabion apron was failing during the time of the survey. The concrete bridge deck has been more recently replaced.

A 36-foot span, 8-foot high, prefabricated concrete bridge will convey the 100-year flow at this site. Approximately 240 feet of stream channel restoration is recommended to restore the channel profile and remove the bedload aggradation upstream of the crossing.

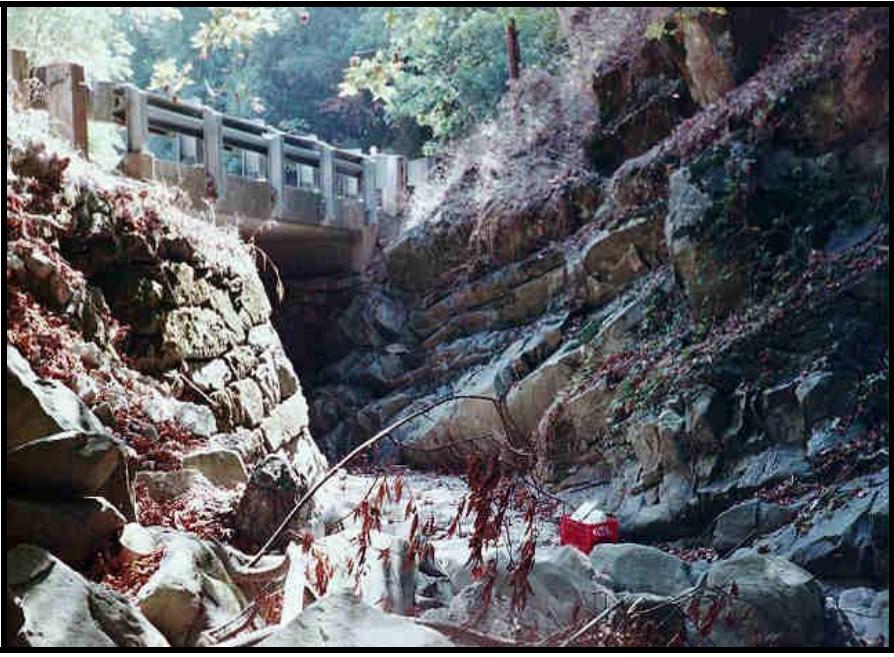
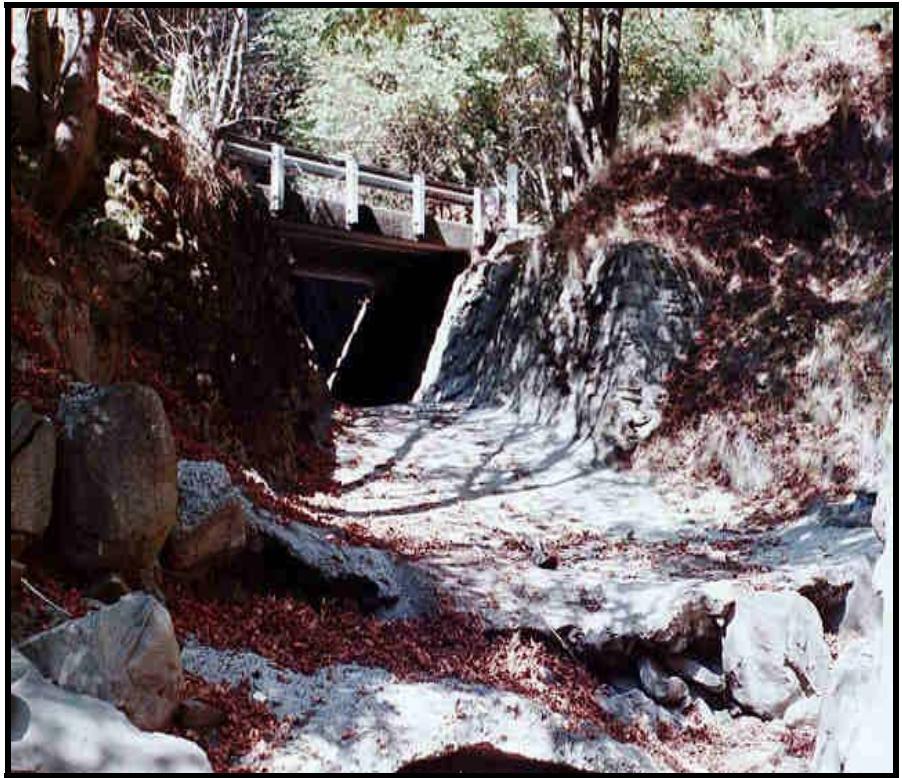
# Stream Mile 1.84 (Stobk#5): Alameda County Bridge Palomares Road, Milepost 8.00

The Palomares Road crossing at Mile Post 8.00 is located approximately 9,200 feet upstream from the confluence of Stonybrook Creek and Alameda Creek. The crossing was surveyed and assessed for fish passage in 2000 (MLA, 2001). The existing crossing consists of grouted masonry channel and a concrete bridge deck. The masonry channel was constructed in the 1930's. Since then, the channel bottom under the bridge has been grouted. The concrete bridge deck has been more recently replaced. The grouted outlet apron is severely undercut.

A prefabricated concrete arch culvert with a 16-foot span and 13-foot rise will convey the 100-year flow at this site. Approximately 135 feet of stream channel restoration is recommended to restore the channel profile through the crossing. The concrete rubble in the channel approximately 200 feet upstream of the crossing should be removed as part of the crossing replacement project

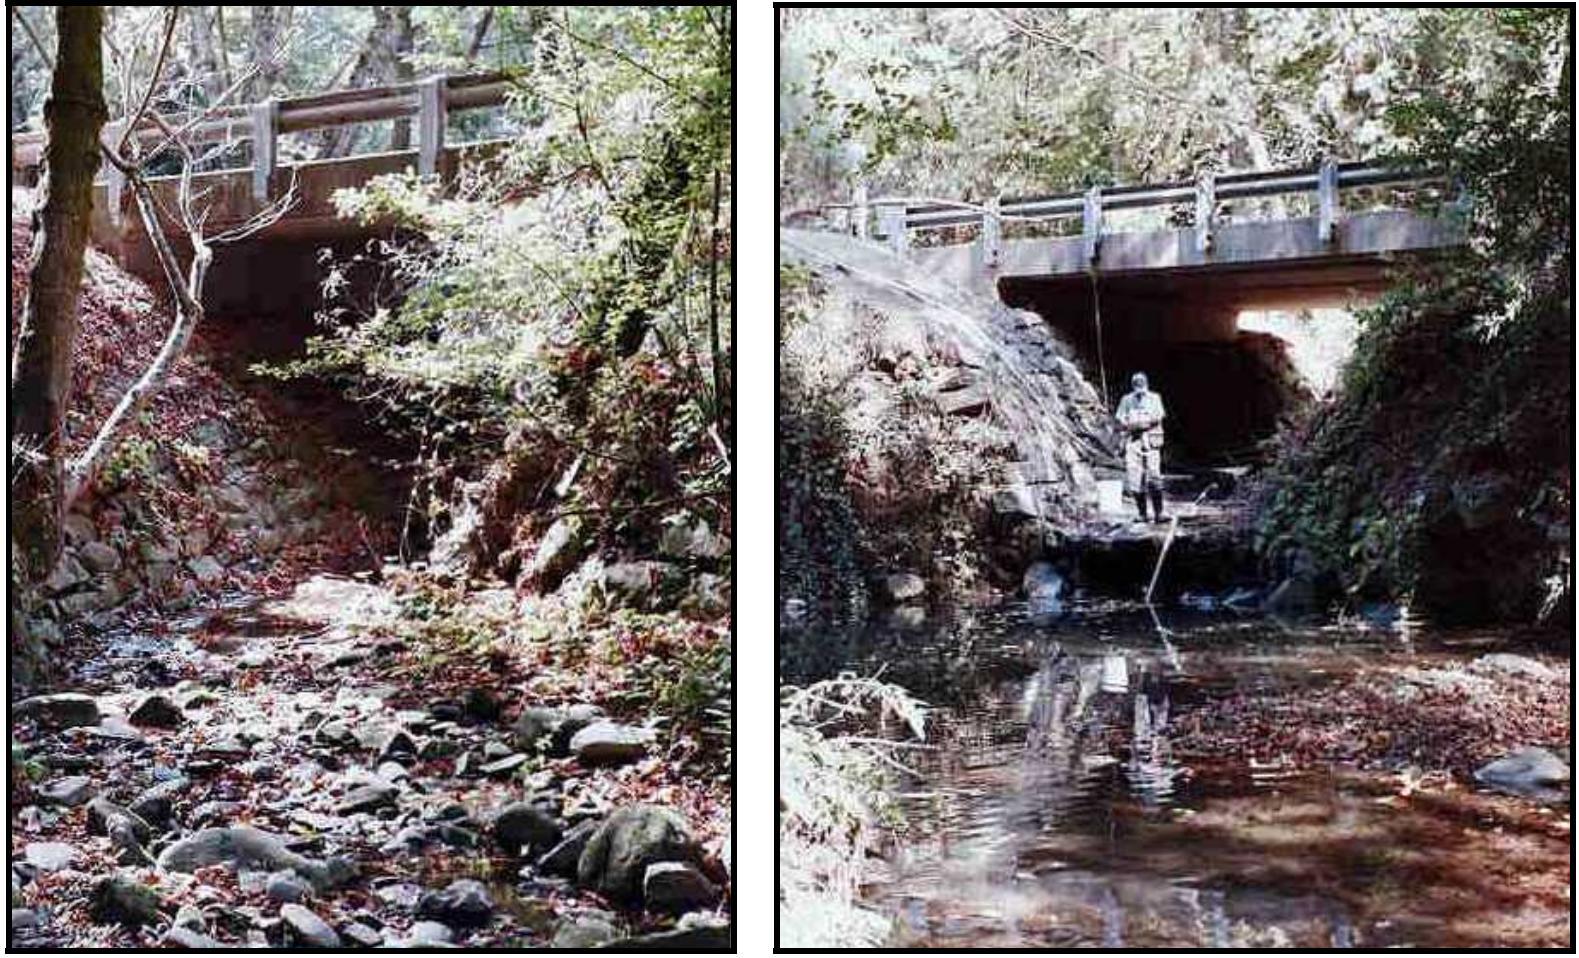
# Stream Mile 2.25 (Stobk#6): Alameda County Bridge Palomares Road, Milepost 7.57

The Palomares Road crossing at Mile Post 7.57 is located approximately 12,000 feet upstream from the confluence of Stonybrook Creek and Alameda Creek. The crossing was surveyed and assessed for fish passage in 2000 (MLA, 2001). The existing crossing consists of grouted masonry channel and a concrete bridge deck. The masonry channel was constructed in the 1930's. Since then, the channel bottom under the bridge has been grouted and the concrete deck replaced. The outlet apron is severely undercut.

The preferred treatment for this site is replacement of the crossing with an open bottom structure. However, it is feasible to retrofit the structure to eliminate the outlet drop and improve hydraulic conditions within the crossing.

Replacement of the crossing could utilize a 20-foot span and 11-foot rise prefabricated concrete arch that conveys the 100-year peak flow at this site. Approximately 200 feet of stream channel restoration is recommended to restore the channel profile through the crossing.
