Yontocket Slough

Fish Passage and Habitat Enhancement Planning Project

Final Report
May 2006

Prepared By: Michael Love & Associates
P.O. Box 4477
Arcata CA 95518
(707) 476-8938
mlove@h2odesigns.com

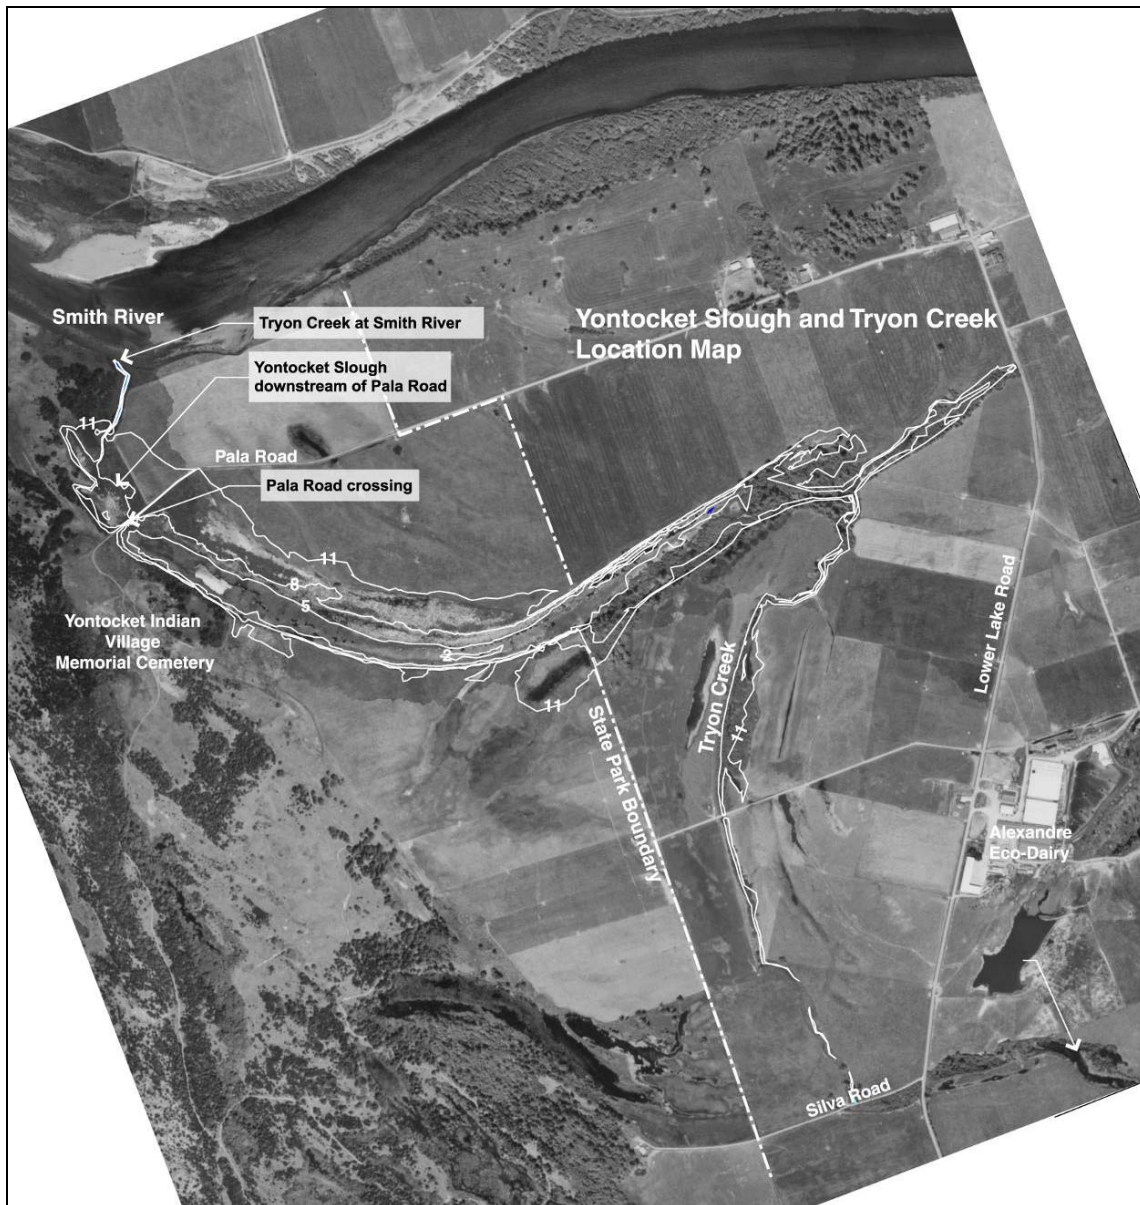
Figure 3.1 - Aerial photo showing area of mapped topography, which included (1) Yontocket Slough, (2) the Tryon Creek channel from Silva Road to the slough, and (3) the channel from the slough outlet to the Smith River. Elevations of contours are in NAVD88 datum.

All survey points were accumulated in AutoCAD LDD3 software to build a digital terrain model (DTM) from which contour lines were generated. The final DTM was built from approximately 20,000 points, 17,000 of which were corrected and filtered bathymetry points collected using sonar.

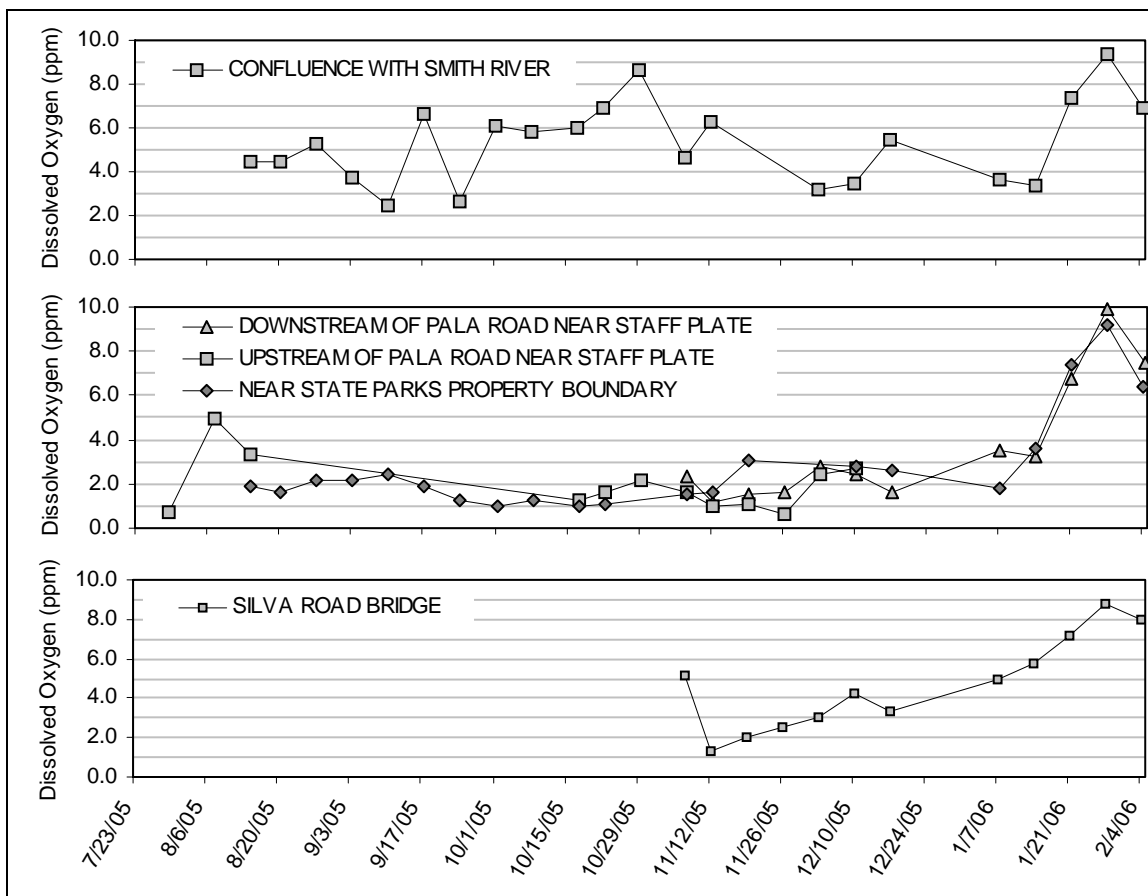
Figure 3.9 – Measured dissolved oxygen at five locations within the project area. In the upper slough levels were lethal (<2ppm) for salmonids through November.

Dissolved oxygen (DO) levels in Yontocket Slough were quite low from when sampling began in August 2005 through the beginning of January 2006; often less than 2.0 ppm, which is below the lethal limit for juvenile salmonids. DO levels remained dangerously low for salmonids even after the slough had refilled in late fall. The low DO is believed to be primarily caused by the large amount of decaying organic matter within the slough associated with the annual die-off of reed canary grass.

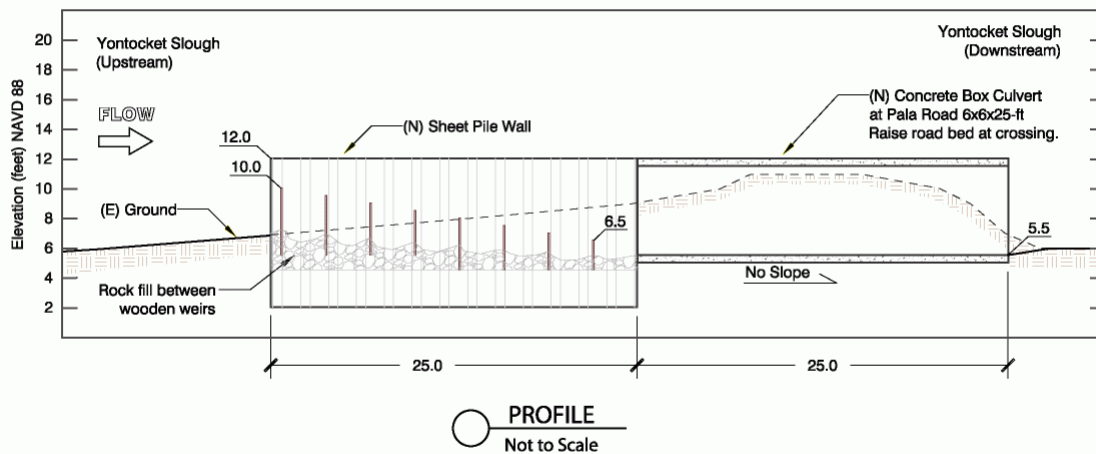
Figure 6.7 – Conceptual drawings of a fish ladder and overflow culvert at Pala Road to control water levels within the upper slough. The ladder is designed for adult and juvenile fish passage. The two new culverts would increase hydraulic capacity, decreasing the frequency of road overtopping and flooding of adjacent pastures.

species. A fish ladder would contain a series of pools and weirs. To provide for juvenile passage, maximum drop over weirs is 6 inches. Fish ladders are easily adjustable to changing water conditions but have a tendency of collecting debris, requiring routine inspection and maintenance.

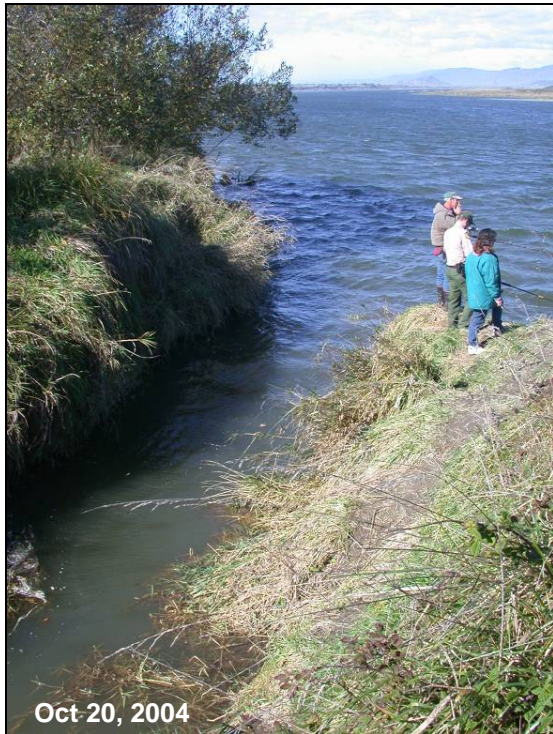
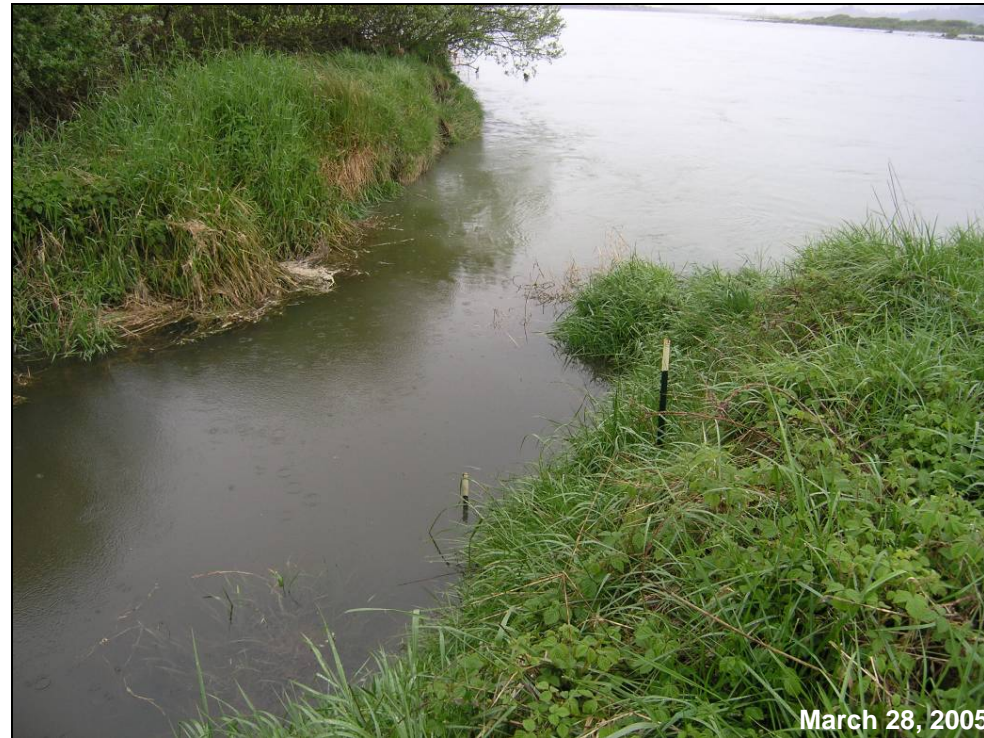
LOCATION 1 – Confluence of Tryon Creek with the Smith River. River levels are tidally influenced. During spring tides and higher river levels the Smith River will backwater and fill the lower portion of Yontocket Slough. When the river at Dr. Fine Bridge is near monitoring stage, the Smith River will completely inundate Yontocket Slough and Pala Road.

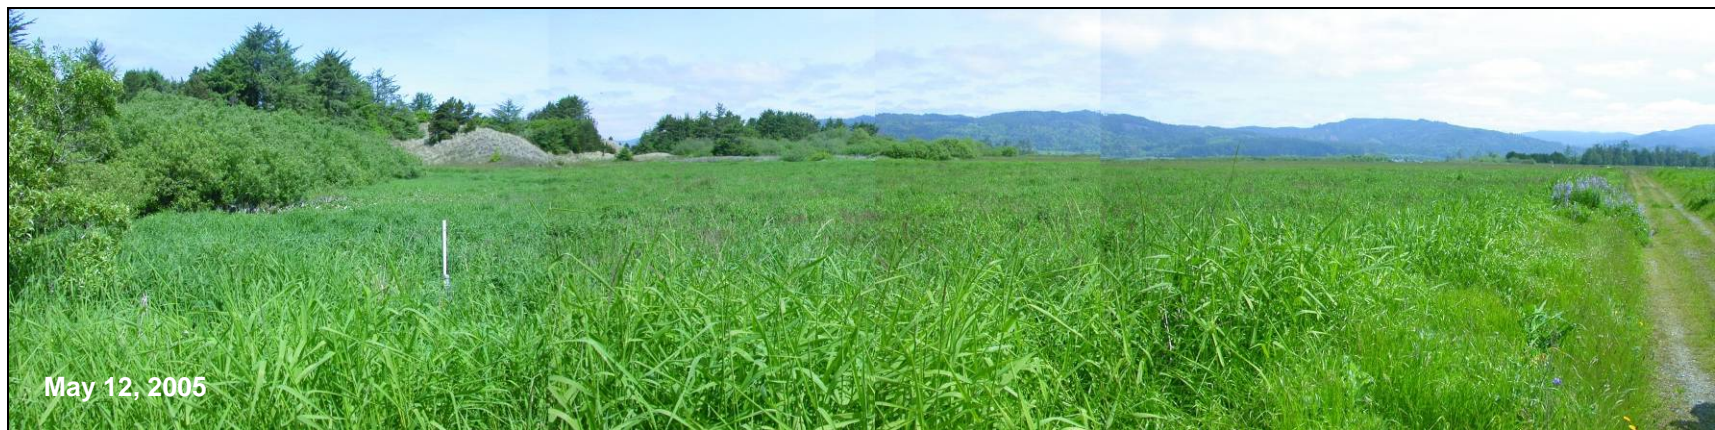
LOCATION 2 – Downstream of Pala Road, reed canary grass has colonized almost the entire slough.

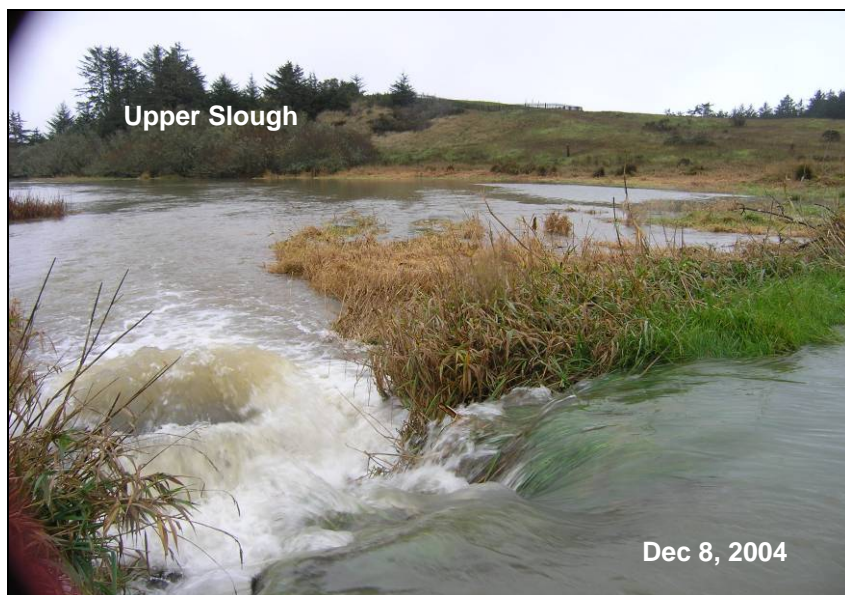
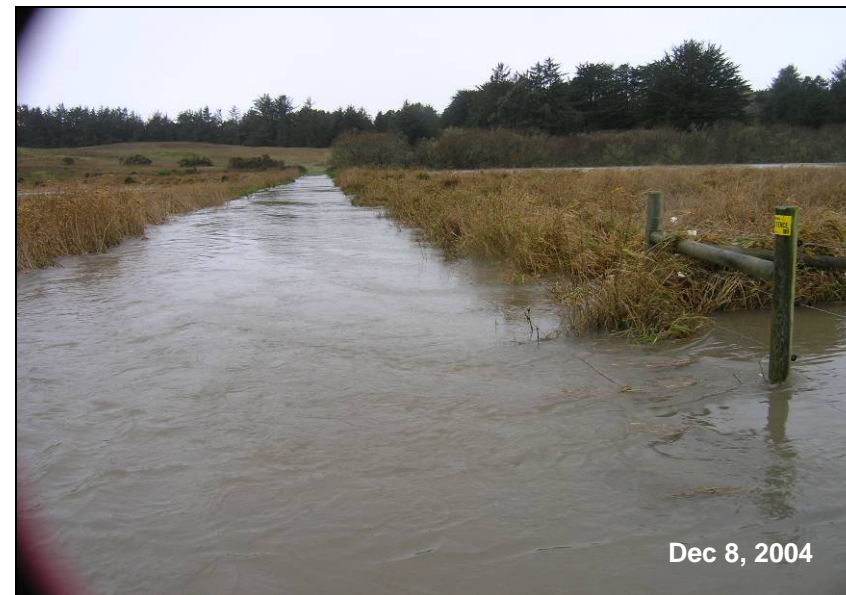
LOCATION 3 – Pala Road during high water in December. The road was overtopped by the Smith River, filling Yontocket Slough.

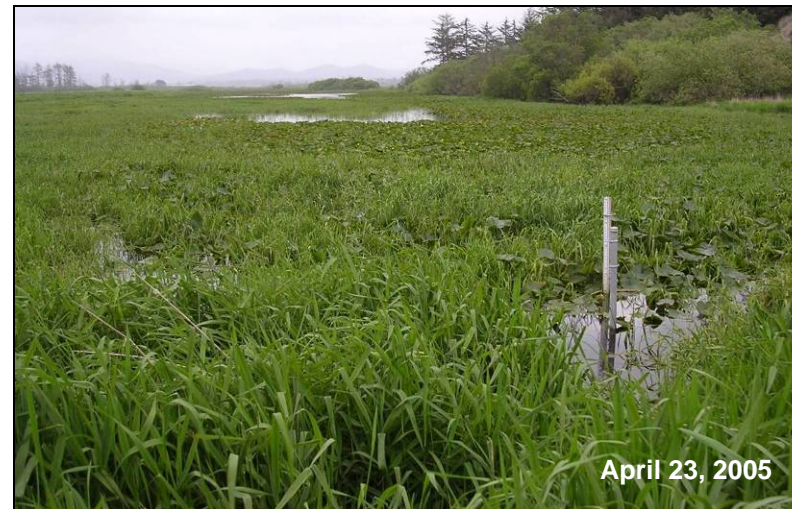
LOCATION 4 - Yontocket Slough upstream of Pala Road during mid-spring. Reed canary grass dominates much of the slough, with yellow (Spatterdock) lily growing among the grass and in deeper sections that are free from grass.

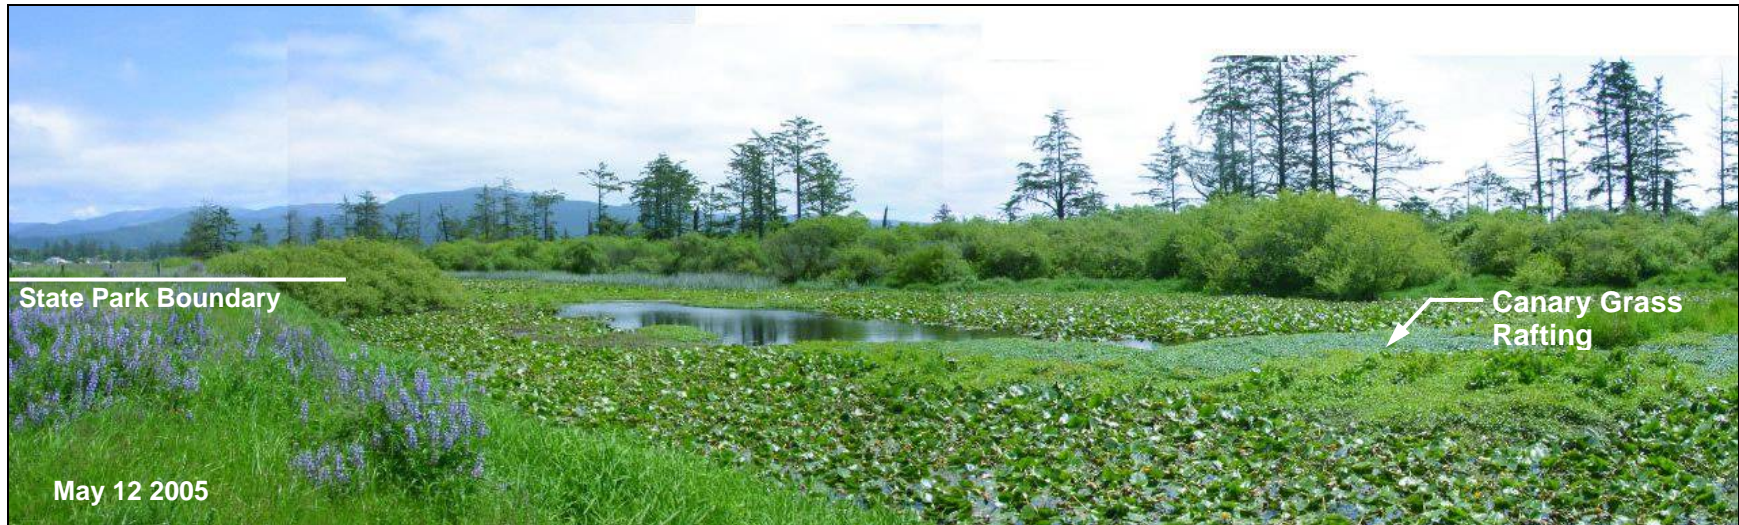
LOCATION 5 – Yontocket Slough at the State Park property boundary. Reed canary grass dominates much of the banks and rafts in the mid sections of the slough. There is a lack of riparian vegetation within the State Park properties.

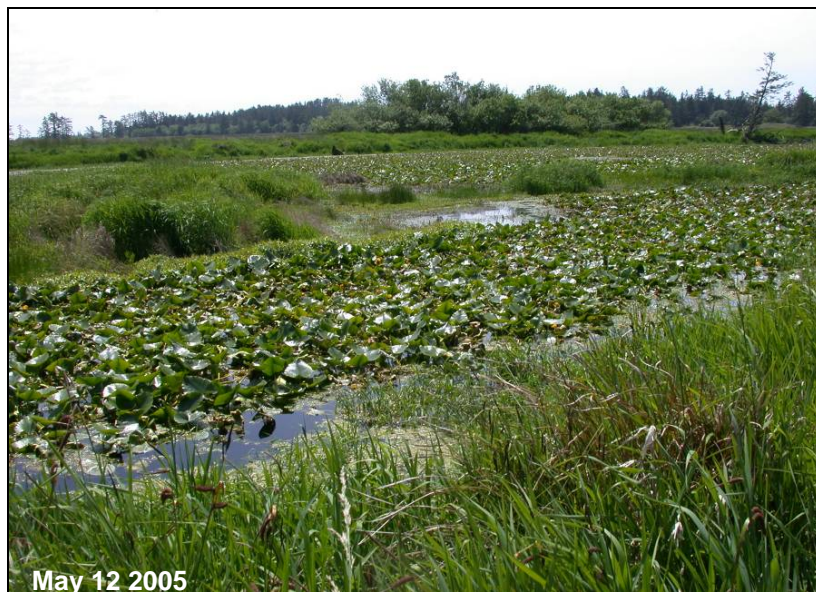
LOCATION 5 – Yontocket Slough within the State Park. This section of slough lacks riparian vegetation. Reed canary grass has colonized the margins and rafts within the slough.

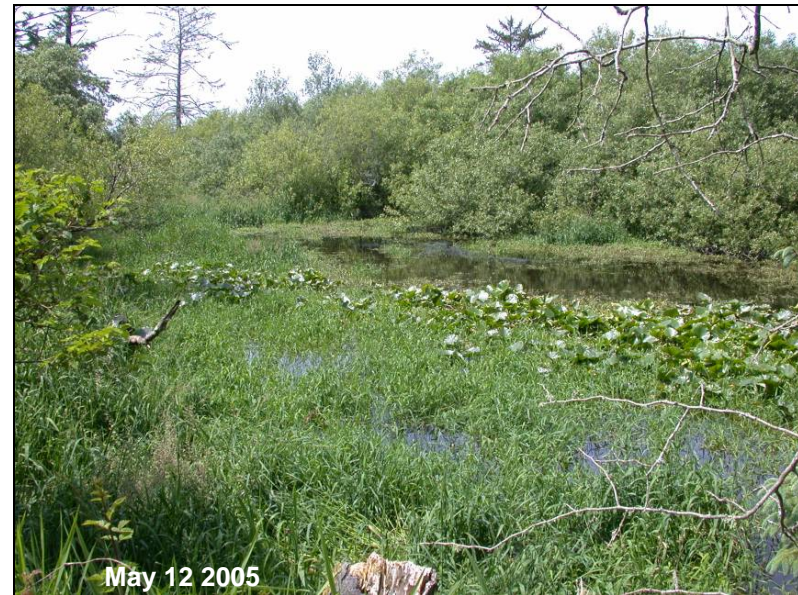
LOCATION 6 – Yontocket Slough near confluence with Tryon Creek. Dense softwood riparian with spruce trees grow on south bank. This section is characterized by areas of open water and lilies with reed canary grass along the margins.

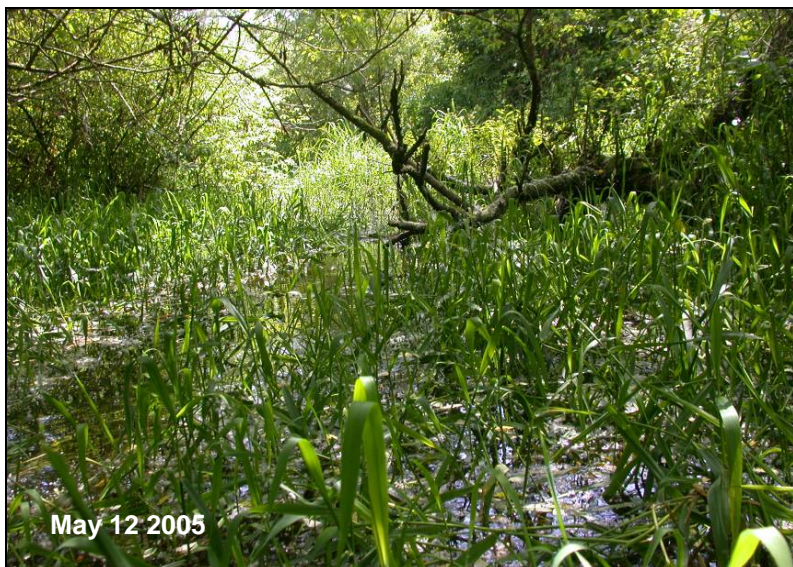
LOCATION 7 – Tryon Creek near confluence with Yontocket Slough is characterized by dense hardwood riparian with reed canary grass growing throughout channel.

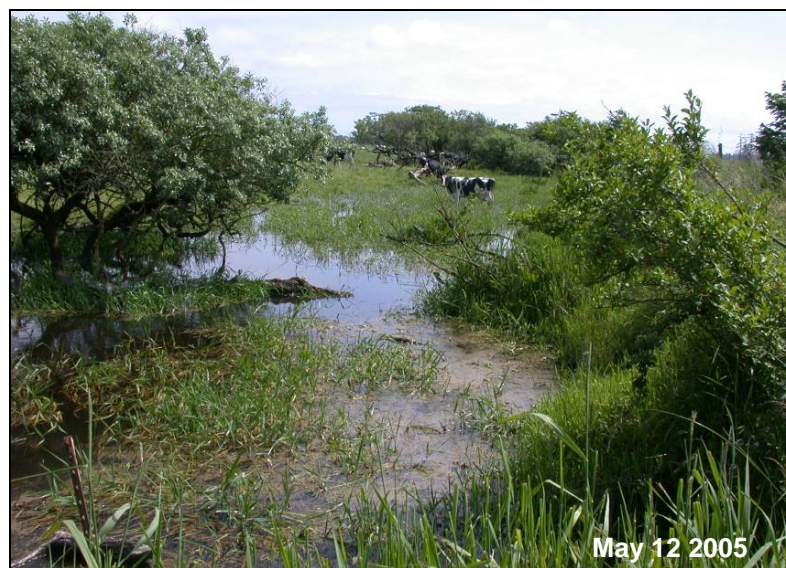
LOCATION 8 – Tryon Creek is unfenced along the right bank and has little riparian vegetation. In this reach, the channel is poorly defined with water spreading outward during high flows.

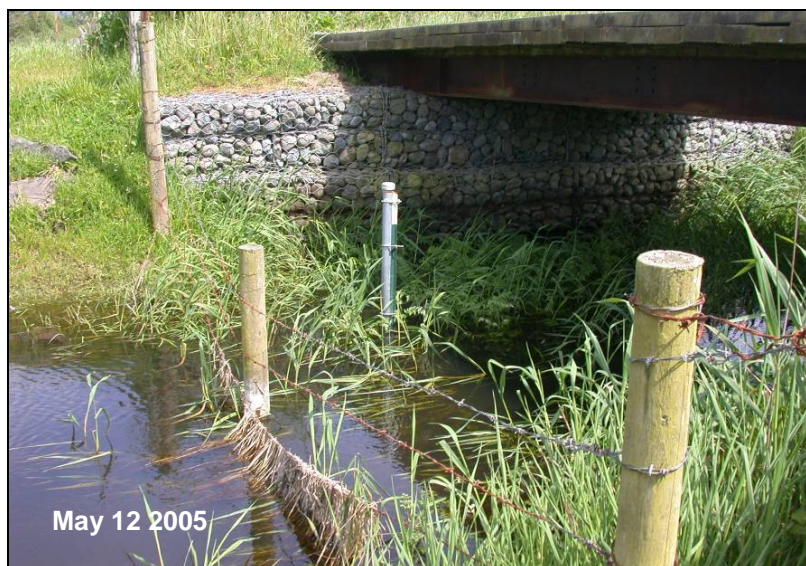
LOCATION 9 – Staff gage at Silva Road Bridge
