Stream Channel Assessment for Horse Creek Dam Removal Project

Michael Love, Hydrologist, Michael Love & Associates
Antonio Llanos P.E., Engineer, Michael Love & Associates

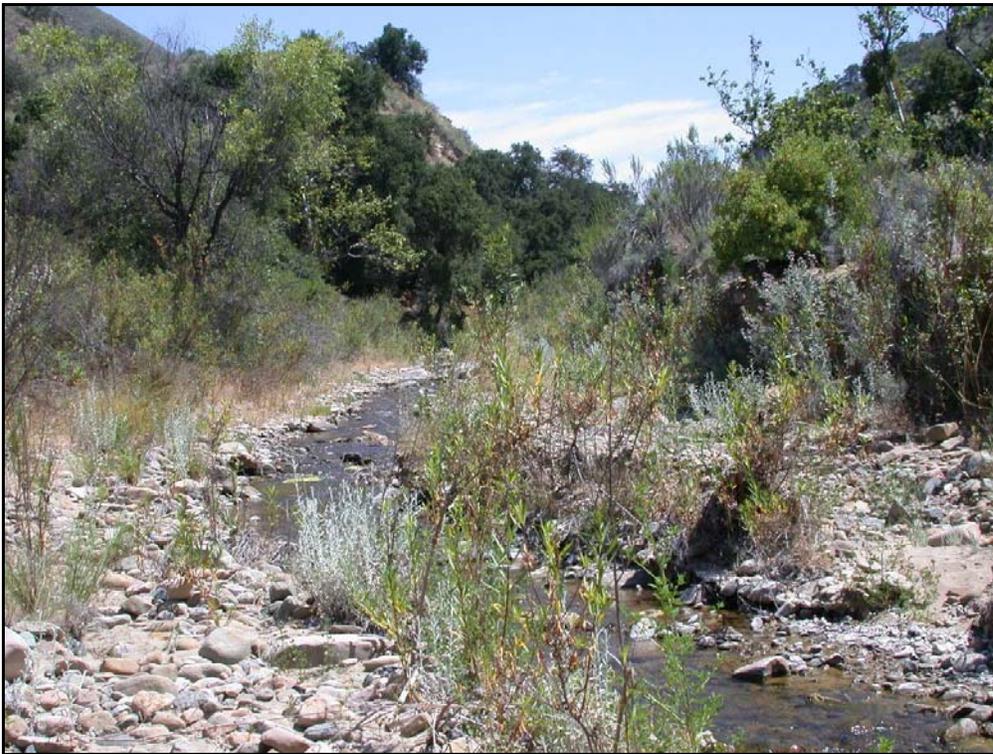
Figure 1 - Horse Creek approximately 400 feet downstream of the abandoned dam.

The dam lies 846 feet upstream of the Sisquoc River at a natural constriction of the stream channel by the adjacent hillslope. The channel below the dam is relatively straight and incised, cutting through an eight to ten foot high terrace formed by the river. The channel bed within this reach has an average bed slope of 2.2% and is predominately comprised of large gravel and cobble mixed with sand (Figure 1). The average width of the actively scoured channel is approximately 35 feet, and the width between the terrace tops varies between 30 and 60 feet (Figure 2 – Site Map). The banks are nearly vertical and show signs of regular sluffing. At the confluence with the river the channel bed drops steeply and shows signs of being backwatered by the river at high flows.

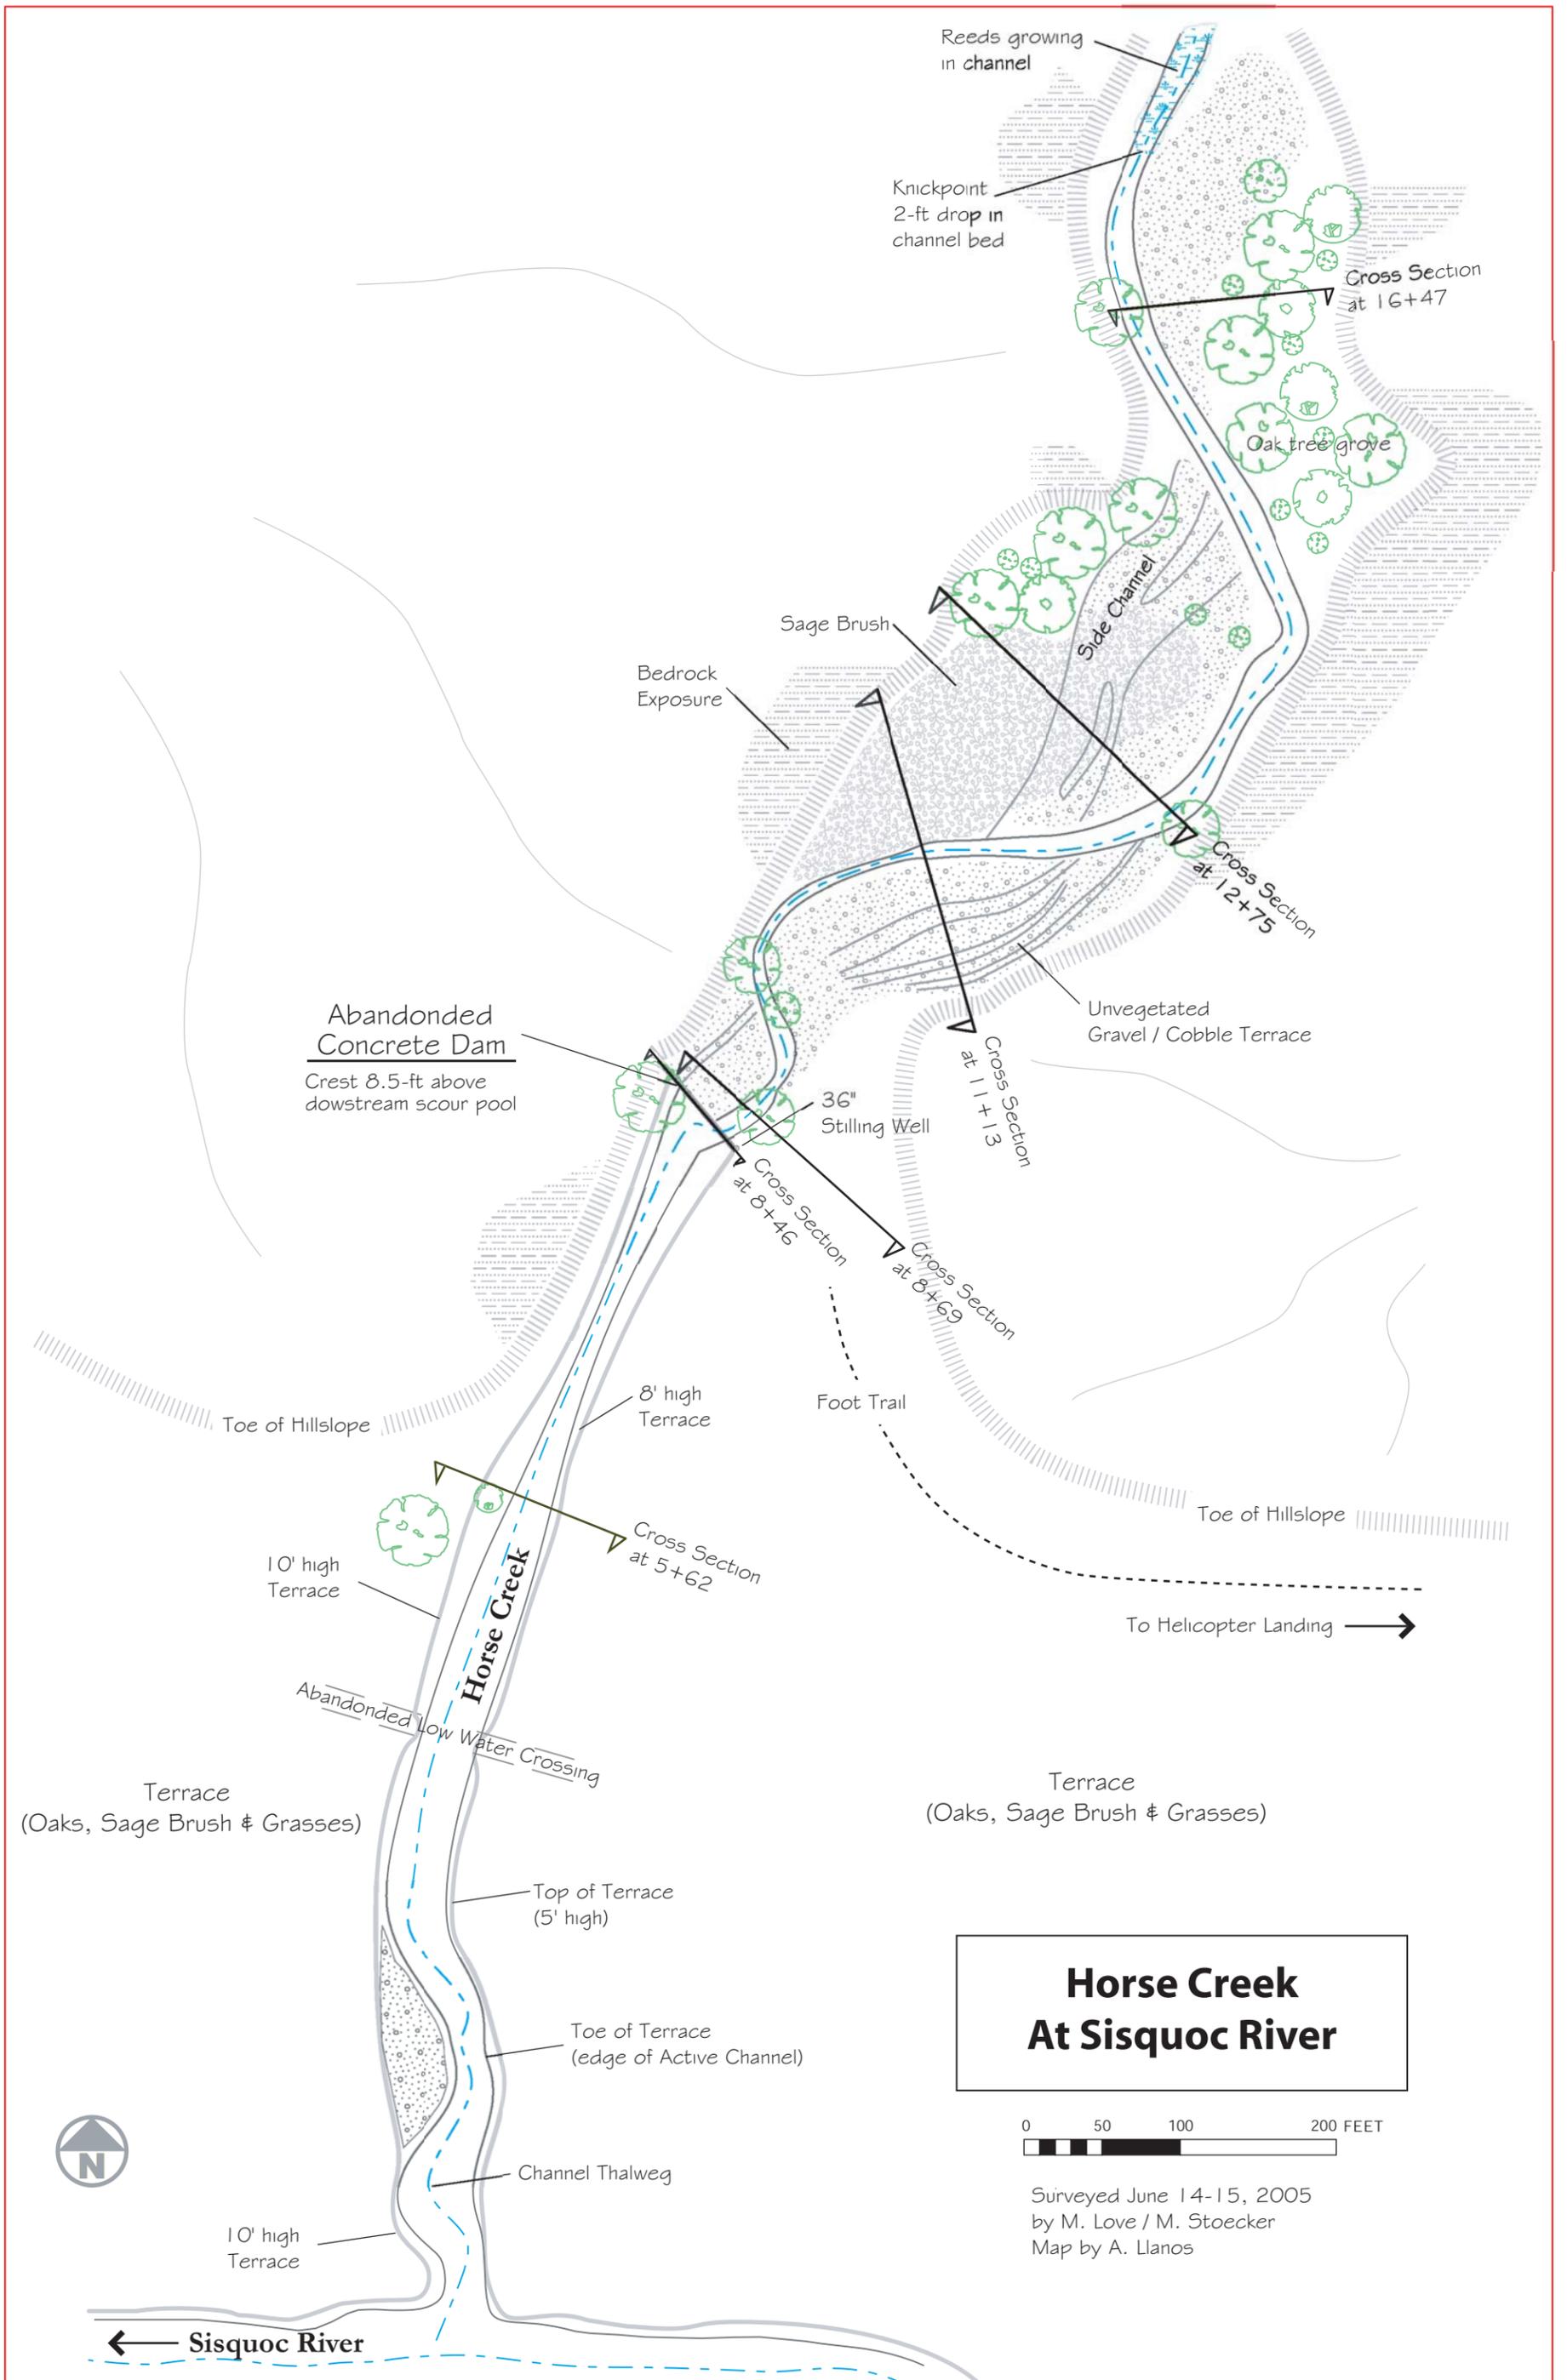
Horse Creek At Sisquoc River

Abandoned Concrete Dam
Crest 8.5-ft above downstream scour pool

Knickpoint
2-ft drop in channel bed

Cross Section at 16+47

Cross Section at 12+75

Cross Section at 11+13

Cross Section at 8+46

A field survey of Horse Creek and the dam site was conducted by Michael Love and Matt Stoecker on June 14-15, 2005. The survey was conducted using an autolevel, stadia rod, survey measuring tapes, and bearing compass. Survey elevations were based on an assumed common datum that was arbitrarily selected. The survey included a longitudinal profile of the channel thalweg that extended 2,200 feet upstream of the confluence with the Sisquoc River. In addition to the longitudinal profile, seven channel cross sections were surveyed: two below the dam, one along the dam crest, and four upstream of the dam. Using the bearing compass and tape, various features (including channel banks, toes of hill slopes, large trees, and vegetation changes) were mapped to create a scaled site map of the area. To roughly characterize the size of sediment stored behind the dam, a Wolman pebble count was conducted approximately 250 feet upstream of the dam.

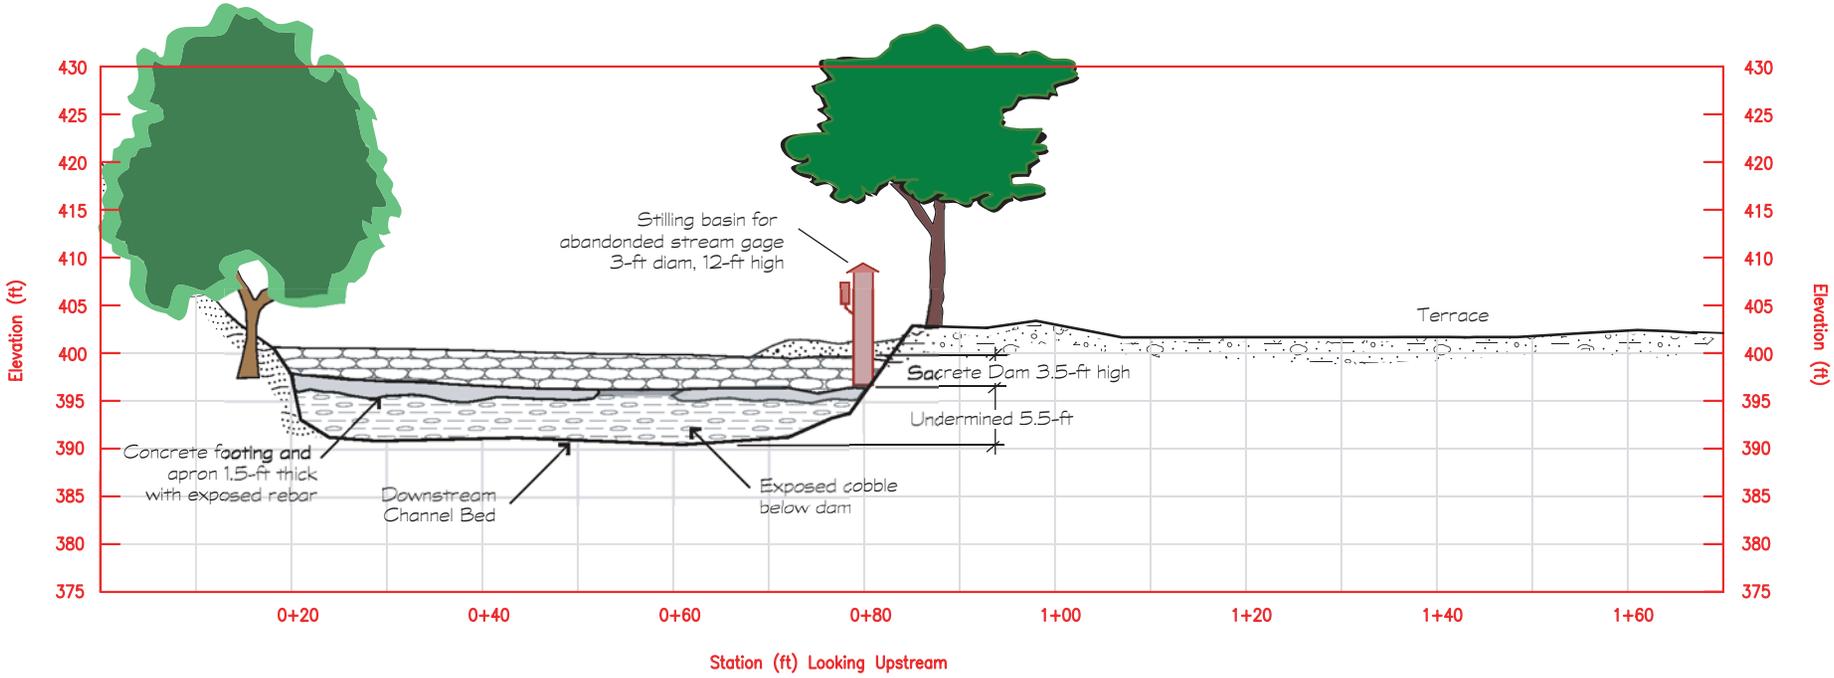
Cross Section at Existing Dam

The face of the dam is approximately 3.5 feet in height. Below the sacrete is a poured concrete footing and apron for the dam that is approximately 1.5 feet thick. However, the downstream channel bed has incised, leaving the footing perched about 4 feet above the outlet pool. There is substantial scour and undermining of the footing. Approximately 1/4" rebar was observed protruding vertically through the footing, suggesting that the entire dam is reinforced with rebar. This likely explains why the dam has not collapsed from the extensive undermining.

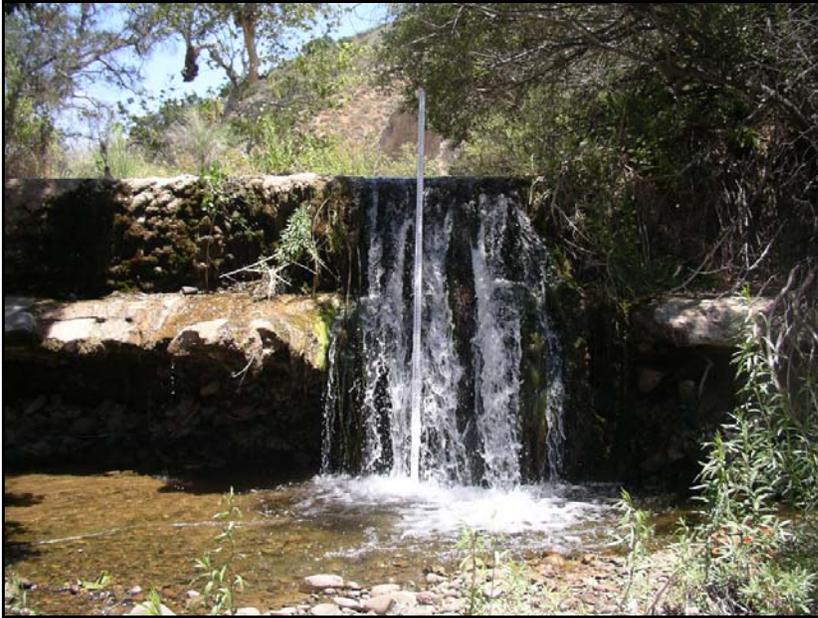
Figure 4 - Horse Creek dam, 846 feet upstream of the confluence with the Sisquoc River.

The abandoned dam is constructed of sacrete (bags of concrete stacked onto each other and cured in-place). The dam crest spans 62 feet, beginning on the hill slope above the right bank (looking downstream) and terminating at the terrace along the left bank (Figures 3 and 4). The dam crest slopes towards the left bank, concentrating low flows towards the left side. At the left edge of the dam there is a 12 feet tall stilling well constructed of 36" diameter corrugated metal pipe. Next to the stilling well, there is a hand written date stamp into the concrete of 11/3/69.

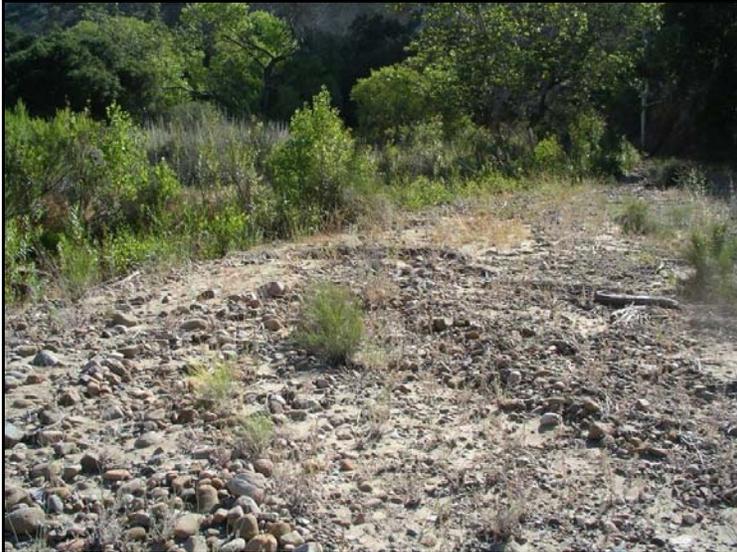
Figure 5 – Depositional bar about 270 feet upstream of dam.

The upstream side of the dam has completely filled with sediment. The channel meanders within the deposited sediment. Paralleling the stream are two steep hill slopes with numerous nearly vertical bedrock exposures. Between the hills and adjacent to the stream channel exist two large depositional bars that are scoured regularly by high flows, preventing vegetation from becoming established (Figure 5). There are also several sizable side channels cutting through the bars.

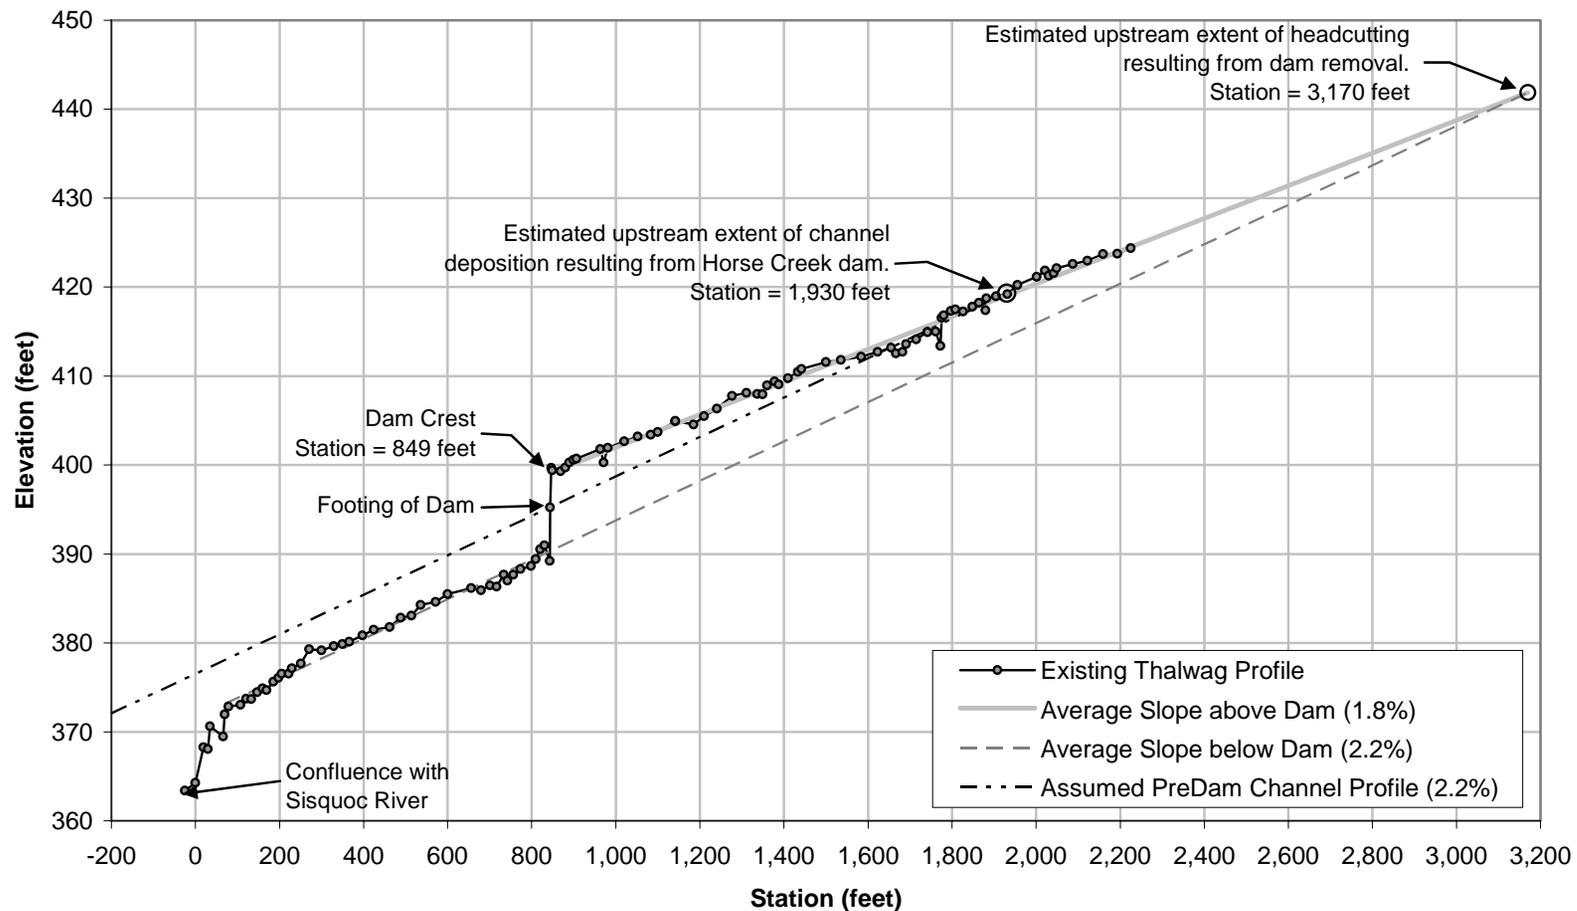
Longitudinal Profile of Horse Creek at Sisquoc River Assessment of Post-Dam Headcutting Potential

Figure 6 - Longitudinal profile of Horse Creek, showing the estimated extent of headcutting resulting from removal of the existing dam. Also shown is the suspected pre-dam channel grade based on existing slope of the downstream channel and the elevation of the dam's footing.

The 2,200 feet longitudinal profile was used to estimate the extent that the channel bed would regrade upstream of the dam once removed (Figure 6). The analysis incorporated techniques outlined by Castro (2003). The first step involved using linear regression of the surveyed thalweg points to estimate the average slope of the channel below the dam (not including the steep drop at the confluence with Sisquoc River) and upstream of the dam. The downstream and upstream slopes were estimated to be 2.2% and 1.8%, respectively. Projecting both of these slopes beyond the end of the survey, we found that they intersect 2,321 feet upstream of the dam. This provides a reasonable estimate of the extent the channel will regrade following dam removal.

The estimated distance is based on several important assumptions. It assumes no hard bedrock features will be exposed as the upstream channel cuts through the deposited streambed material. If hard bedrock is exposed, it will likely limit any further upstream regarding of the channel bed. This is not anticipated based on the width between the valley walls and that the channel bed did not expose bedrock below the dam.

We attempted to estimate the location of the channel bed prior to the dam's construction by assuming it had the same overall slope as currently exists in the reach below the dam but was positioned 5 feet higher, matching the elevation of the dam's footing and apron. From the longitudinal profile we can see that the predicted depth and length of sediment deposited above the dam after construction is relatively small in comparison to the depth and length the channel will likely regrade after the dam is removed.

The potential volume of sediment to be mobilized following dam removal was estimated using the anticipated post dam profile (Figure 6) combined with the surveyed cross sections. The channel shape below the dam is relatively uniform. The downstream cross section 5+62 (285 feet below the dam) was used as a reference section. We assumed the post dam channel shape within the regraded reach, once restabilized, would resemble the

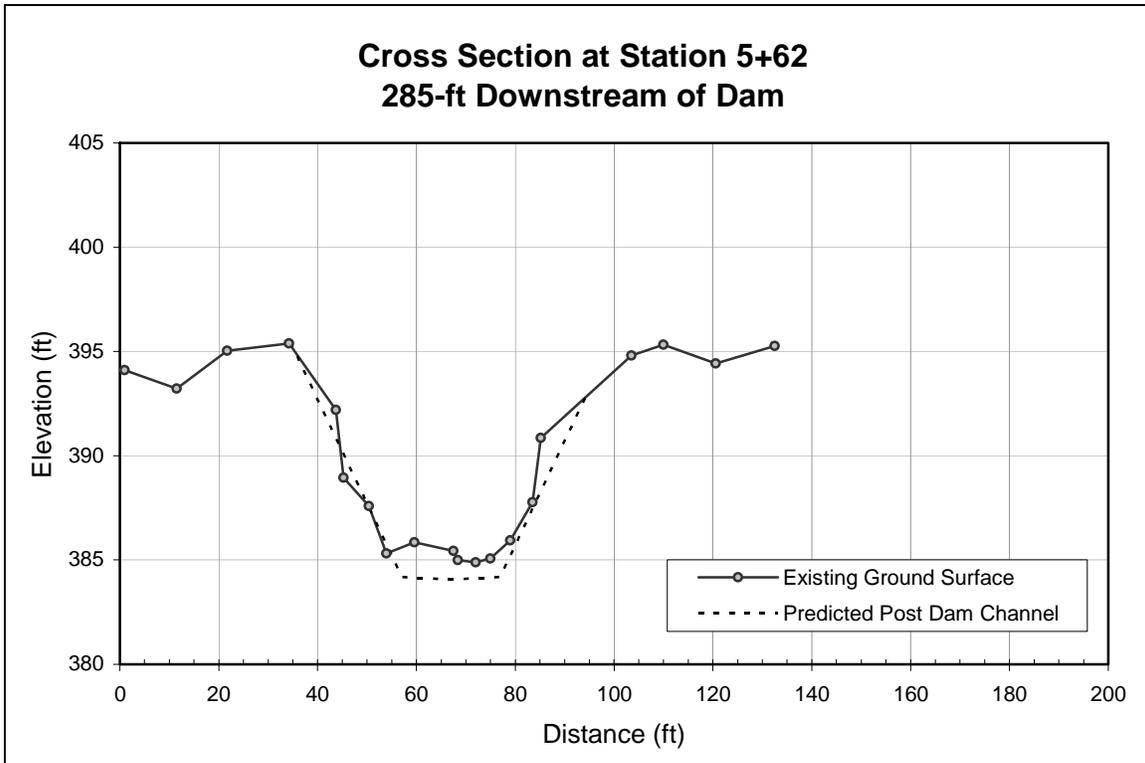
Figure 7 – The channel shape below the dam was used to predict the stabilized shape of the upstream channel after removal of the dam.

existing channel shape below the dam. The new channel is assumed to have a trapezoidal shape with a bottom width of 20 feet and 2:1 (horizontal: vertical) side slopes (Figure 7).

This trapezoidal channel shape was overlaid upon each of the five cross sections located at and above the dam (Appendix A). The bottom of the post dam channel was placed at the elevation given by the anticipated post dam profile shown in Figure 6. Next, the differences in areas between the existing cross sections and the post dam channel sections were calculated. The areas were then multiplied by the distance between cross sections to estimate volumes.

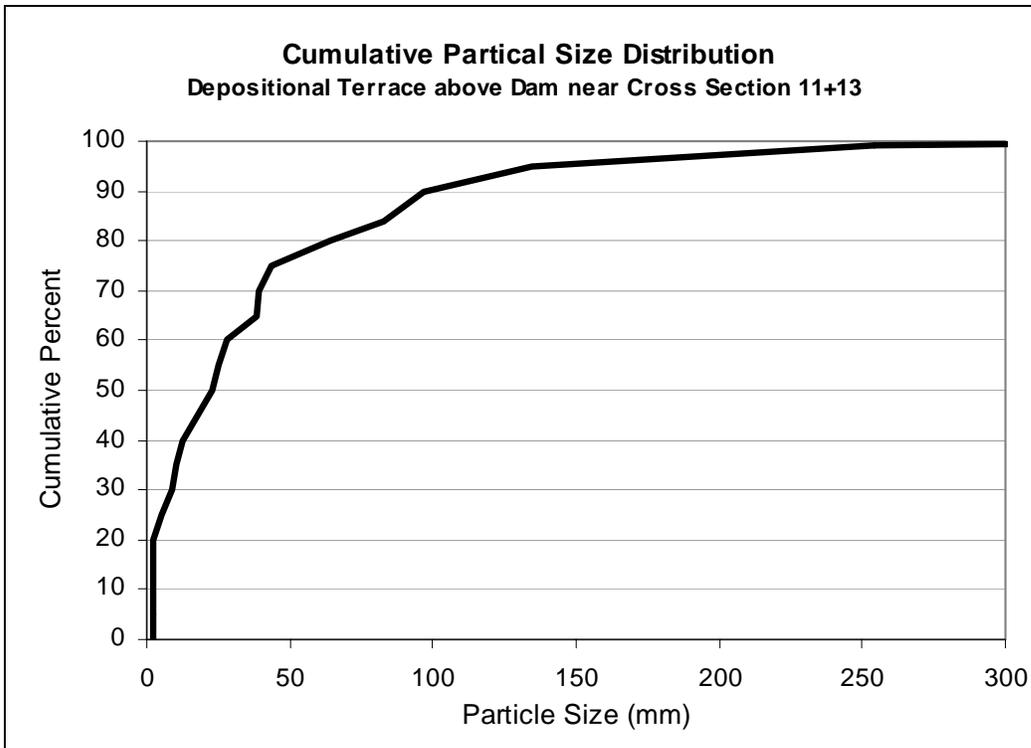
Figure 8 – Particle size distribution measured between 200 to 300 feet upstream of Horse Creek Dam.

Using a 100 count sample size, a cumulative frequency plot was constructed (Figure 8). The d35 (35 percentile), d50, and d84 were estimated to be 10 mm (medium gravel), 23 mm (coarse gravel), and 82 mm (small cobble) respectively. This represents relatively course substrate suitable as spawning gravel for adult steelhead and resident rainbow trout.

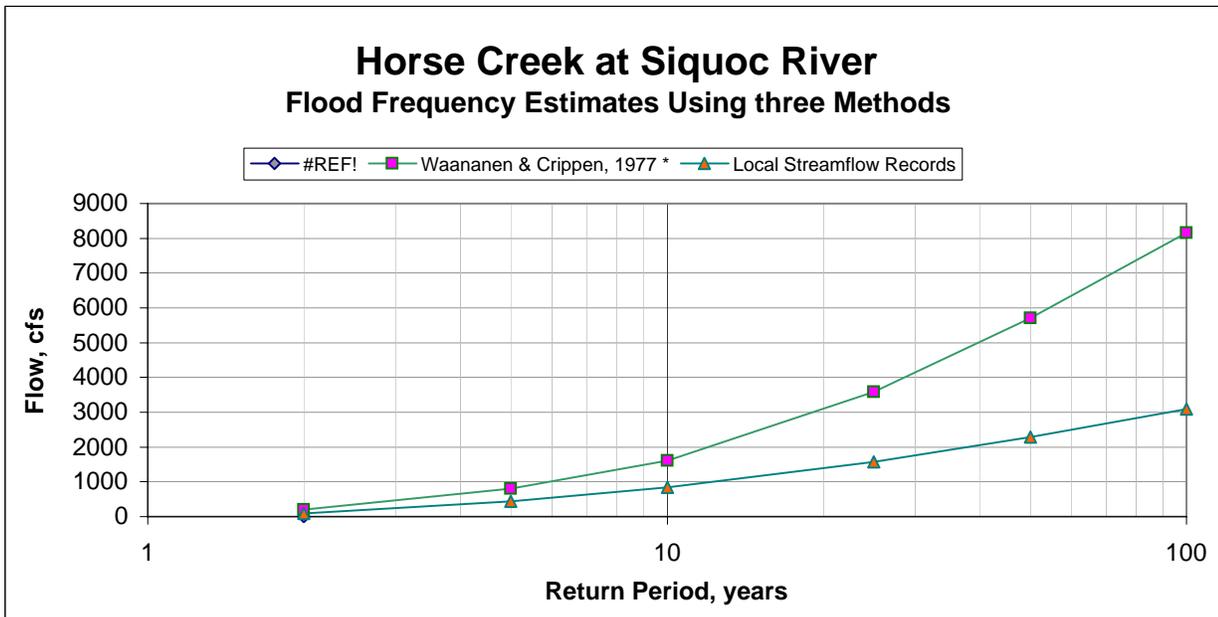
Summary of Peak Flow Calculations

Method	Q-2yr (cfs)	Q-5yr (cfs)	Q-10yr (cfs)	Q-25yr (cfs)	Q-50yr (cfs)	Q-100yr (cfs)
Waananen & Crippen, 1977 *	193	797	1,607	3,592	5,716	8,152
Local Streamflow Records						
Average	99	432	839	1,579	2,280	3,093
Minimum Estimate	22	104	223	489	800	1,232
Maximum Estimate	266	898	1,487	2,328	3,466	4,807

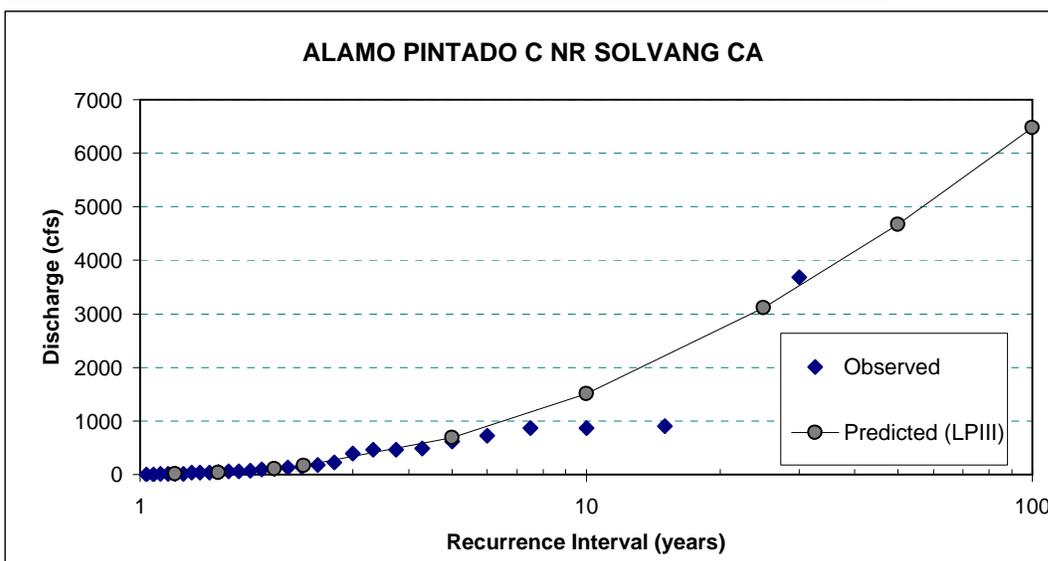
USGS ALAMO PINTADO C NR SOLVANG CA

Flood Frequency based on Annual Maximum Series

Return Period (years)	Exceedence Probability	Log-Pearson K	Predicted Discharge (cfs)
1.2	0.833	-0.96636	7
1.5	0.667	-0.31879	35
2.0	0.500	0.12921	109
2.33	0.429	0.29714	167
5.0	0.200	0.85623	686
10	0.100	1.16878	1,512
25	0.040	1.45505	3,115
50	0.020	1.61584	4,675
100	0.010	1.74529	6,482

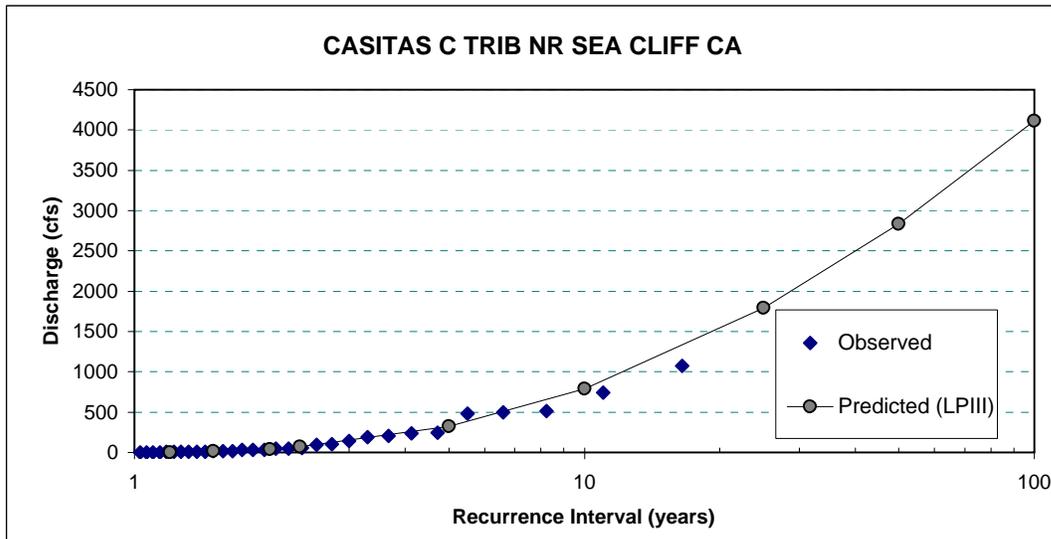
USGS ZACA C NR BUELLTON CA

Flood Frequency based on Annual Maximum Series

Return Period (years)	Exceedence Probability	Log-Pearson K	Predicted Discharge (cfs)
1.2	0.833	-0.96769	2
1.5	0.667	-0.32248	12
2.0	0.500	0.12547	42
2.33	0.429	0.29380	68
5.0	0.200	0.85646	327
10	0.100	1.17287	792
25	0.040	1.46438	1,789
50	0.020	1.62906	2,835
100	0.010	1.76229	4,114

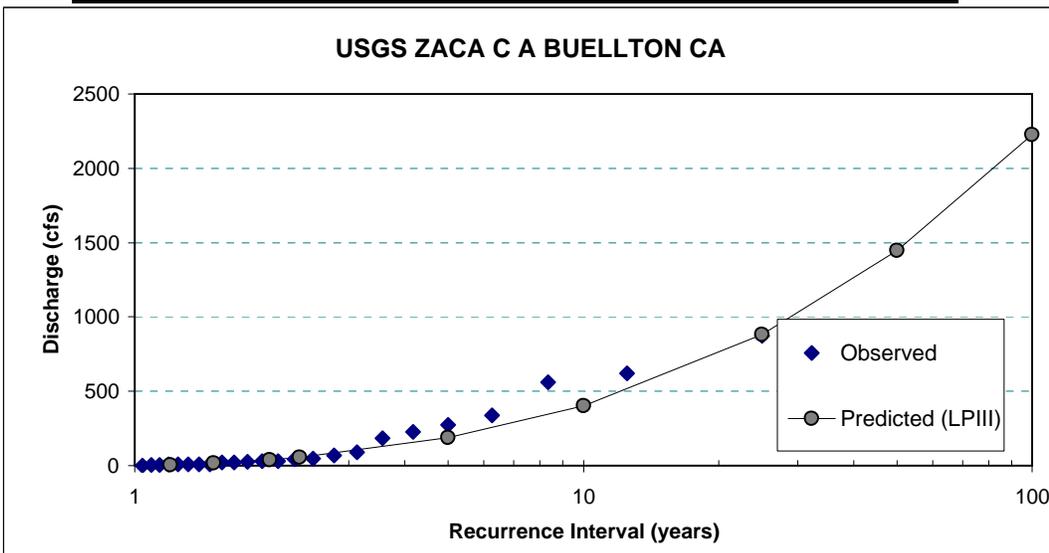
USGS ZACA C A BUELLTON CA

Flood Frequency based on Annual Maximum Series

Return Period (years)	Exceedence Probability	Log-Pearson K	Predicted Discharge (cfs)
1.2	0.833	-0.98681	6
1.5	0.667	-0.40251	17
2.0	0.500	0.03820	40
2.33	0.429	0.21390	56
5.0	0.200	0.85075	187
10	0.100	1.25436	402
25	0.040	1.66909	884
50	0.020	1.92854	1,446
100	0.010	2.15599	2,227

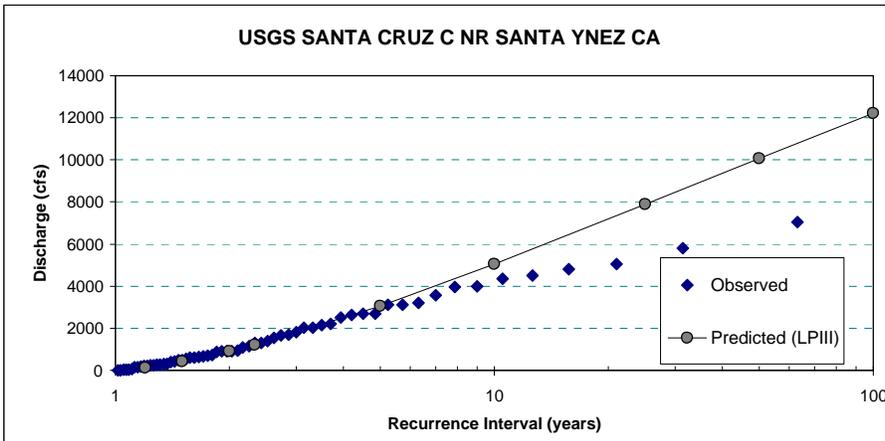
USGS SANTA CRUZ C NR SANTA YNEZ CA

Flood Frequency based on Annual Maximum Series
