Fish Passage Assessment and Recommended Treatment Options for Los Padres National Forest Stream Crossings on Davy Brown and Munch Creeks

June 2009

**Fish Passage Assessment and Recommended Treatment Options
for Los Padres National Forest Stream Crossings
on Davy Brown and Munch Creeks**

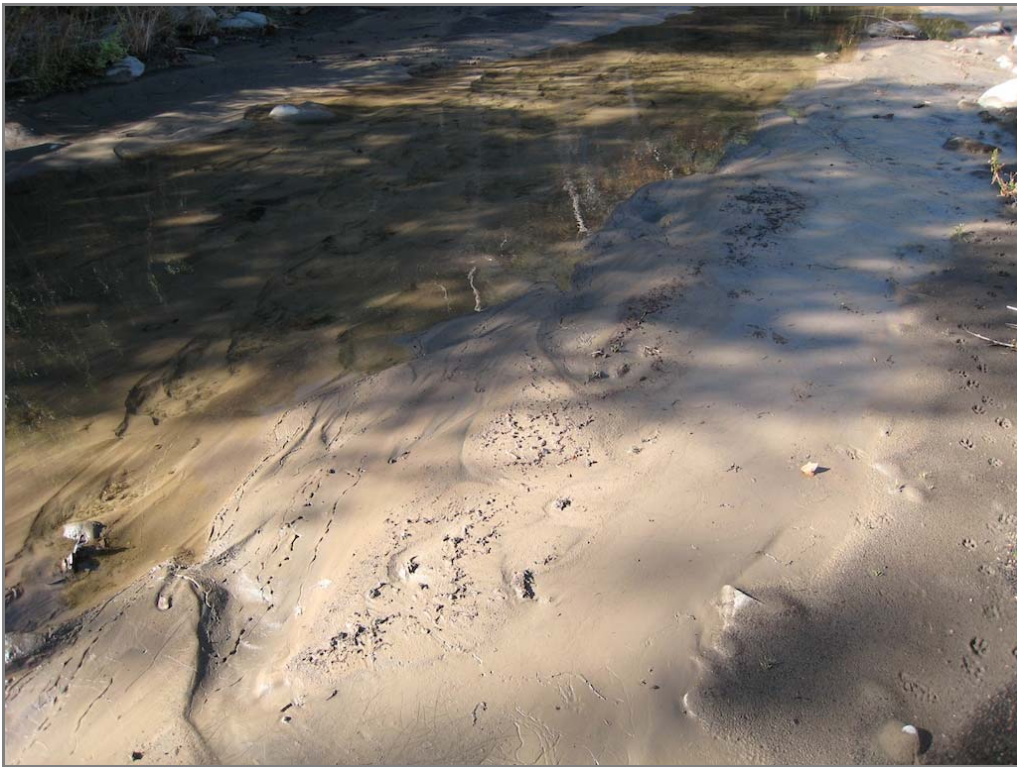
Figure 4 – Excessive sediment in Manzana Creek in 2009 following the 2007 Zaca Fire. Photo: M. Stoecker

The Zaca Fire of 2007, which was the second largest in California history, burned much of the Sisquoc River watershed and caused massive erosion and subsequent sediment deposition, which eliminated pool habitat and trout occurrence throughout much of the Manzana Creek tributary (pers. obs. Stoecker 2008) (Figure 4). Davy Brown Creek and its tributaries were relatively unaffected by the more northern fire. As a result, habitat in Davy Brown and Munch Creek is still in excellent condition and is now more important than ever for the Sisquoc River's returning adult steelhead population and resident coastal rainbow trout. For several more years, if not decades, the aftermath of the Zaca Fire will likely continue to cause depressed habitat quality for trout and reduced a population size for much of the Sisquoc River watershed. Davy Brown Creek is critical cold-water refugia and provides possibly the best remaining habitat for fish in Manzana Creek to escape the fire-related elevated sediment loads and resulting elevated water temperatures. To provide all age classes of trout access to the high quality habitat available in Davy Brown and Munch Creek, it is essential to identify and remove road-stream crossings, and any other anthropogenic barriers, that hinder fish passage.

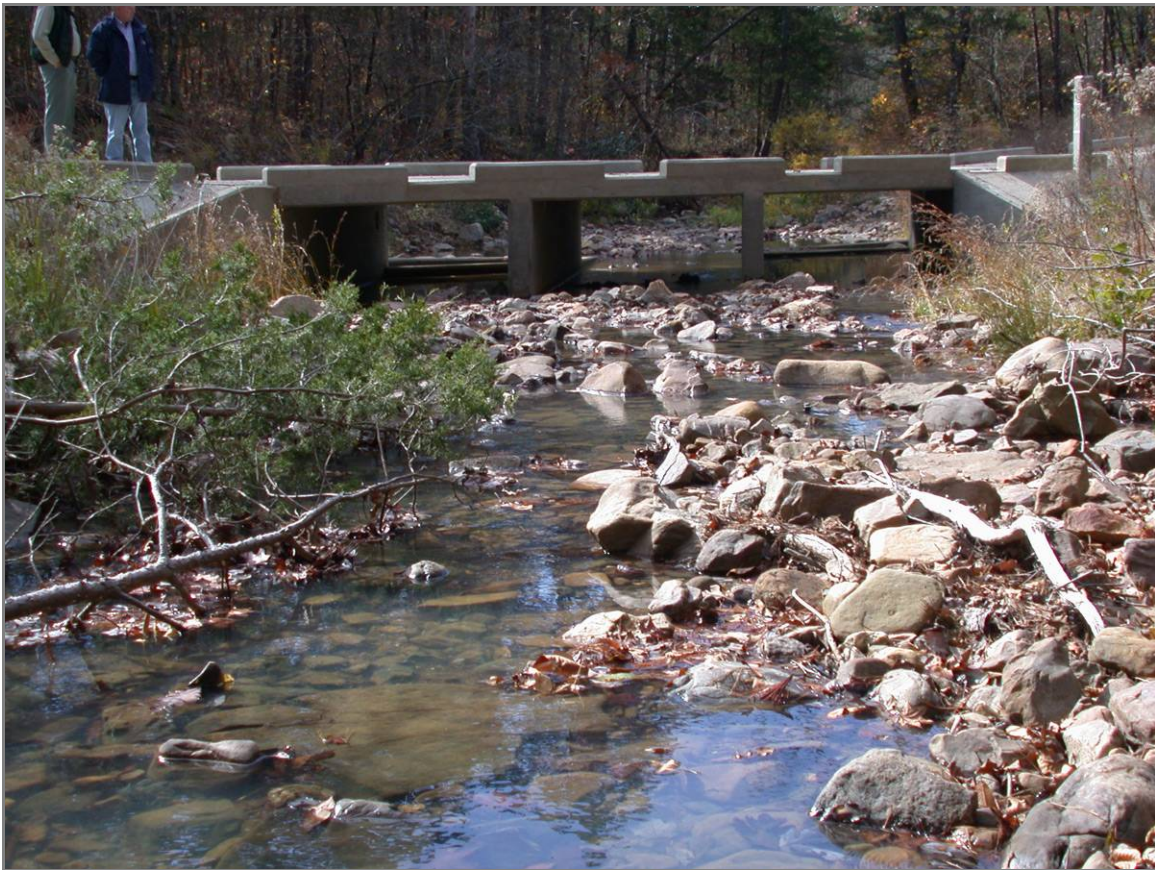
Figure 6 – Example of a Vented Ford type low-water crossing on the Ouachita National Forest, Arkansas. From the *FishXing Case Studies* website (<http://www.stream.fs.fed.us/fishxing/>).

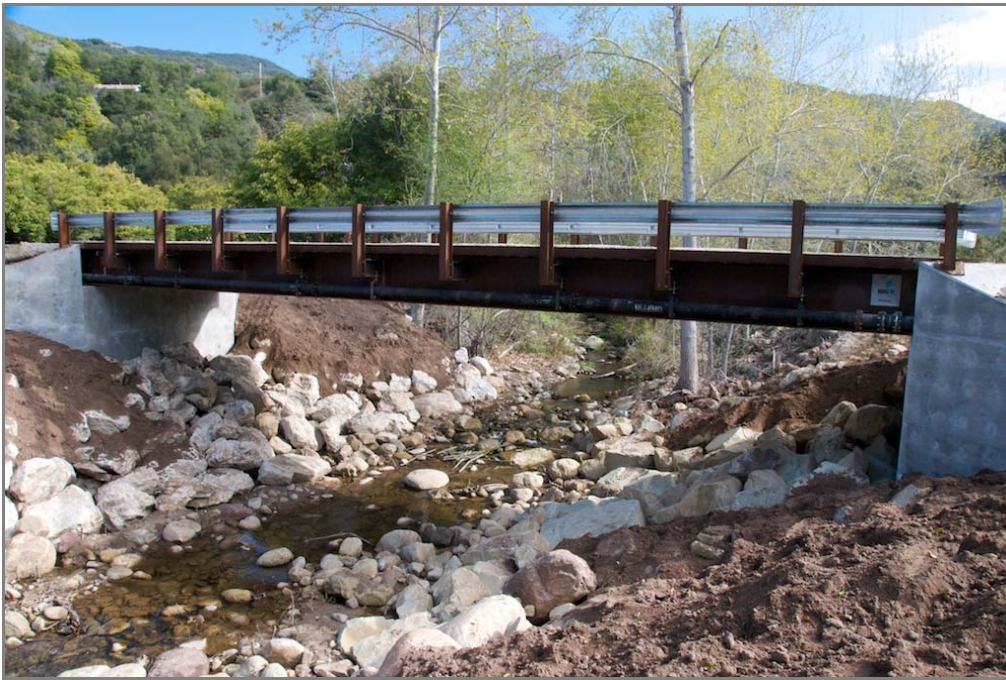
Figure 7 – Completed bridge installation for fish passage on Carpinteria Creek 2009.

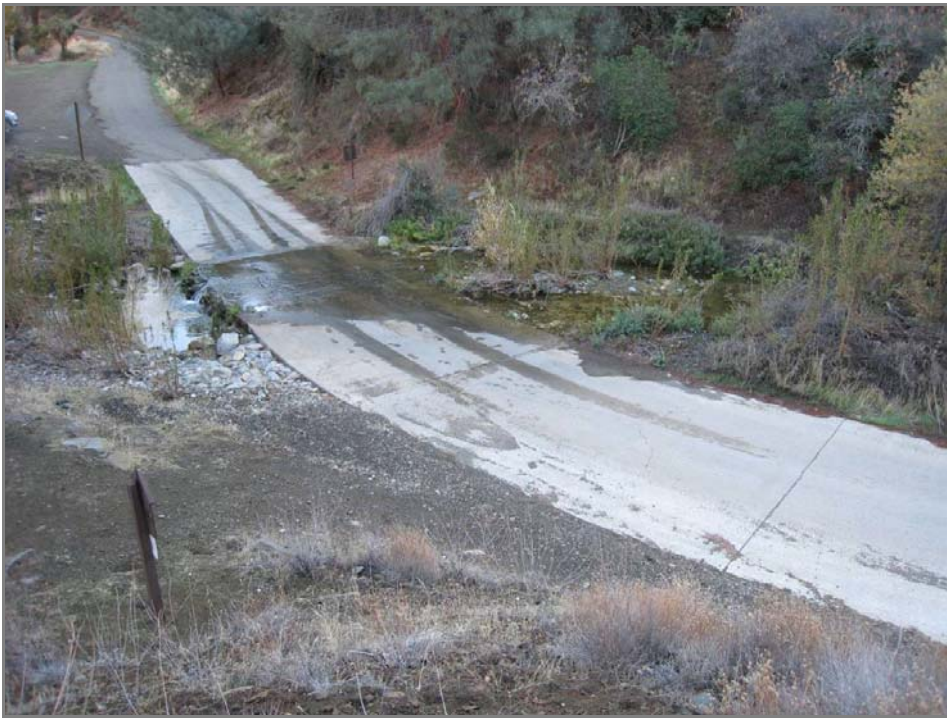
Figure 8 – Lower Sunset Valley Road at Davy Brown Creek (H-150'59-3). The 18-foot wide concrete low-water ford is located 130 feet upstream of the confluence with Manzana Creek. The trailhead is visible in the foreground and the trailhead parking lot is seen at the top of the photo.

The low-water crossing is an 18-foot wide concrete ford and extends approximately 130 feet in length. The concrete appears to be in good condition with minimal downstream scour. The approach road is asphalt. Heading north, the road runs along the left side (facing downstream) of the steep and narrow Davy Brown Creek canyon before turning sharply and crossing the stream. The approach road along the left side of the stream is built on a bench into the hill slope, with side-cast fill along the outside edge that extends into and constricts the channel. A summary of the crossing dimensions and channel cross sections are provided in Appendix C.

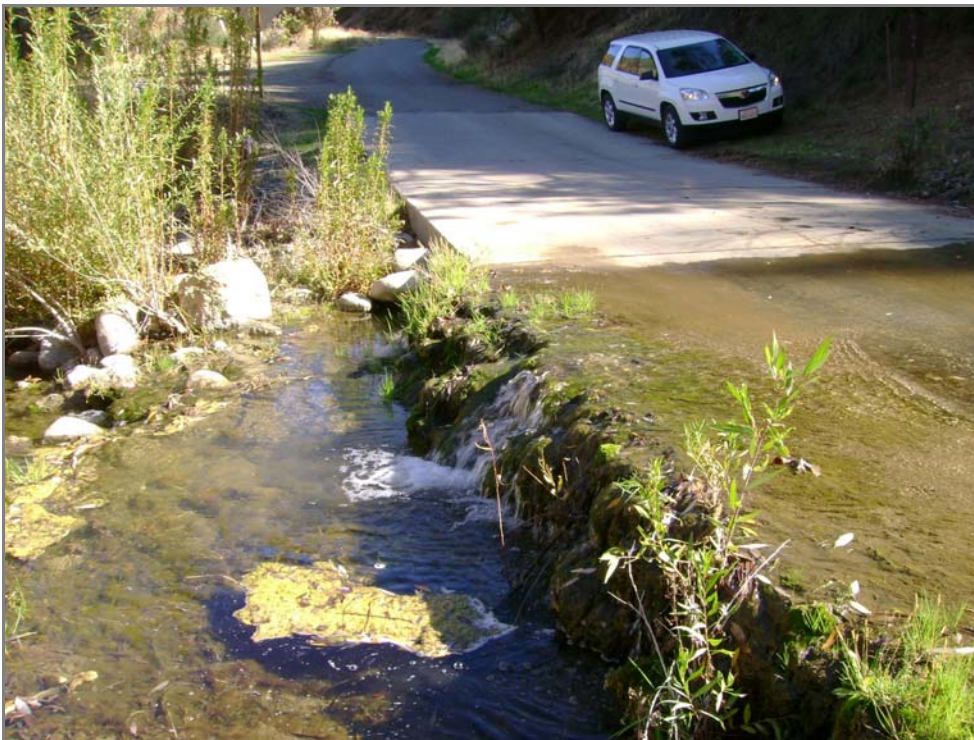
Figure 9 – Drop at the downstream edge of the low-water crossing on the lower Sunset Valley Road crossing at Davy Brown Creek.

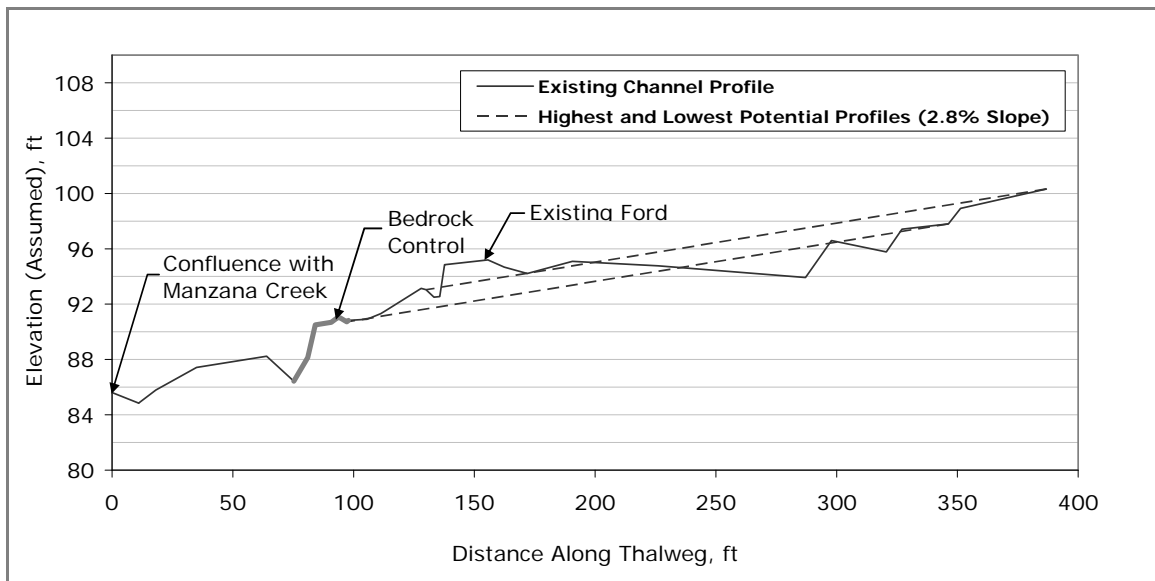
Figure 11 – Channel profile Davy Brown Creek at the lower Sunset Valley Road crossing. The highest and lowest design profiles were estimated to describe an estimate of the potential vertical adjustment of the channel that may occur if the ford is replaced.

crossing provides a stable knickpoint that represents the lowest likely elevation for streambed adjustment. Both profiles have 2.8% channel slopes, and they are offset by approximately 1 foot of vertical adjustment (Figure 11).

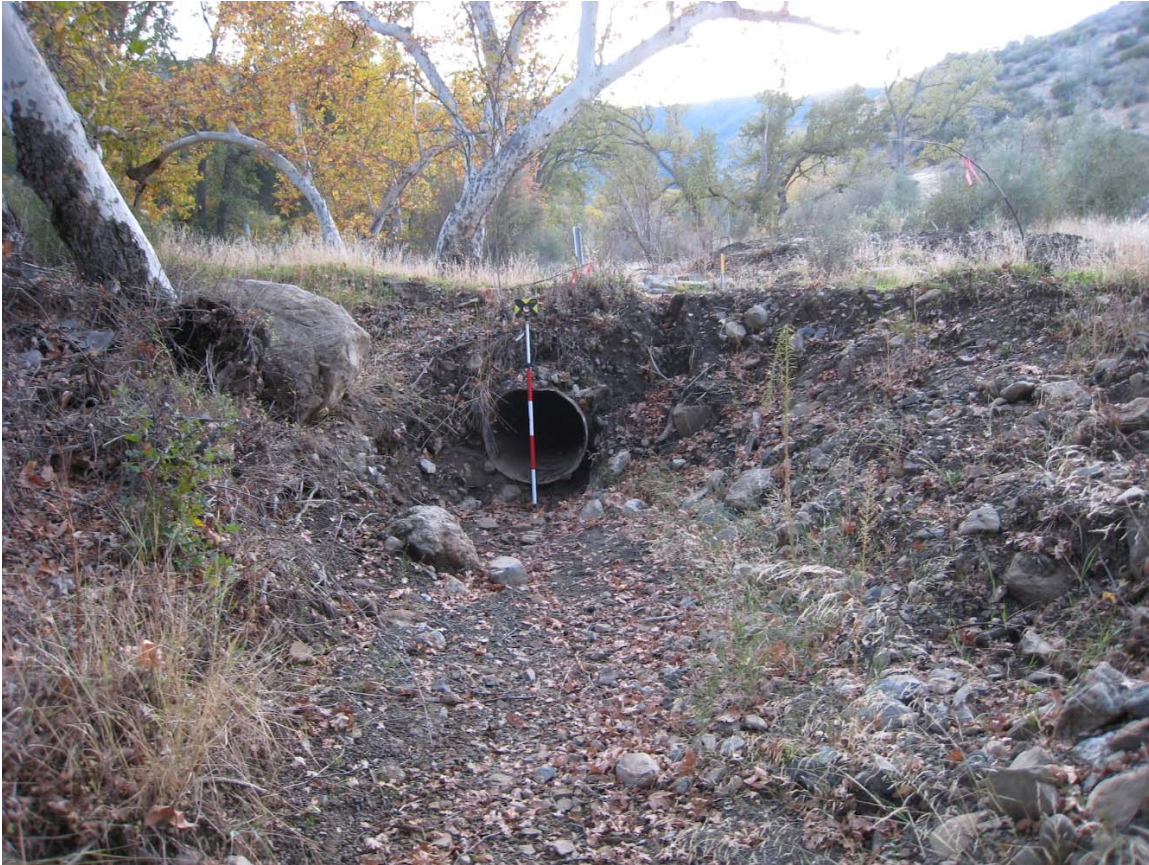
Figure 16 – Side channel culvert located approximately 125 -ft from the Upper Sunset Valley Road crossing. The culvert has a 3-ft diameter and is rusted, showing signs of regular sediment removal at the inlet. During high flows water diverted from the ford re-enter the channel at this location.

A small channel runs parallel to Davy Brown Creek along the left bank and flows through a rusted and undersized 3-foot diameter culvert approximately 125 feet north of the lower crossing site (Figure 16). The culvert is squashed and shows evidence of recent sediment removal at the inlet. This culvert should be replaced with a larger diameter culvert, but was not analyzed as part of this study.

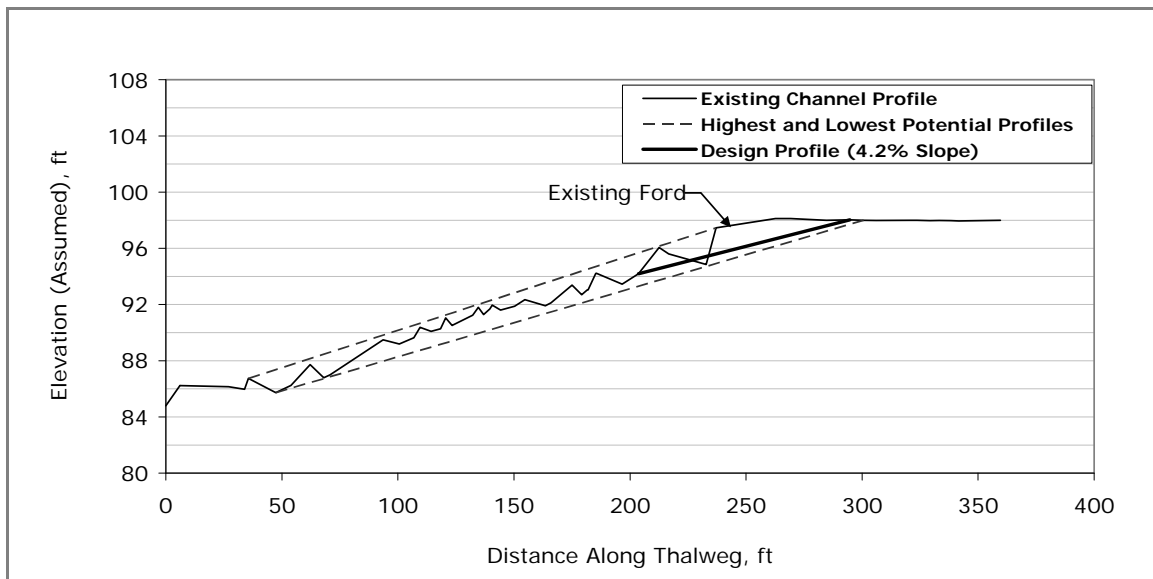
Figure 19 – Existing Davy Brown Creek channel profile at the upper Sunset Valley Road crossing. The highest and lowest profiles were estimated to describe the potential vertical adjustment of the channel if the ford was replaced.

For the upper Sunset Valley Road crossing a stable grade was estimated using the downstream channel, assuming the coarse bed material stored upstream of the existing crossing will be mobilized. A channel bed slope of 4.2 % was used for streambed and vented ford design (Figure 19). Our preliminary design analysis used the design profile and resultant channel elevations.

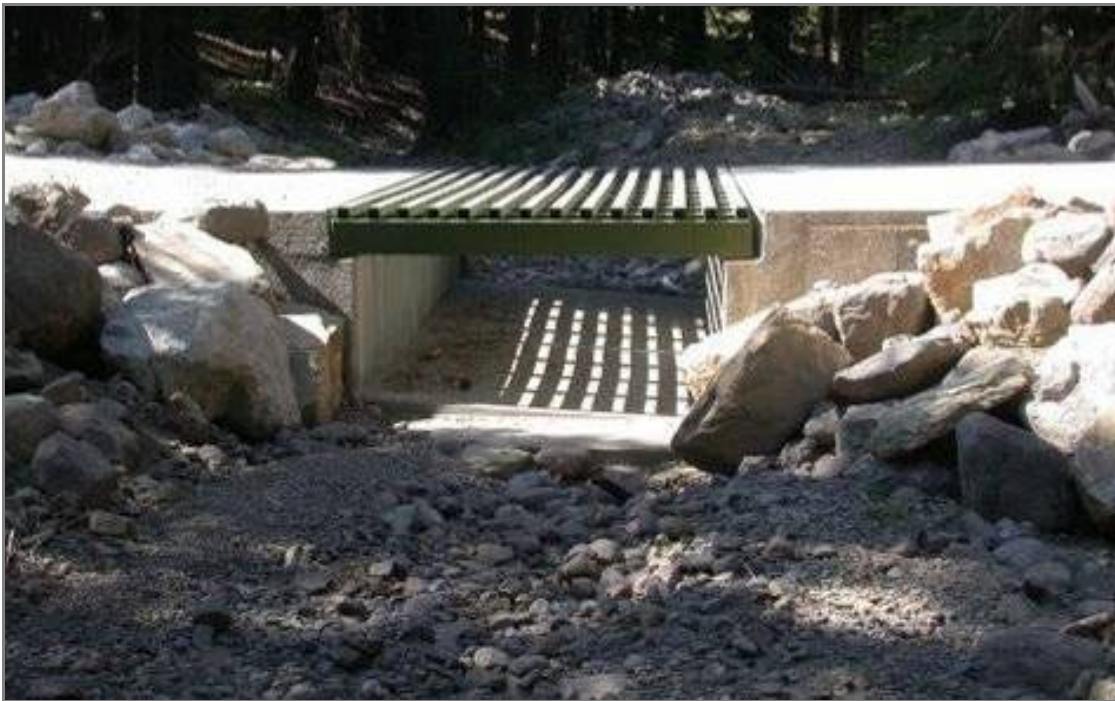
Figure 23 – Example of modifying an existing low-water crossing by cutting and forming a new box to create a vented ford. The crossing is designed using hydraulic criteria for fish passage and will not retain a natural streambed. The grate is removable to clear debris that may accumulate during high flows.

This option was considered at both the lower and upper Sunset Valley Road crossings. However, the existing channel-road configuration makes installation of a vent into the existing ford problematic. Any vent installed into the existing ford would only have a two-foot high opening at best. In addition, the maximum span for a single concrete vent is typically 12 feet, which is much narrower than the existing channel width. Therefore, this type of modification would be highly susceptible to clogging with the large bedload present throughout the channel. This type of crossing would require routine

maintenance and, when clogged with sediment, create impassible conditions for upstream migrating fish. Therefore, modification of the existing fords was not considered further.

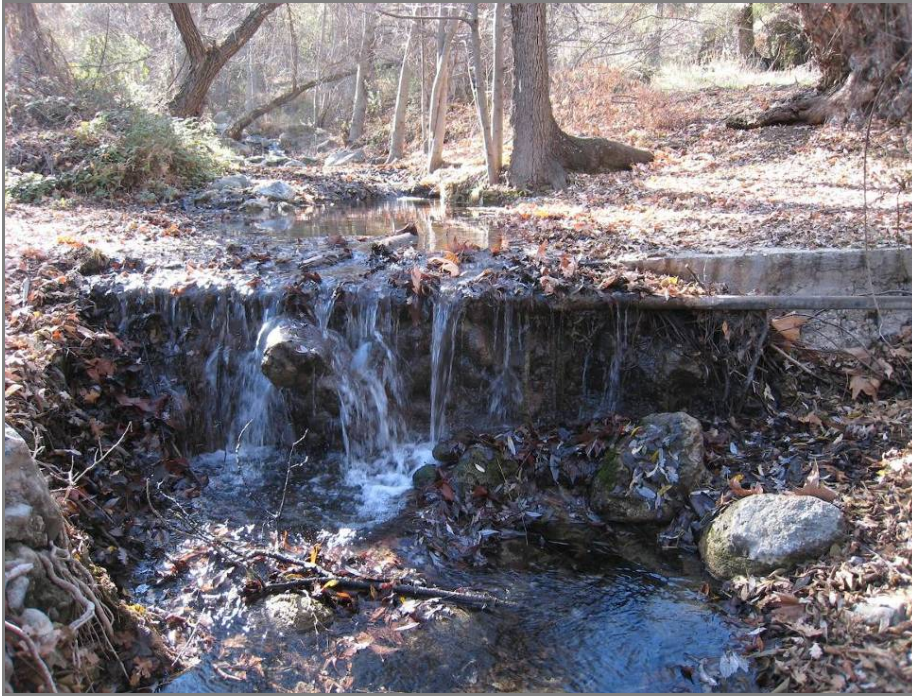
Figure 25 –Munch Creek crossing (H-150'59-1) is an abandoned 13-foot wide concrete low-water ford. Complete removal is recommended.

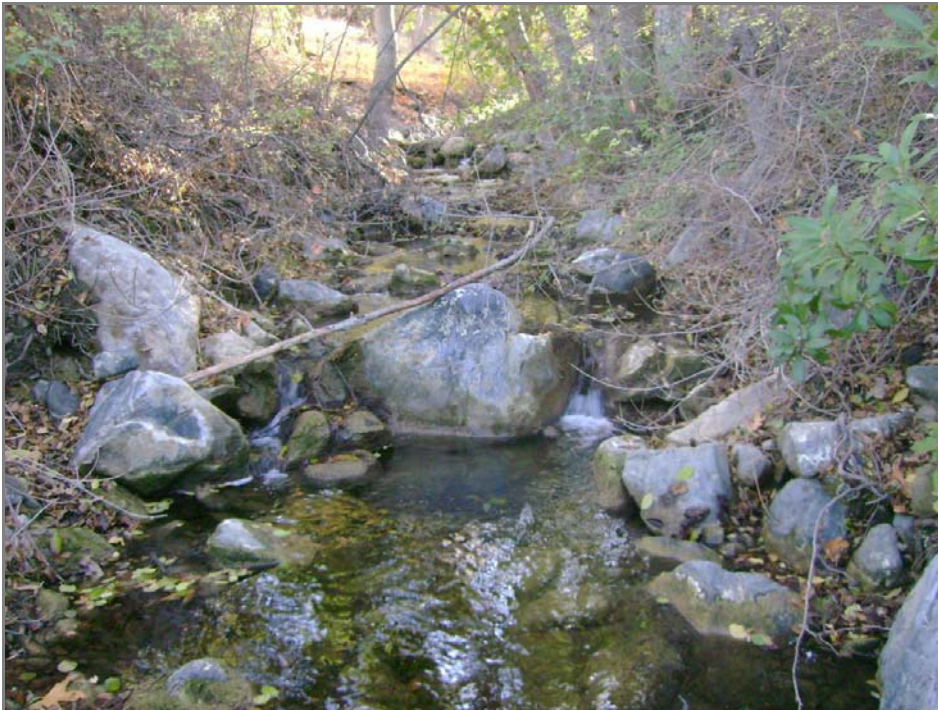
Figure 26 – Typical boulder step feature in the Munch Creek channel at the campground. Boulder steps form the primary channel feature upstream of the crossing. Pools ranged from 0.8 to 2 feet deep below boulder steps.

At 160 feet upstream of the crossing, the channel appears to be aggraded, forming braids and tighter spacing of steps with smaller drops. At this location there is evidence of overbank flow being diverted down the road, around the levee on the right bank, and re-entering the channel at the crossing. The aggradation along the upstream portion of the reach suggests that the steps in the channel may have formed at an elevation slightly higher than the original channel, possibly due to the ford acting as a knickpoint.

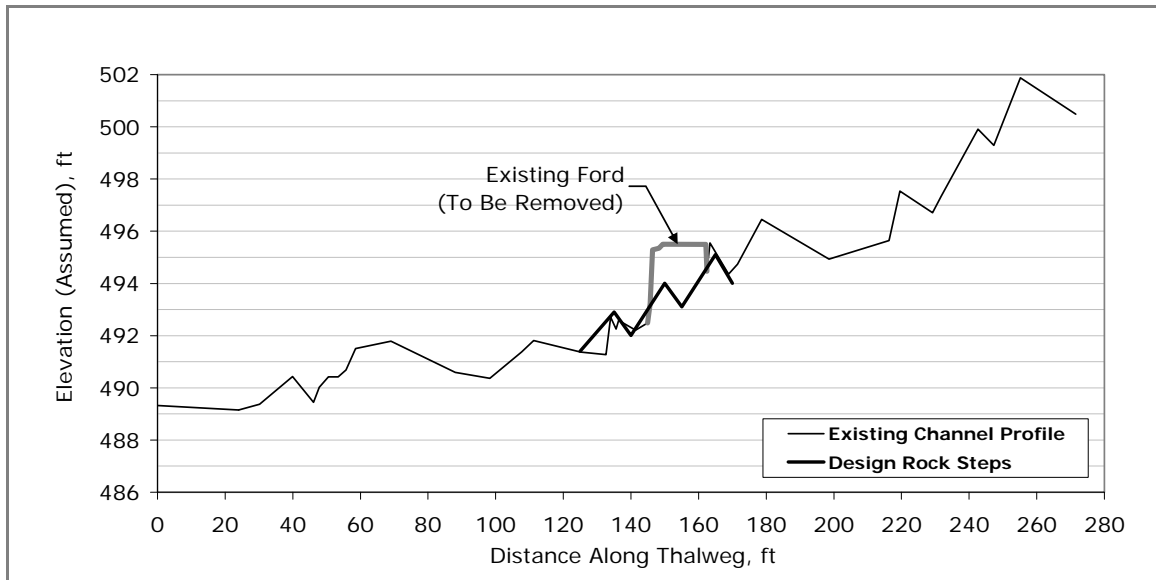
Figure 28 – Longitudinal profile for Munch Creek at the existing concrete ford. A new series of three rock steps with 1.1-foot drops can replace the crossing to provide fish passage and match the upstream channel morphology.

We propose to create a series of three boulder steps that are similar in size and function to the boulder steps of the upstream channel (Figure 27). Steps should be placed 15 feet apart with a drop of 1.1 feet at each step (Figure 28). The rock steps would be built within the excavated area of the crossing, which will facilitate rock placement and proper installation of rocks to maintain stability. Unlike typical rock weirs, these steps are not intended to be immobile but rather to function as the other large rocks in channel to form complex flow patterns and bed form. They would be sized and placed to have similar stability characteristics as the existing naturally formed steps, with the large rock becoming mobilized when the upstream natural steps mobilize. Following the analog of the reference channel, placing a few large “keystone” rocks will provide anchor points for rocks to naturally form steps. These large keystones can be 2 to 3-ton sized rock. The rest of the steps will be constructed from a mix of ¼-ton to 1-ton sized rock. When possible, such as at the most downstream step, naturally occurring boulders should be used in the step construction.

The rock steps should have “U” shaped plan forms with the apexes pointing upstream, and with crests that slope to the center of the channel in section view. This orientation will help concentrate flow to the center of the channel to form pools and protect the banks from excessive scour. Tapering the crest to the center of the channel also improves fish passage conditions by providing a distinct plunging nape for leaping.
