# Peacock Creek Pool and Weir Fishway

## THE DESIGN SOLUTION - VORTEX POOL and WEIR FISHWAY

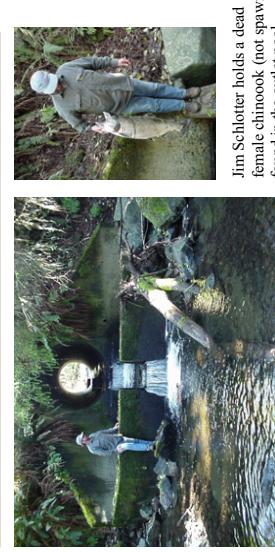
Jim Schlotter holds a dead female chinook (not spawned) found in the outlet pool.

Old County Culvert was:

- Undersized, (7.5 ft) overtops at 5-yr flow
- Perched with an Outlet Weir
- Too Steep, 4.3%
- Complete Barrier to all Species and Life Stages
- Previously Modified with Baffles that failed

Fish Passage Barriers at the site identified by Ross Taylor using FishXing included:

- High Velocities
- Excessive Leap
- Lack of Depth in Outlet Pool

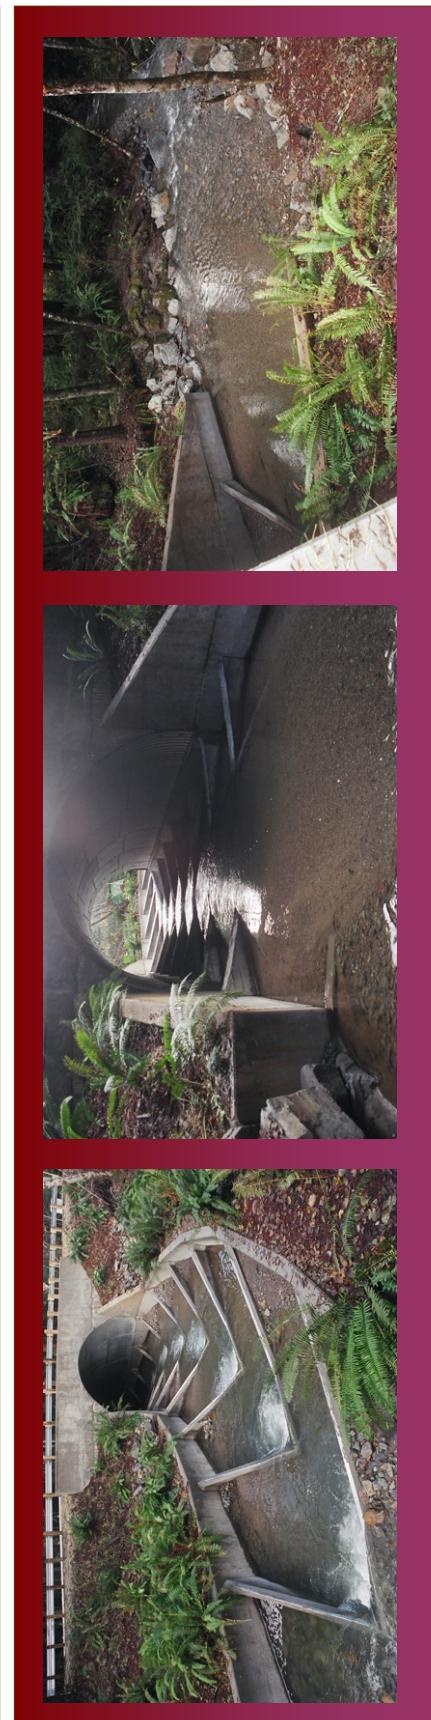
Looking downstream at culvert inlet (fishway exit). Vortex weirs with 8 inch drops concentrate flow to create scoured pools. This weir shape increases the ranges of flows for fish passage, and improves jump conditions for juvenile fish.

Looking downstream at outlet (fishway entrance). The last two weirs are backwatered to provide a swim in entrance and to protect the downstream channel from the erosion of high high flows.

Looking upstream at culvert outlet (fishway entrance). The two weirs are backwatered to provide a swim in entrance at low flows and energy

energy dissipation at high flows.

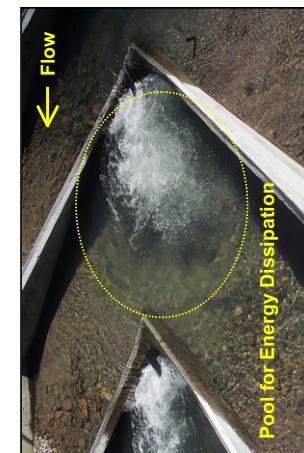
## POOL and WEIR FISHWAY

Pool and weir fishways operate in **Plunging Flow** regime during fish passage flows and in streaming flow at higher discharges

The **Energy Dissipation Factor** is a measure of turbulence in each pool. EDF values greater than 4 than 4 lb/ft<sup>2</sup>s indicate flow may be turbulent enough to disorient and fatigue fish.

The pool must be deep enough to provide adequate volume to dissipate energy from the plunge.

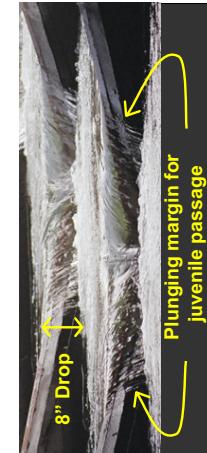
## VORTEX WEIR SHAPE

Vortex weirs allow for wider range of fish passage flows than other weir configurations:

- Concentrates the plunge and scour to maintain pool volume
- Increases the crest length which results in a lower velocity for a given flow
- Provides a leaping margin for juveniles and swim up conditions for adults

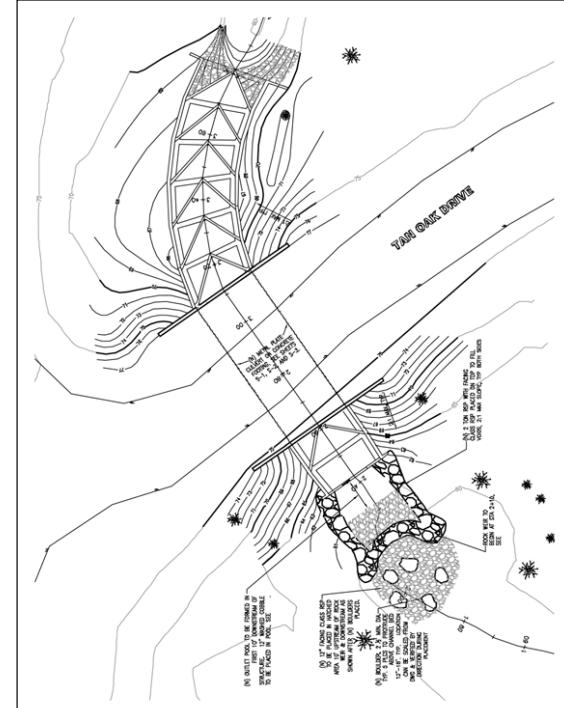
## FINAL DESIGN - PLAN VIEW

Fishway and Weir Dimensions					
Upstream Habitat	7,000 ft	Total Length	120 ft	Drop Over Weirs	8 in
Watershed area	2.2 mi <sup>2</sup>	Total Headloss	7 ft	Weir Side Slope	5:1 (hv)
100-year Flow	1,250 cfs	Fishway Slope	6.7%	Vortex Angle	90°
Adult High Passage Flow	78 cfs	Fishway Width	20 ft	Pool Depth	2.5 ft
Adult Low Passage Flow	3.0 cfs	Pool Spacing	10 ft

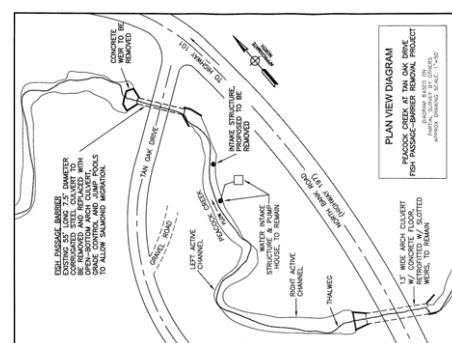
### Site Constraints included:

- Two upstream water intakes (one to be removed)
- Caltrans culvert upstream (not a barrier)
- Need to minimize headcutting & project limits
- 7 Feet vertical drop over 80 feet of channel
- Adjacent fill prism (Hwy 197)
- Pristine State Parks downstream
