# Lower Strawberry Creek Restoration Planning Report

**March 2008**

# LOWER STRAWBERRY CREEK RESTORATION PLANNING REPORT, ORICK, CALIFORNIA

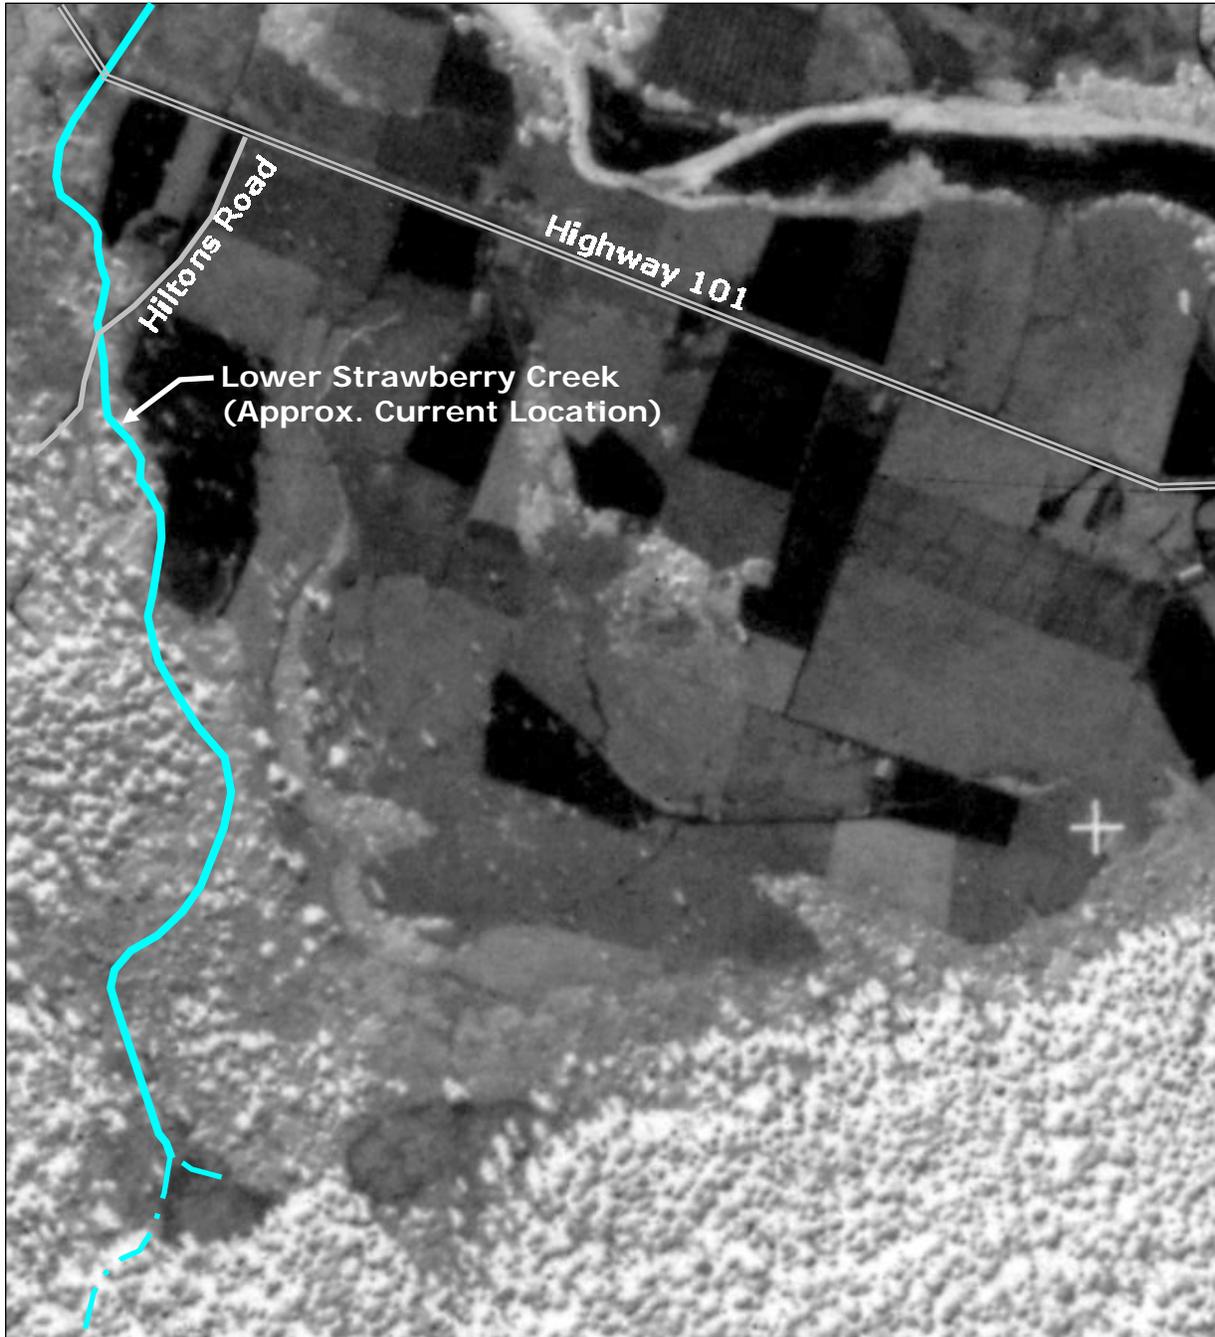
Figure 2.1 – The current location of Strawberry Creek overlaid on the 1936 aerial photograph, which shows that the lands adjacent to the stream were vegetated with a mixed height canopy.

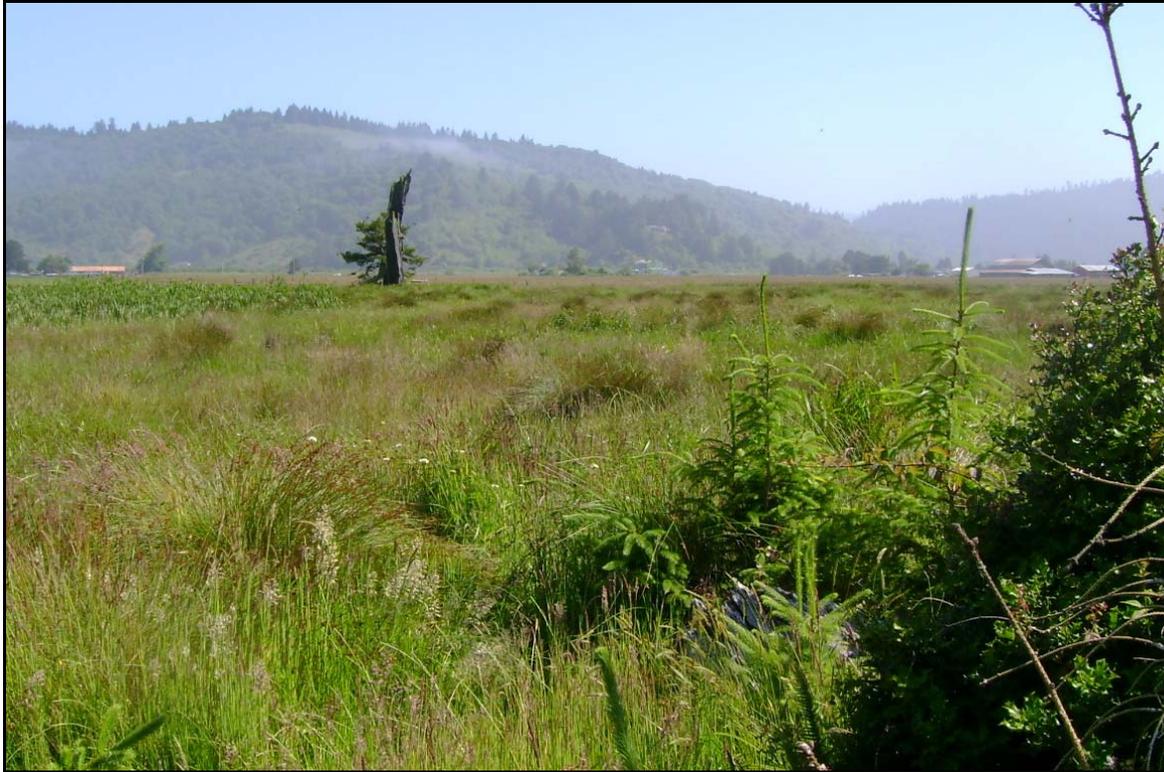
**Figure 2.2 – Present conditions on RNSP property, looking northward across the lower Strawberry Creek wetland complex towards an island of higher ground that supports a large snag and a living Sitka spruce tree. In the foreground several new spruce saplings grow next to a stump on another island within the wetland.**

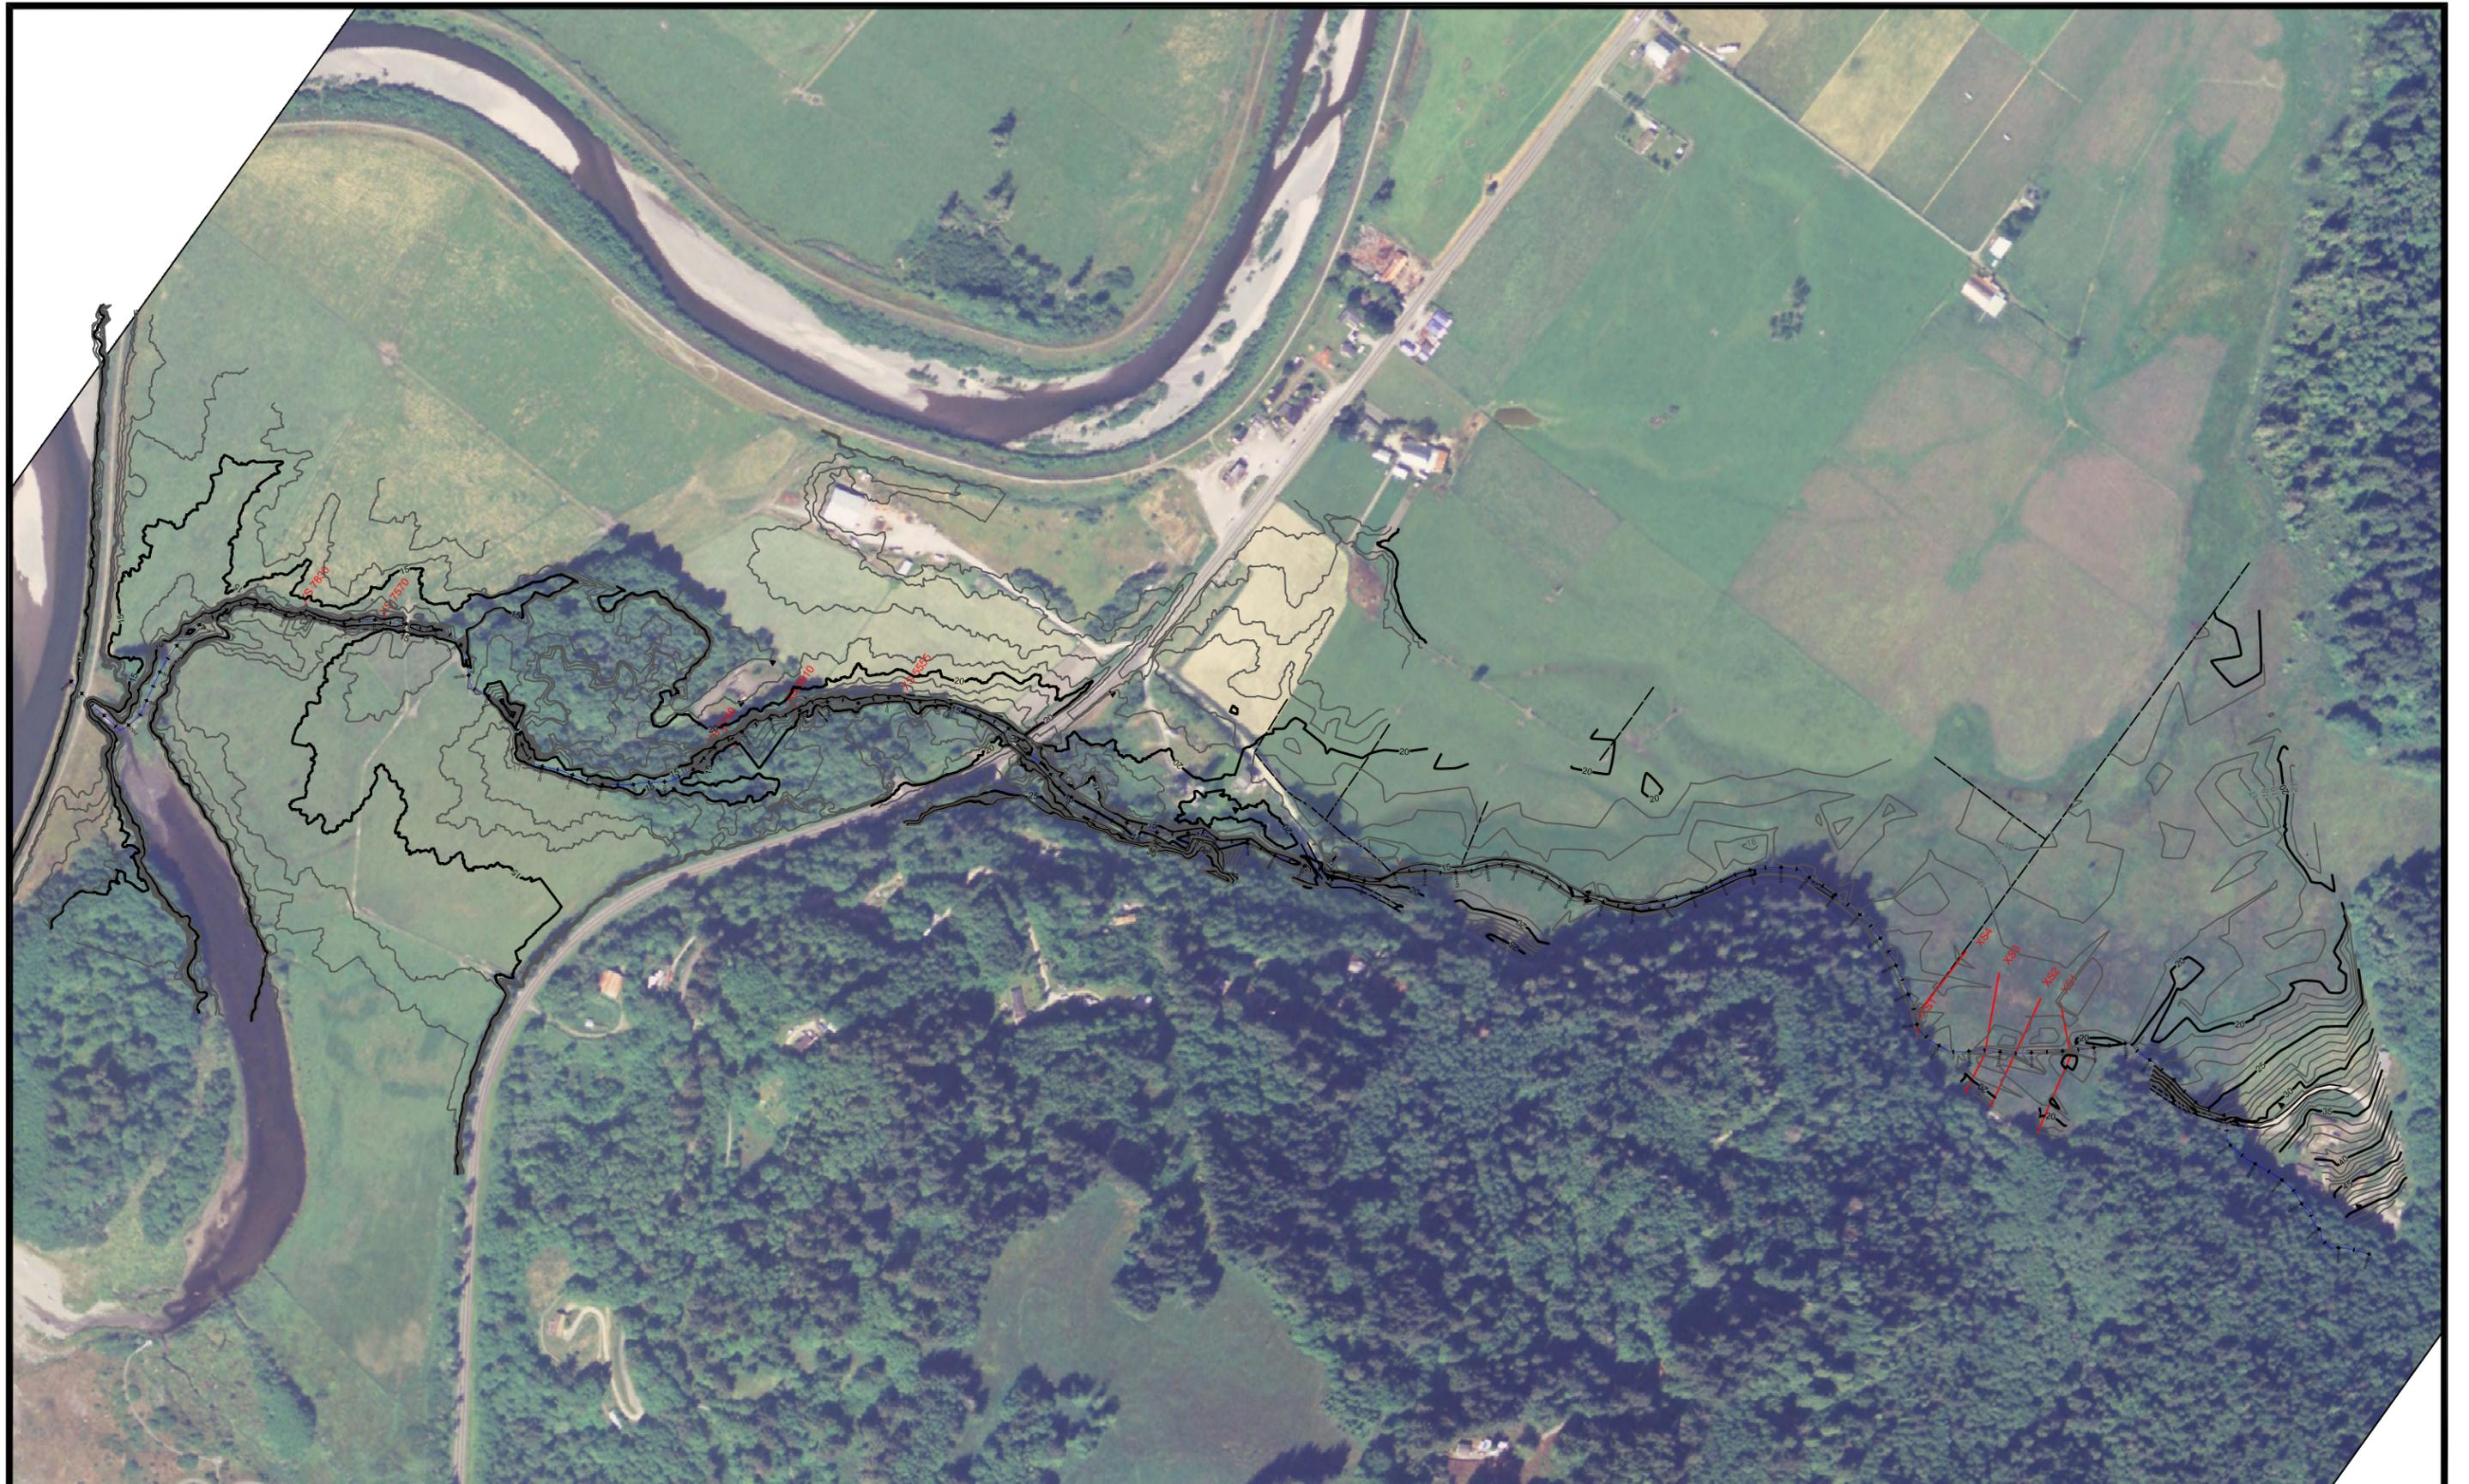
**STRAWBERRY CREEK TOPOGRAPHY**  
**FEBRUARY, 2007**  
**Humboldt County, California**

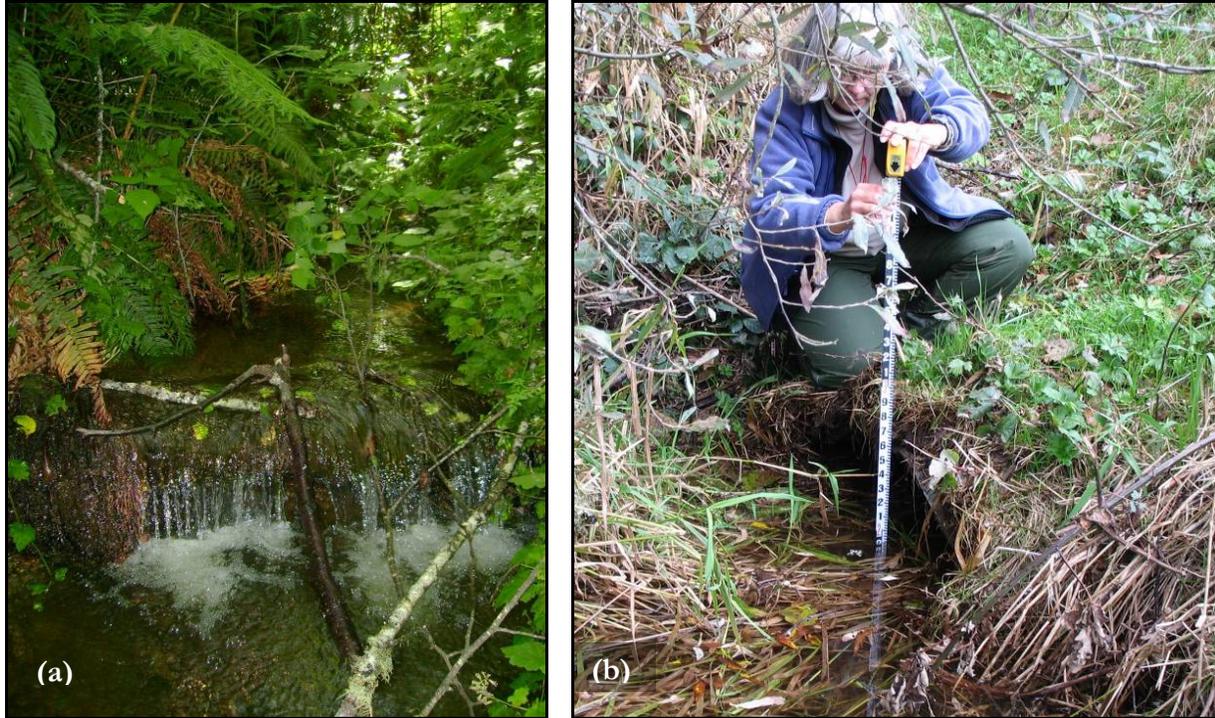
Figure 2.8 – Upstream of the old SOC (a) the tributary is characterized as wood-forced step-pool channel. The channel grade decreases as it flows across the alluvial fan, causing aggradation at the Access Road culvert inlet (b) and outlet.

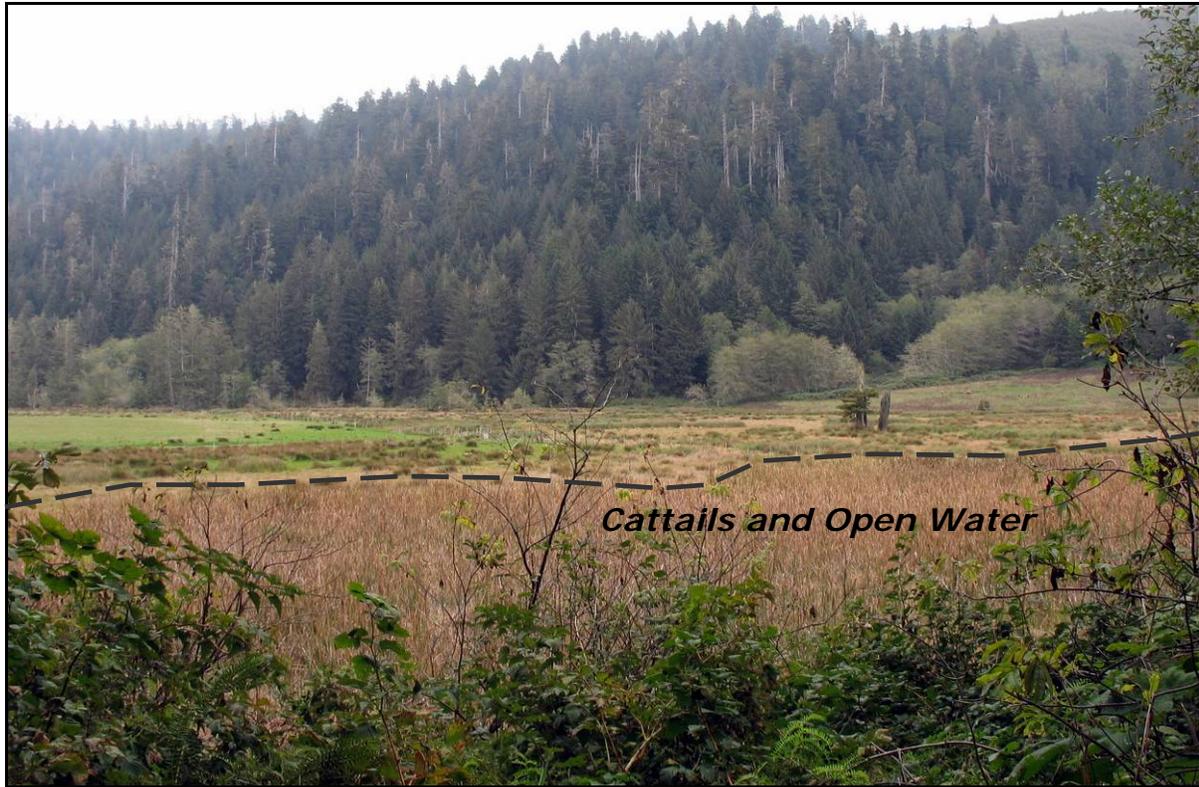
Figure 2.10 – Reach D consists of a wetland adjacent to the stream channel (below dashed line) that contains cattails and areas of open water, and remains free of RCG.

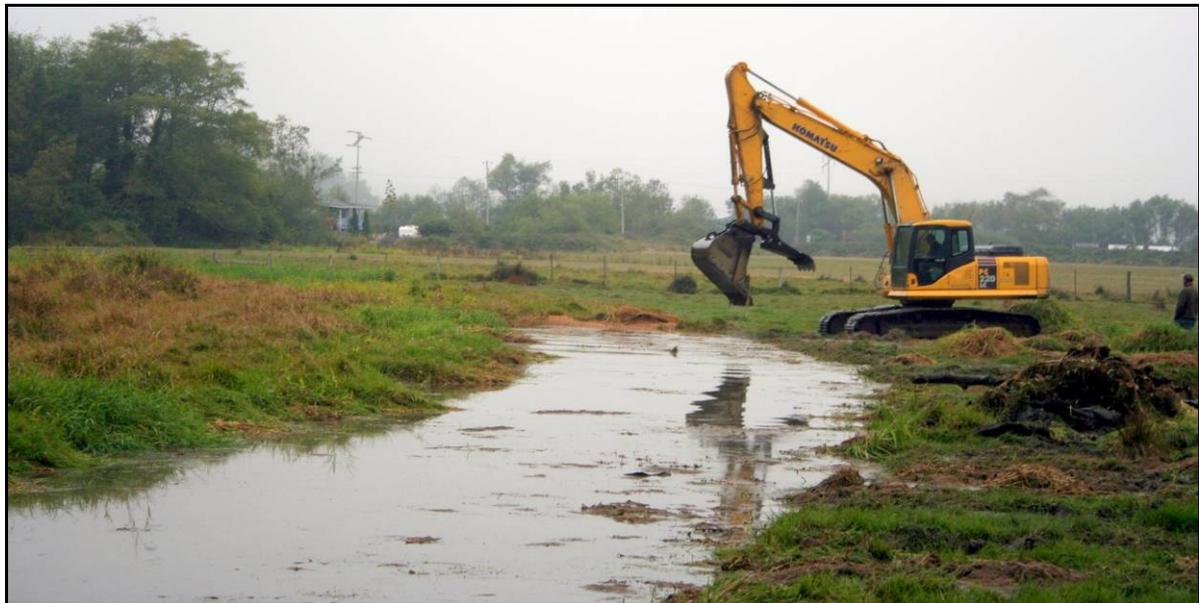
Figure 2.11 – Reed Canary Grass was removed from Reach E during the summer of 2006 (shown) and 2007. This reach requires routine clearing of the RCG to maintain flow capacity and prevent extensive inundation of adjacent stream banks.

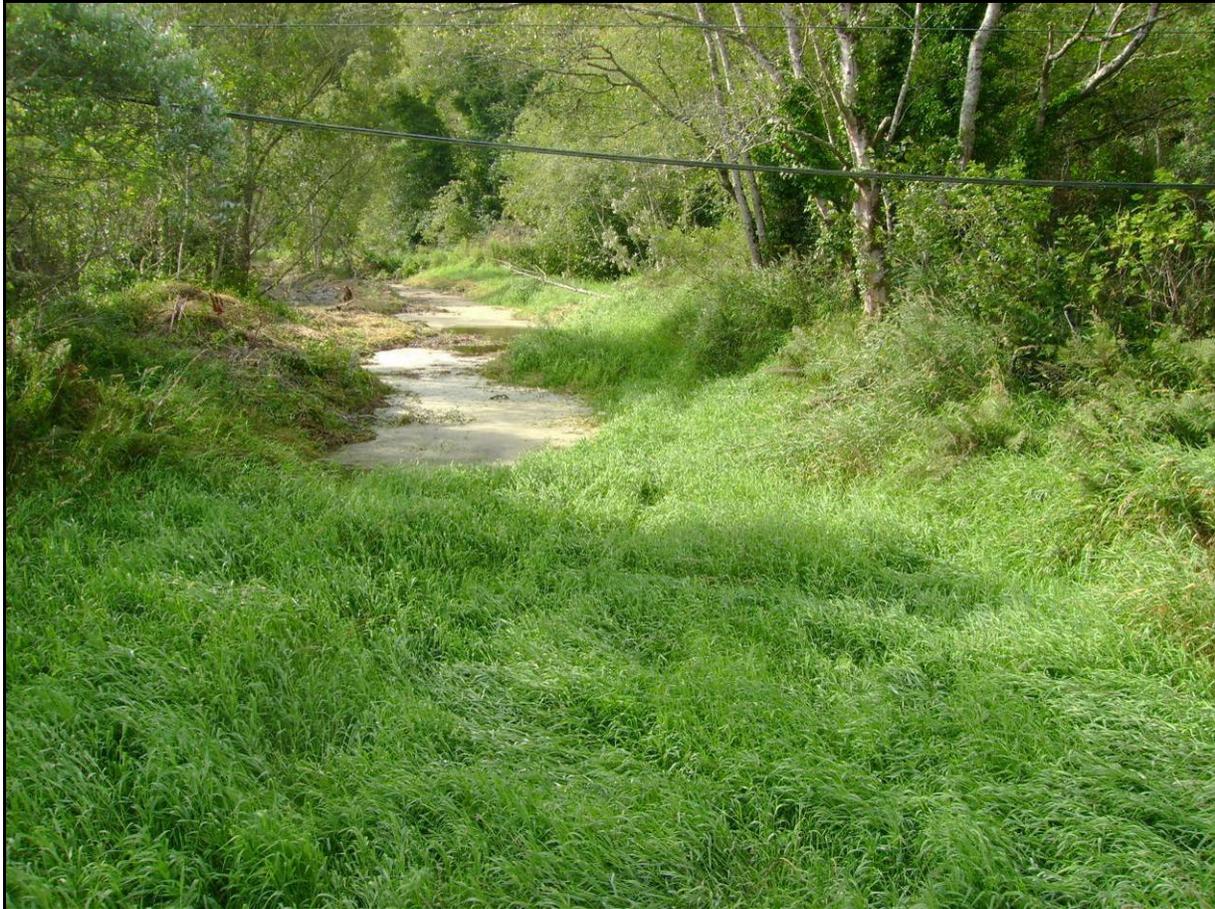
**Figure 2.12 – Reach F, partially cleared of RCG in September 2007. This reach is more confined and has higher banks than the upstream reaches. In-channel RCG raises the water level in this reach and prevents the upstream reaches from draining.**

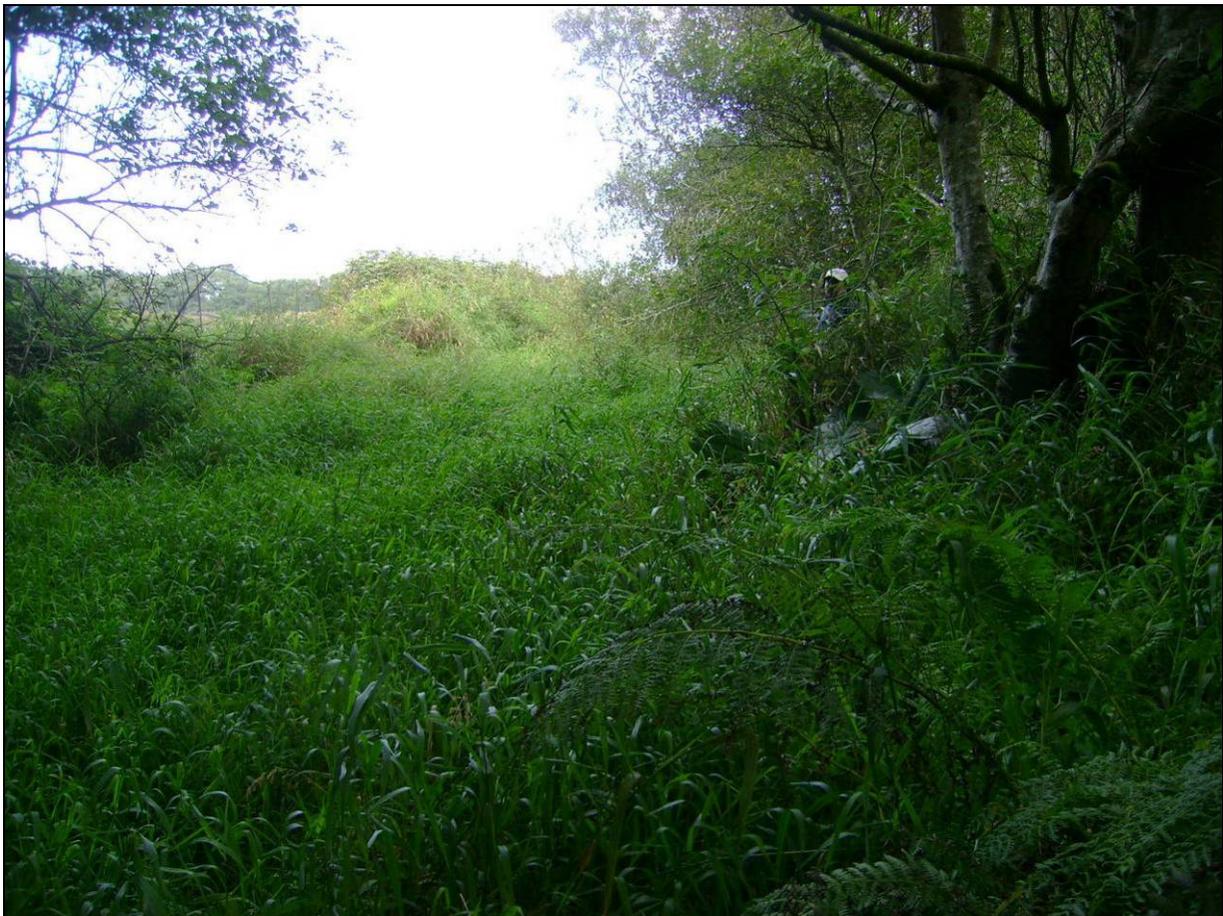
**Figure 2.13 – RCG grows throughout the active channel and open pasture in the lower portions of Reach H between the Zuber property and Transfer Station parcel. However, the RCG does not grow into the forested riparian areas due to adequate shading caused by a complex canopy.**

Within the lower 800 feet of the reach the riparian area persists on the east bank of the stream channel. The western overbank, owned by the Zuber family, is covered with RCG and the streambanks are grazed and unstable. RCG grows vigorously throughout much of the wetted channel. However, its growth is significantly less vigorous on the forested side of the channel (Figure 2.13).

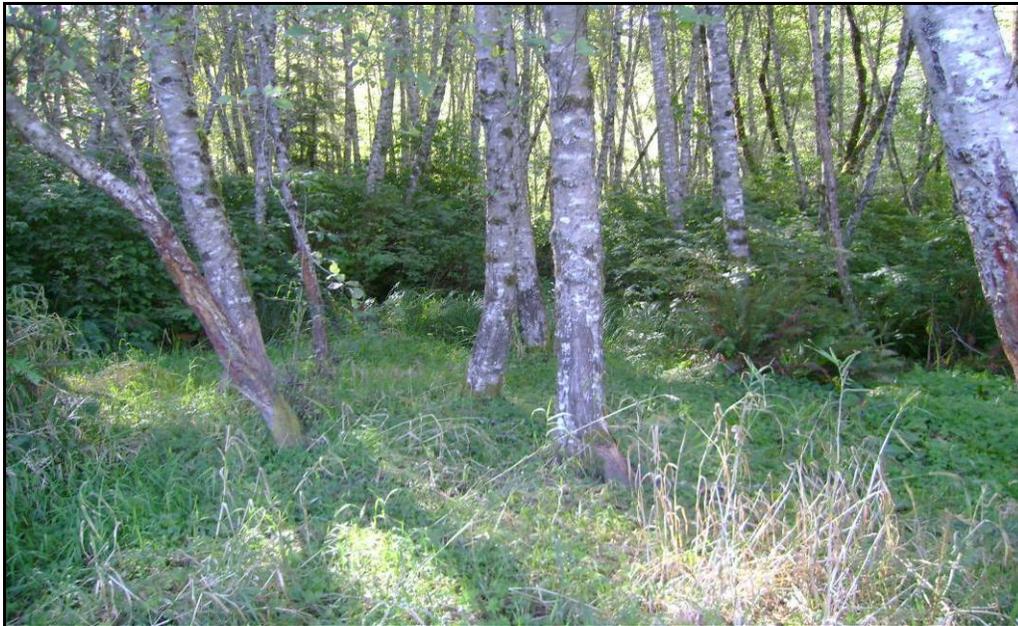
**Figure 2.14 – RCG grows under a dense alder canopy (foreground) but is not present among the salmonberry and alder (background), likely due to the effective shading caused by the mixed-level canopy.**

A visual inspection of existing vegetation within the project area was performed in the fall of 2007 for developing a RCG management plan (Gedik, 2008, Appendix A). The wooded area to the south and west of the project area is characterized by second growth redwood and Sitka spruce forest with red alder in the wetter areas (RNSP, 2006a). The wooded area on the Transfer Station parcel is dominated by mature alder canopy with shrub undergrowth. Young deciduous and coniferous trees are sparse. RCG was observed to grow less vigorously in riparian areas. RCG was observed growing under a dense red alder canopy along the West Tributary adjacent to the SOC Access Road. However, a short distance upstream a dense understory of salmonberry prevents the RCG from growing, likely due to the mixed shade canopy (Figure 2.14).

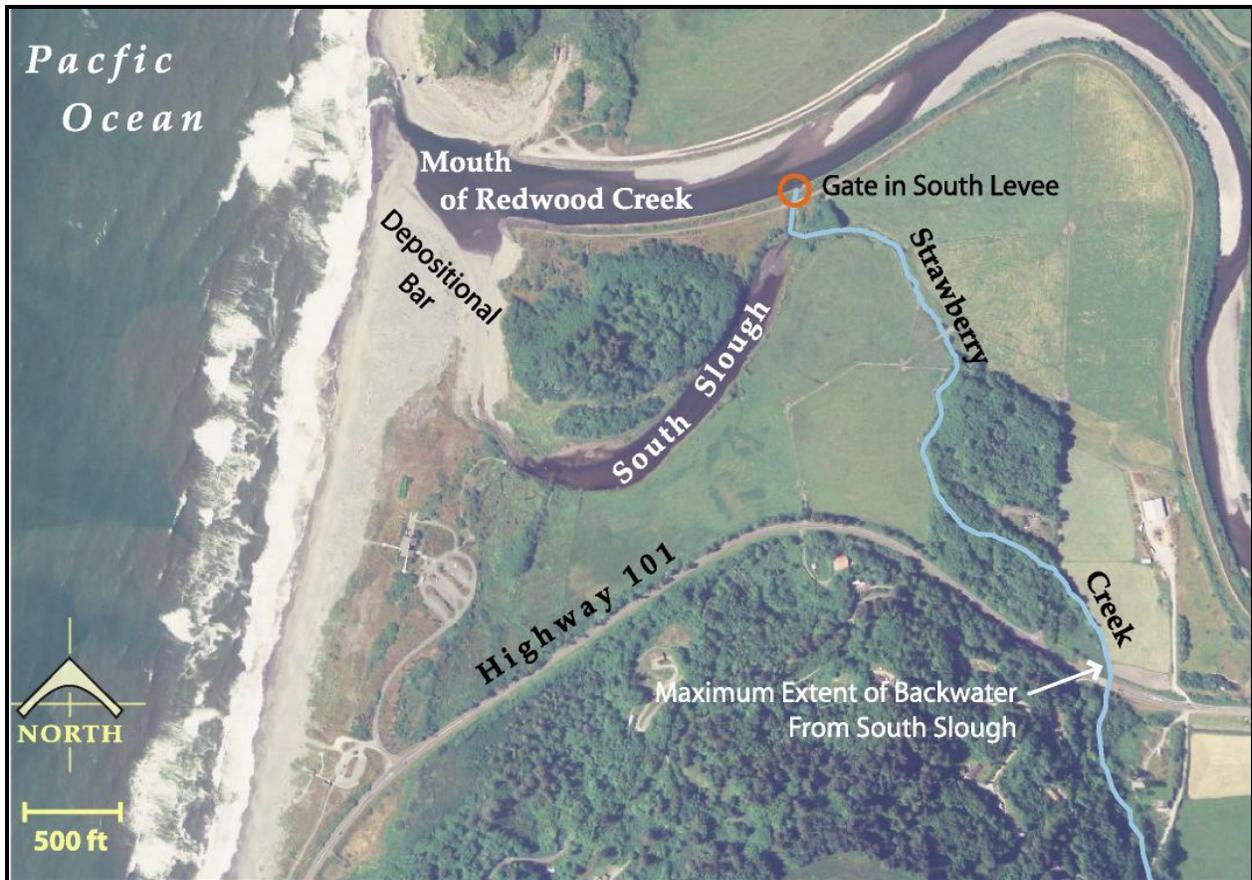
**Figure 3.2 - Aerial photograph showing the depositional bar across the mouths of Redwood Creek and South Slough. When the mouth is closed during summer and early fall, water levels in South Slough can rise dramatically, increasing water levels in the lower portions of Strawberry Creek.**

When the bar at the mouth of Redwood Creek is open, water levels in Redwood Creek generally fluctuate with changes in the tides and stream flow. Because the South Slough is connected to Redwood Creek, its water level tends to follow those of Redwood Creek. When the gate in the levee is closed the depositional sand bar located across the mouth of the South Slough limits tidal exchange in the South Slough by preventing the Slough from draining below elevation 6.9 feet (NAVD 88).

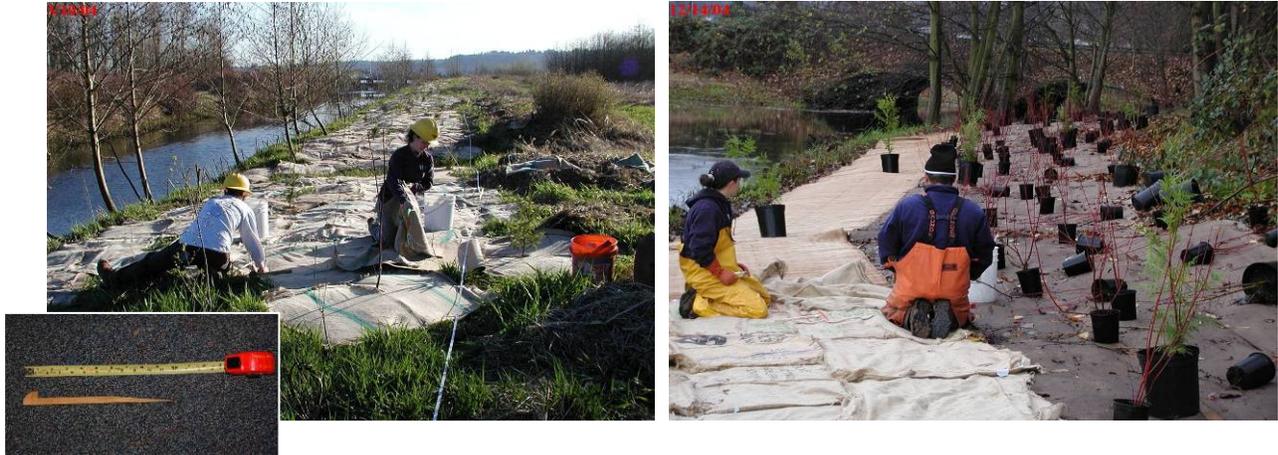
**Figure 4.1 - Dense planting along streambanks using cardboard and burlap bags held in-place with 12 inch long hardwood stakes. Photos courtesy City of Kent, WA.**

To plant streambank areas, reed canary grass should first be mowed/ weed-whacked to the ground surface where feasible, then covered with staked corrugated cardboard and burlap bags (pers. comm. M. Knox, 2007). This combination serves to suppress RCG growth by limiting light while allowing water to penetrate the cardboard and burlap. Because this planting method will hold materials in place, it is well suited for areas that will be frequently inundated. While both materials will biodegrade over time, burlap extends the life of the cardboard covering long enough for planted native species to become established. Species should be planted in small holes cut into both materials, and materials should be staked-down using a combination of live willow stakes and hardwood stakes. At lower elevations along the streambanks coir wattles may be staked in place and planted with live plants into the coir.

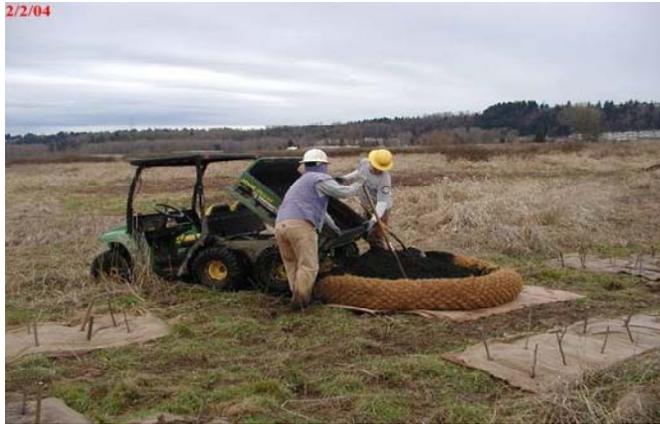
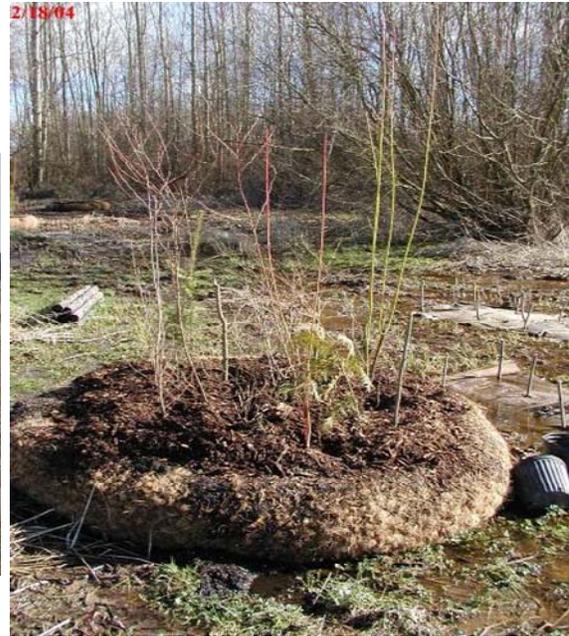
**Figure 4.3 - Dense planting in wattle “donuts” placed on chipboard and filled with nutrient-rich well-draining soils.**

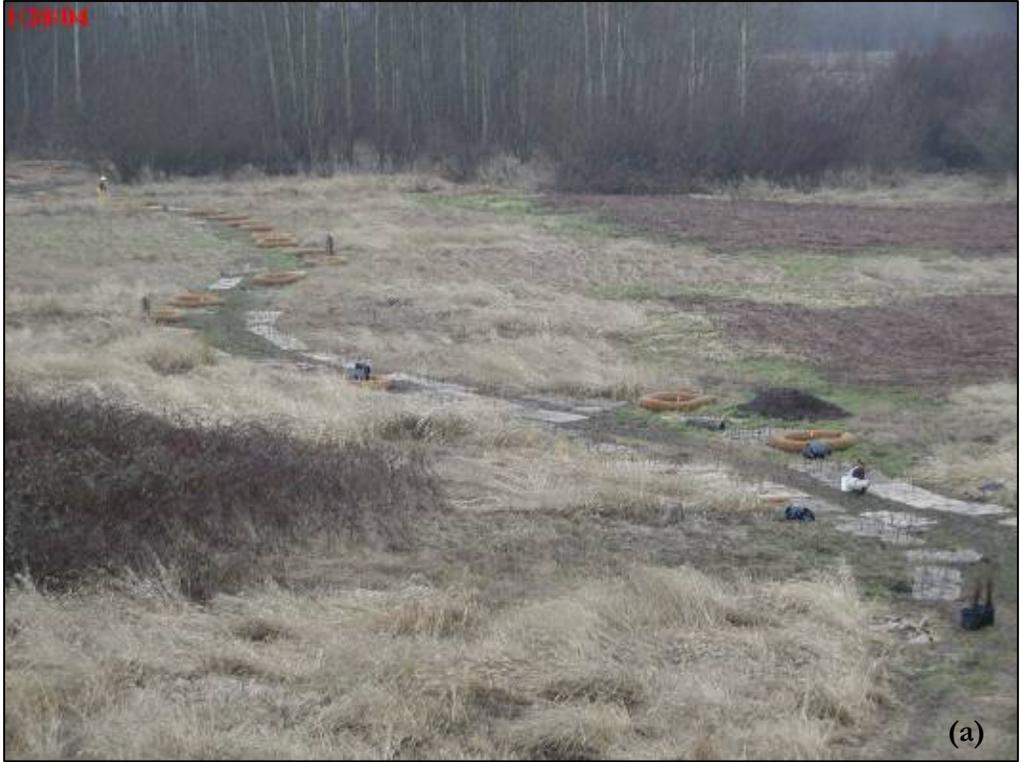
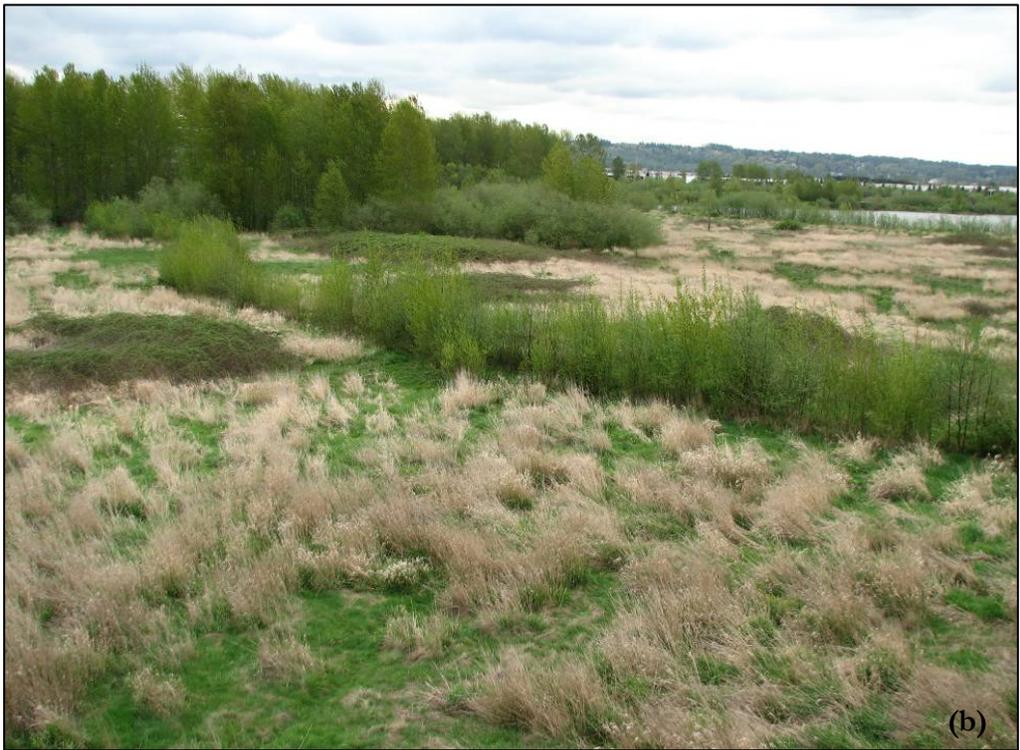
**Figure 4.4 - Planting in a RCG infested field in January 2004 (a) utilizing both wattle donuts and cardboard and burlap covering. Subsequent photo monitoring (b) in April 2007 shows a dense riparian area becoming established. Photos courtesy City of Kent, WA.**
