## FINAL REPORT

# Steamboat Falls Fish Passage Evaluation and Alternatives Analysis

**The North Umpqua Foundation**

Michael Love & Associates  
PO Box 4477, Arcata CA 95501  
mlove@h2odesigns.com • 707-476-8938

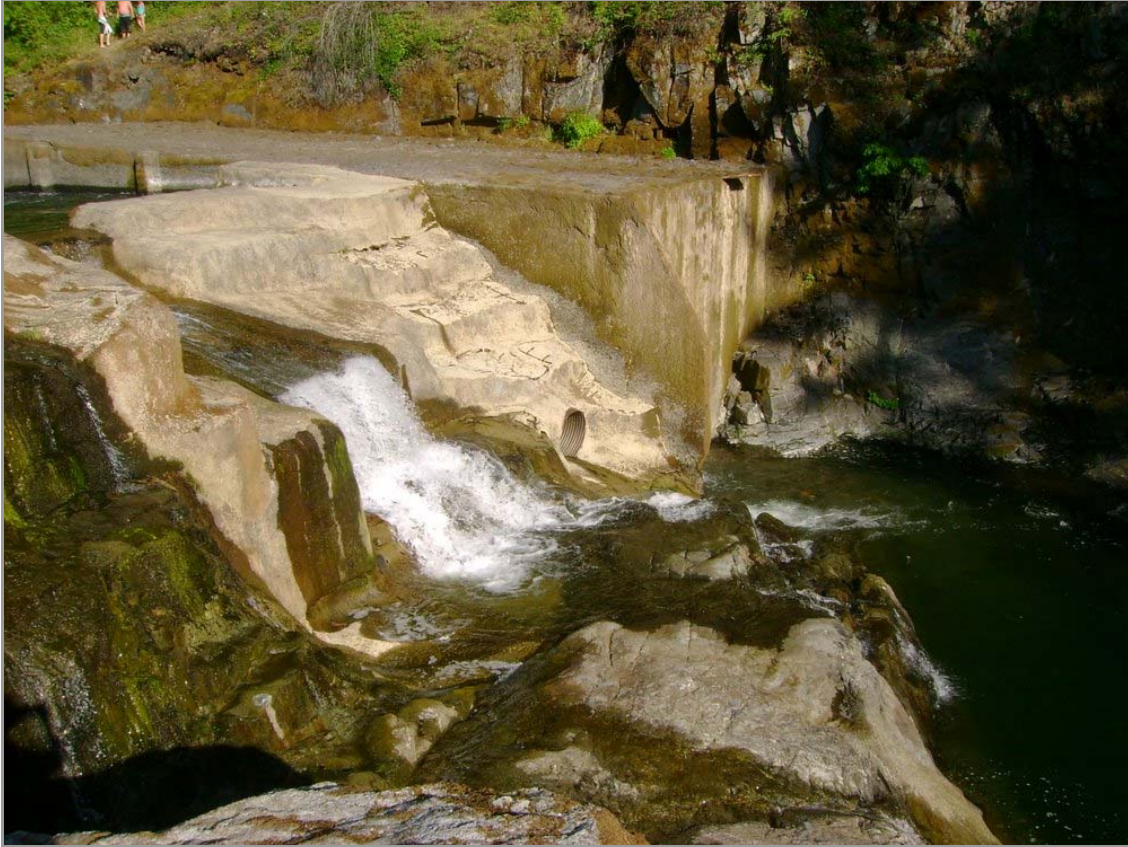
Figure 1-1. Existing enclosed fishway and spillway at Steamboat Falls.

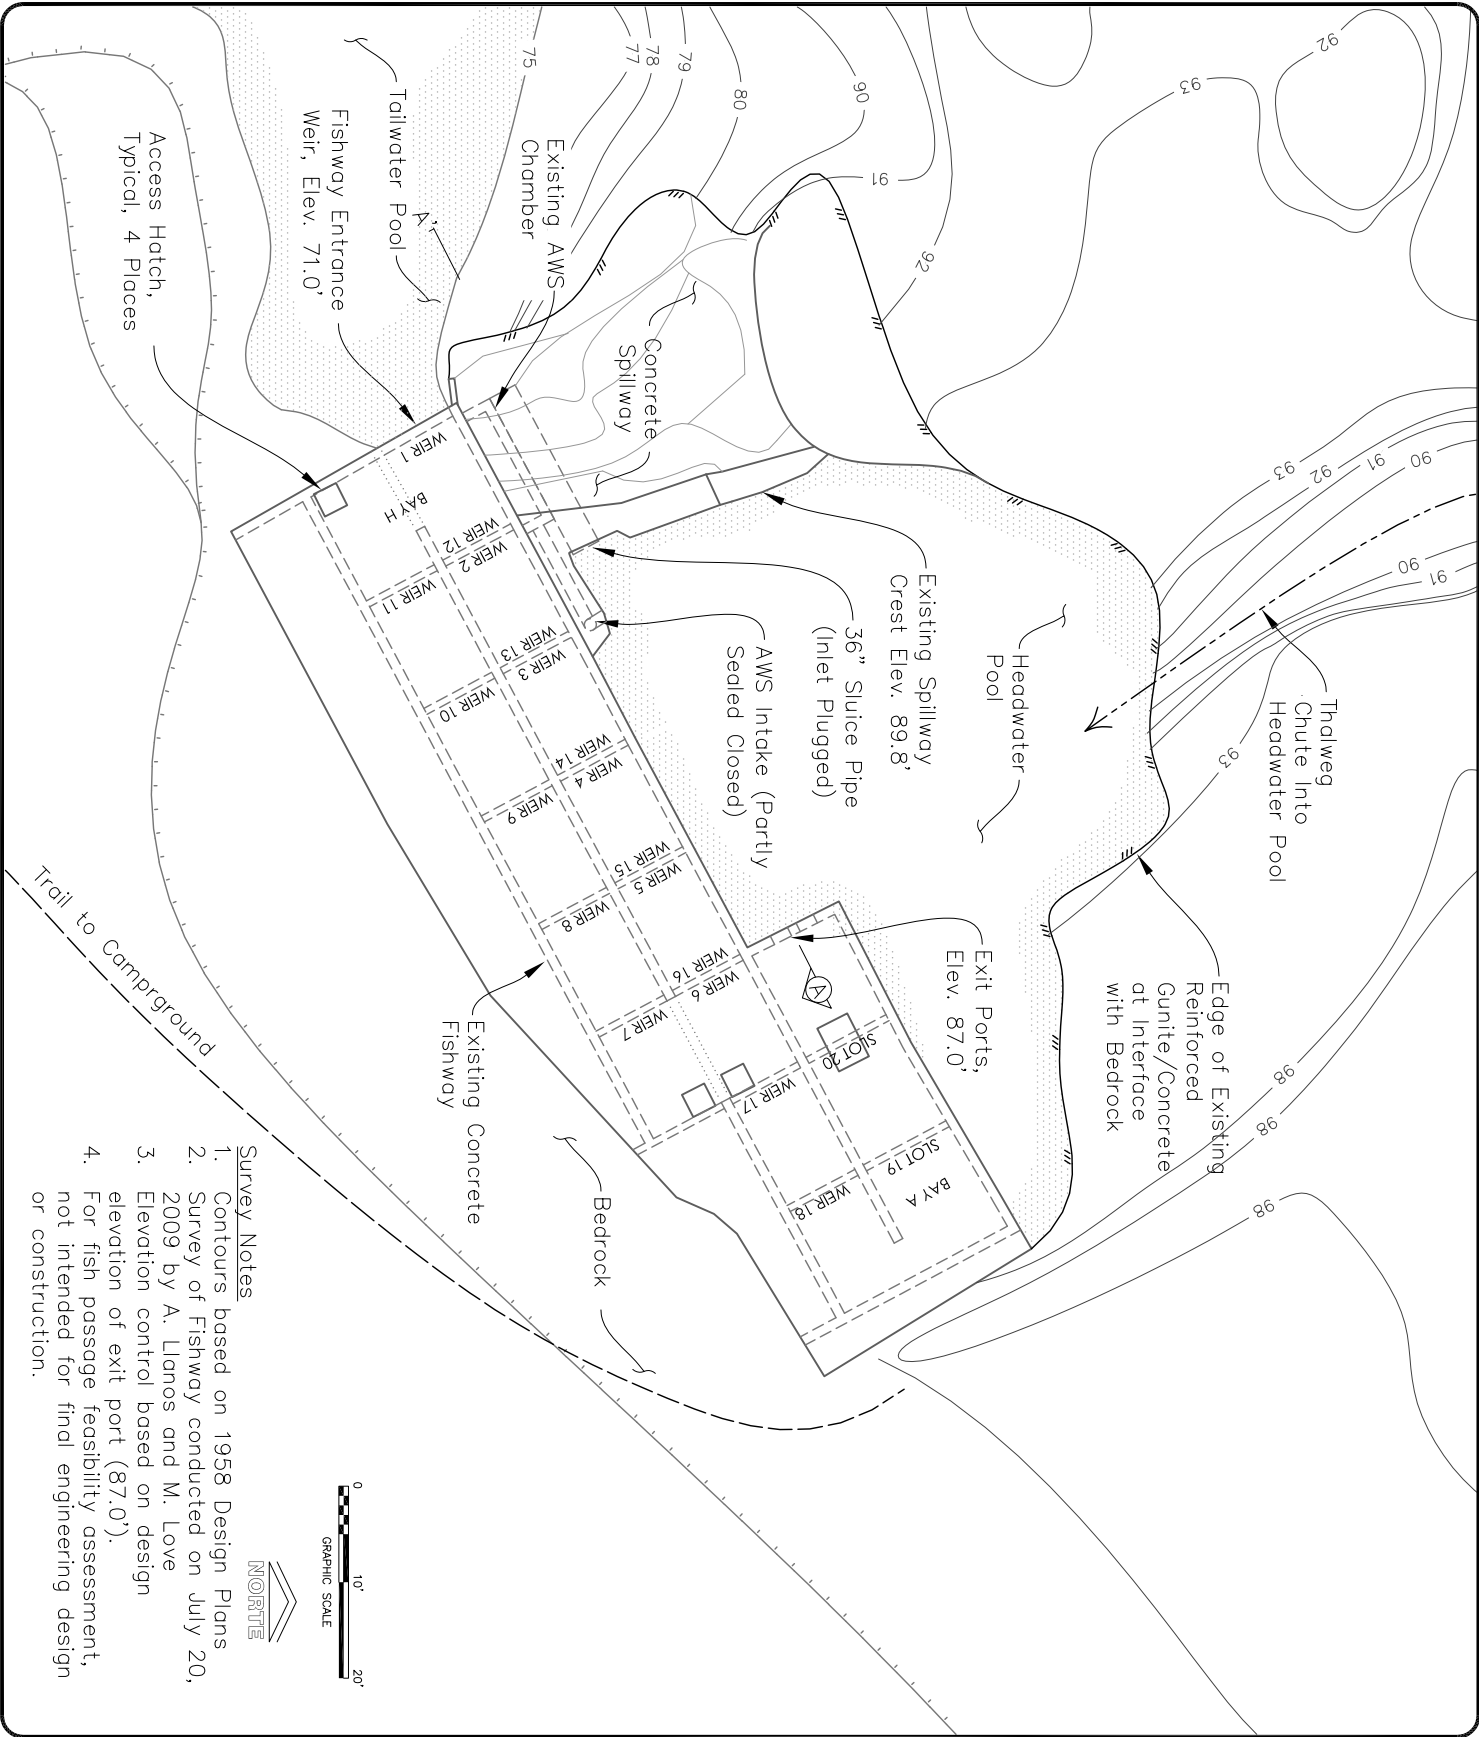
Figure 1-2. Existing fishway configuration.

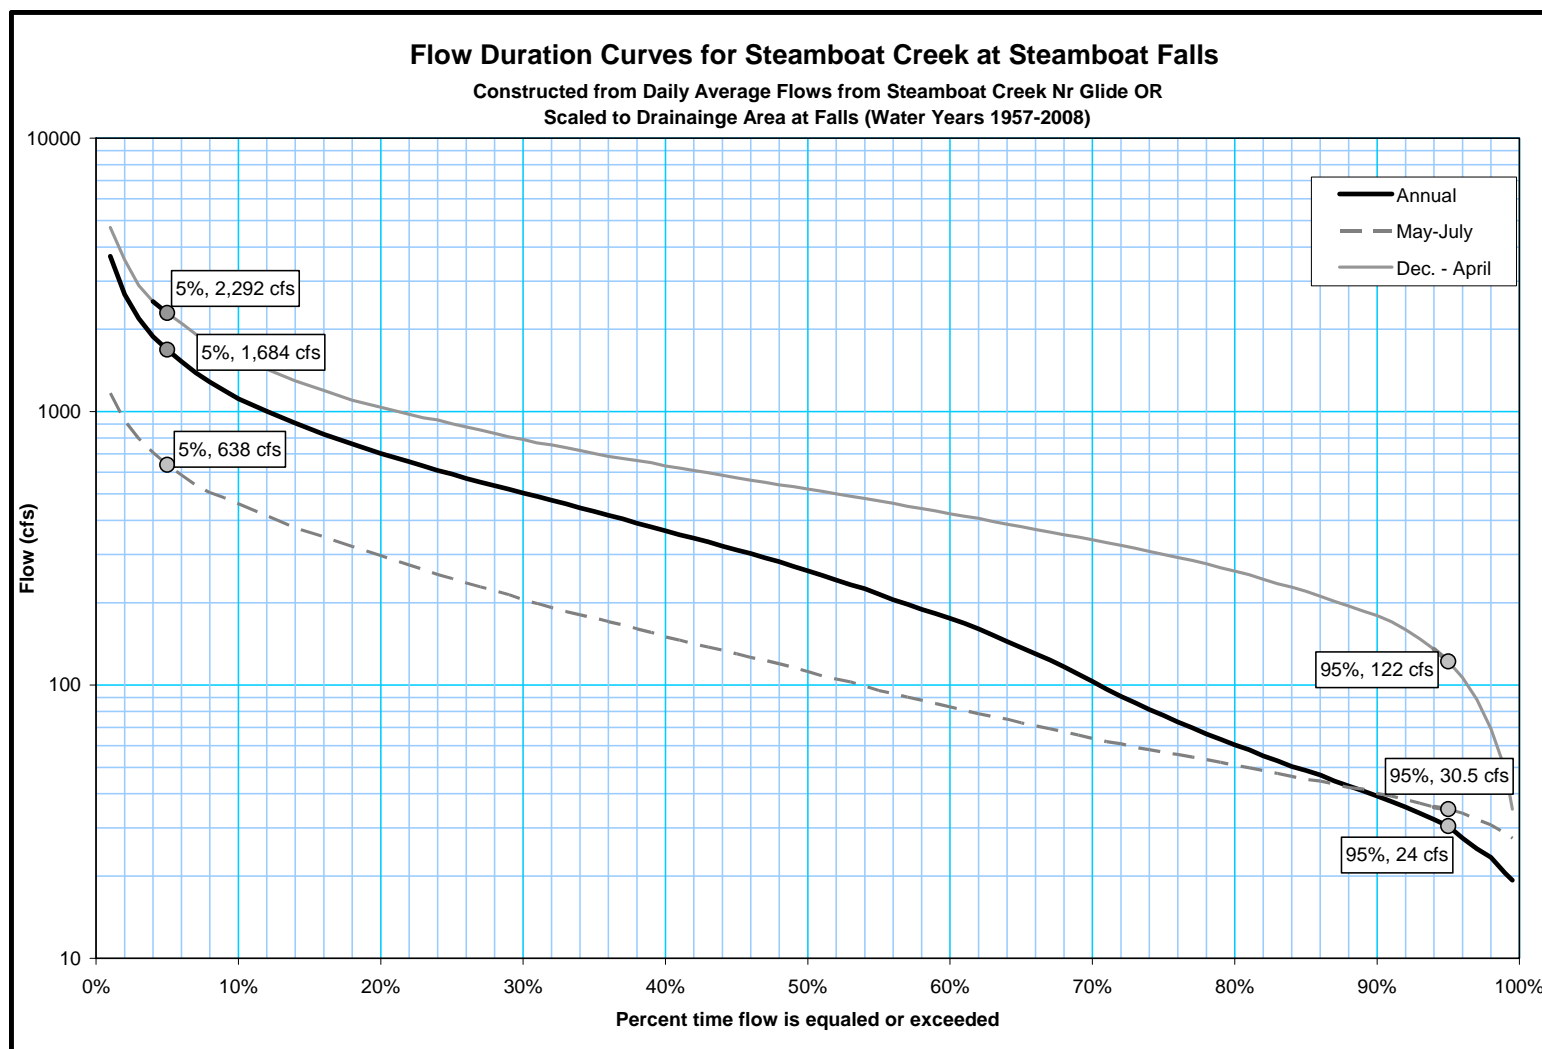
Figure 3-3. Annual, “summer-run” and “winter-run” flow duration curves for Steamboat Creek at Steamboat Falls. The 5% and 95% exceedance flows are provided for each curve.

For summer steelhead and winter steelhead running up Steamboat Creek between December and April, streamflows at the falls during this period typically remain above 100 cfs, 300 cfs, and 400 cfs during Dry, Average, and Wet years, respectively (Figure 3-4). Therefore, if upstream passage for these fish is desired, suitable fish passage conditions should be provided at streamflows from 100 cfs to at least 400 cfs.

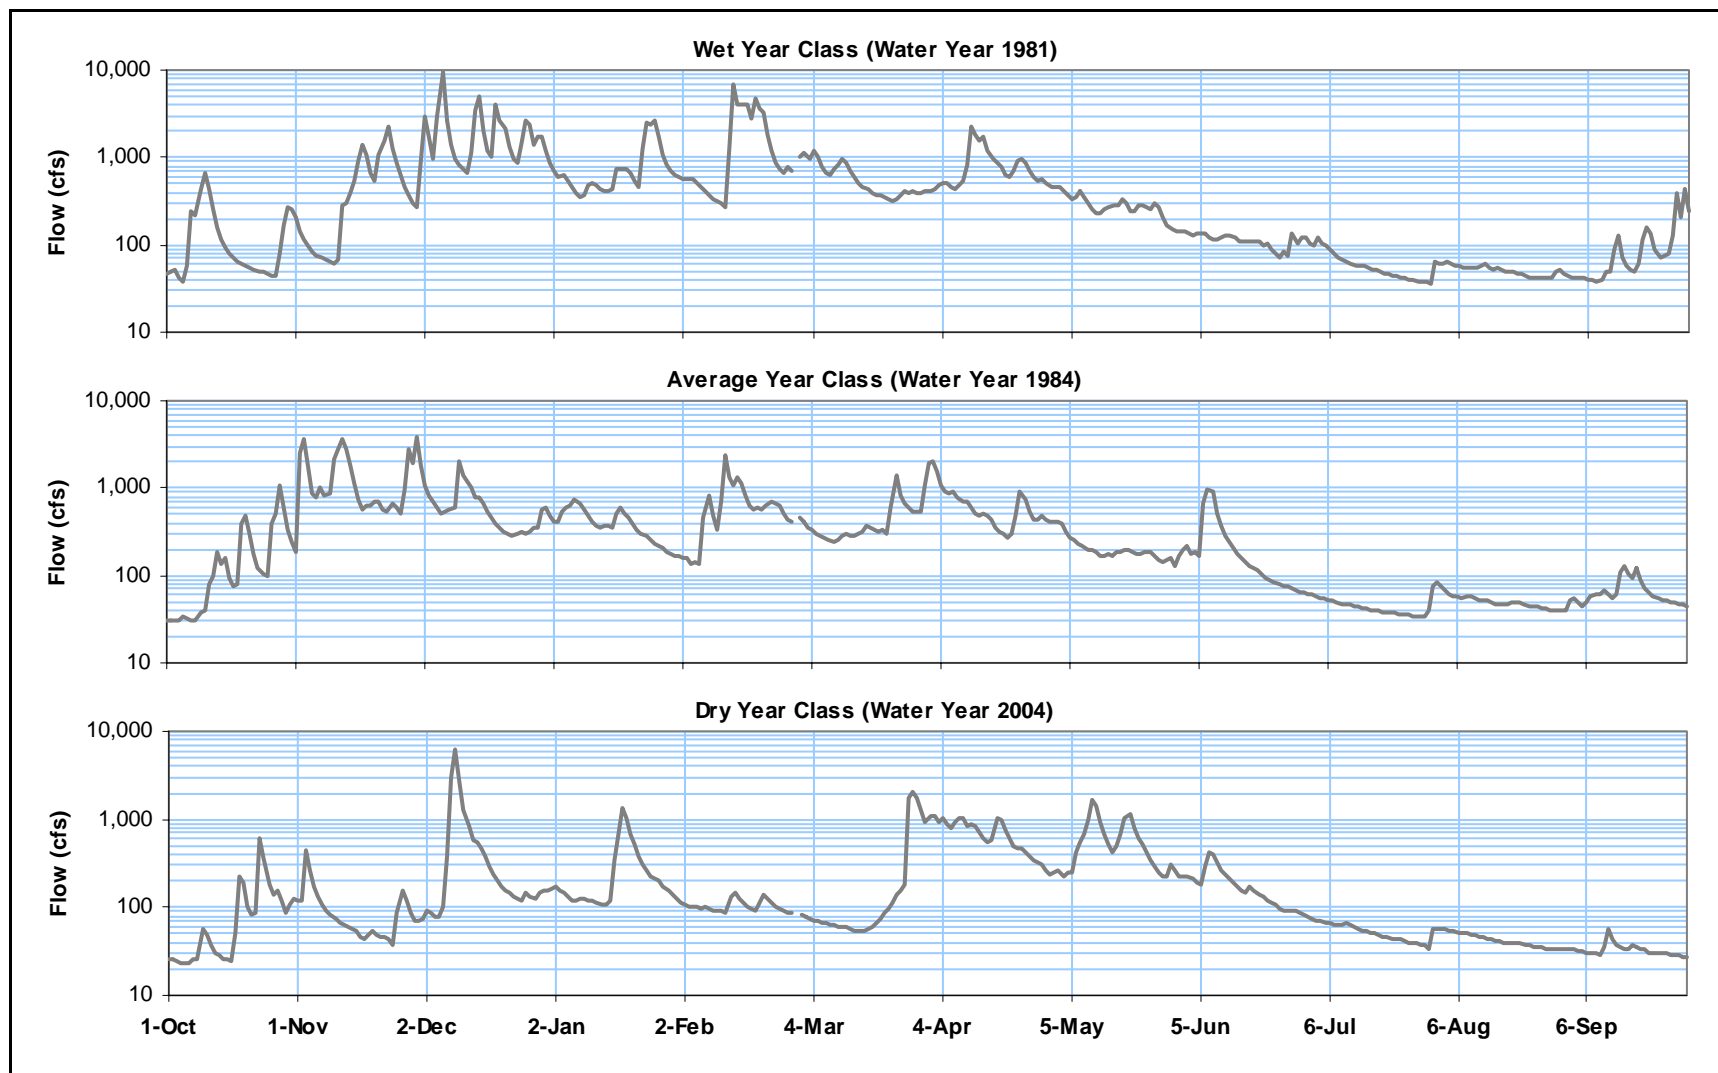
Figure 3-4. Hydrographs for flow at Steamboat Falls for statistically Wet, Average, and Dry water years. Constructed with daily average flows from USGS Station No. 14316700 (Steamboat Creek Nr Glide) and scaled to the drainage area at Steamboat Falls.

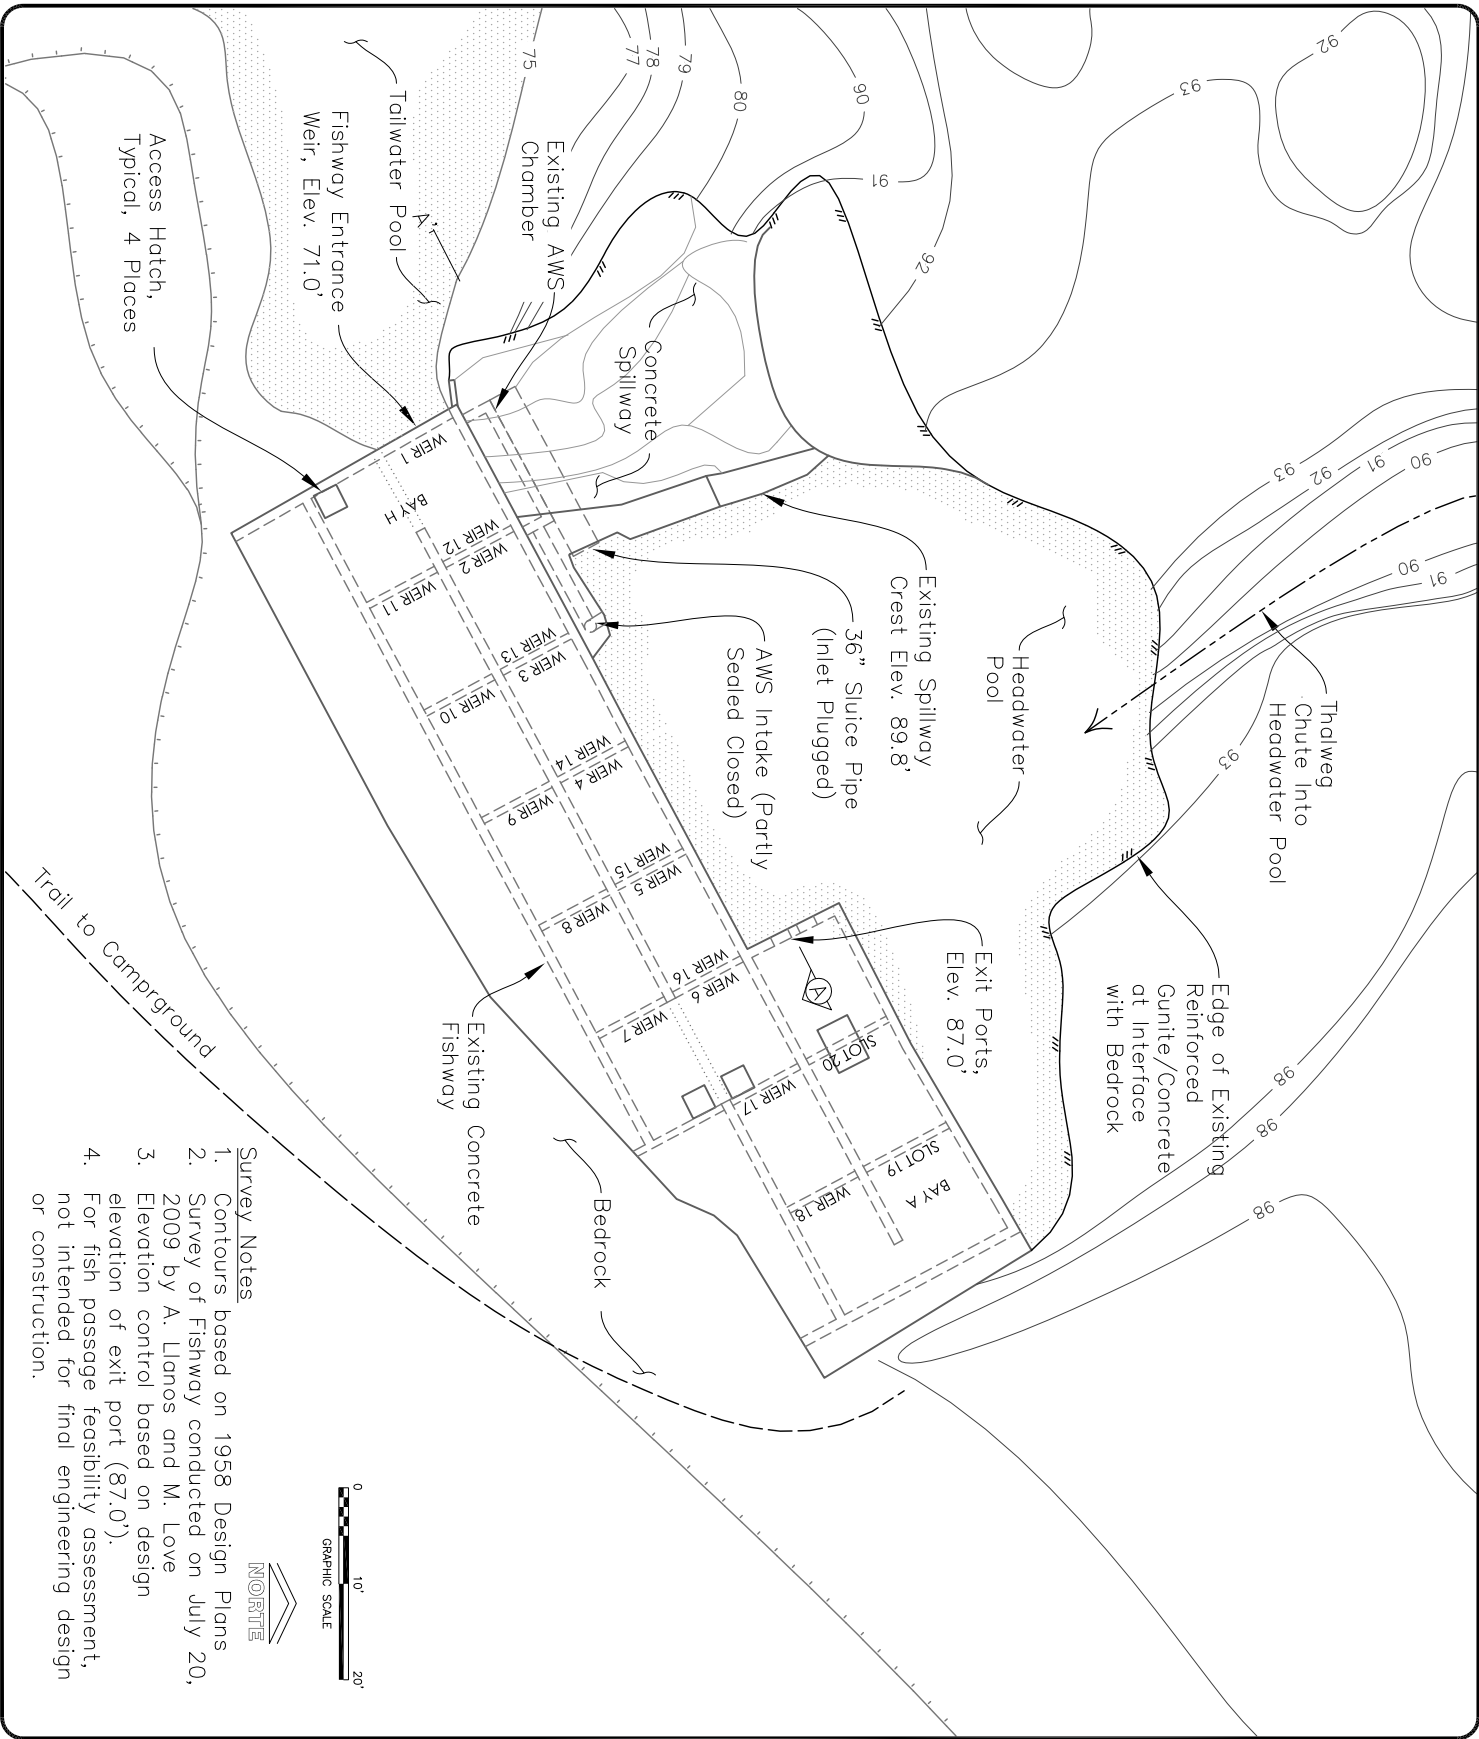
DATE	Dec. 2009
SUBMITTAL	CONCEPT
DESIGN	Love / Llanos
DRAWN	Llanos
FIGURE	5-1

Figure 5-1. Plan view of the existing concrete fishway at Steamboat Falls.

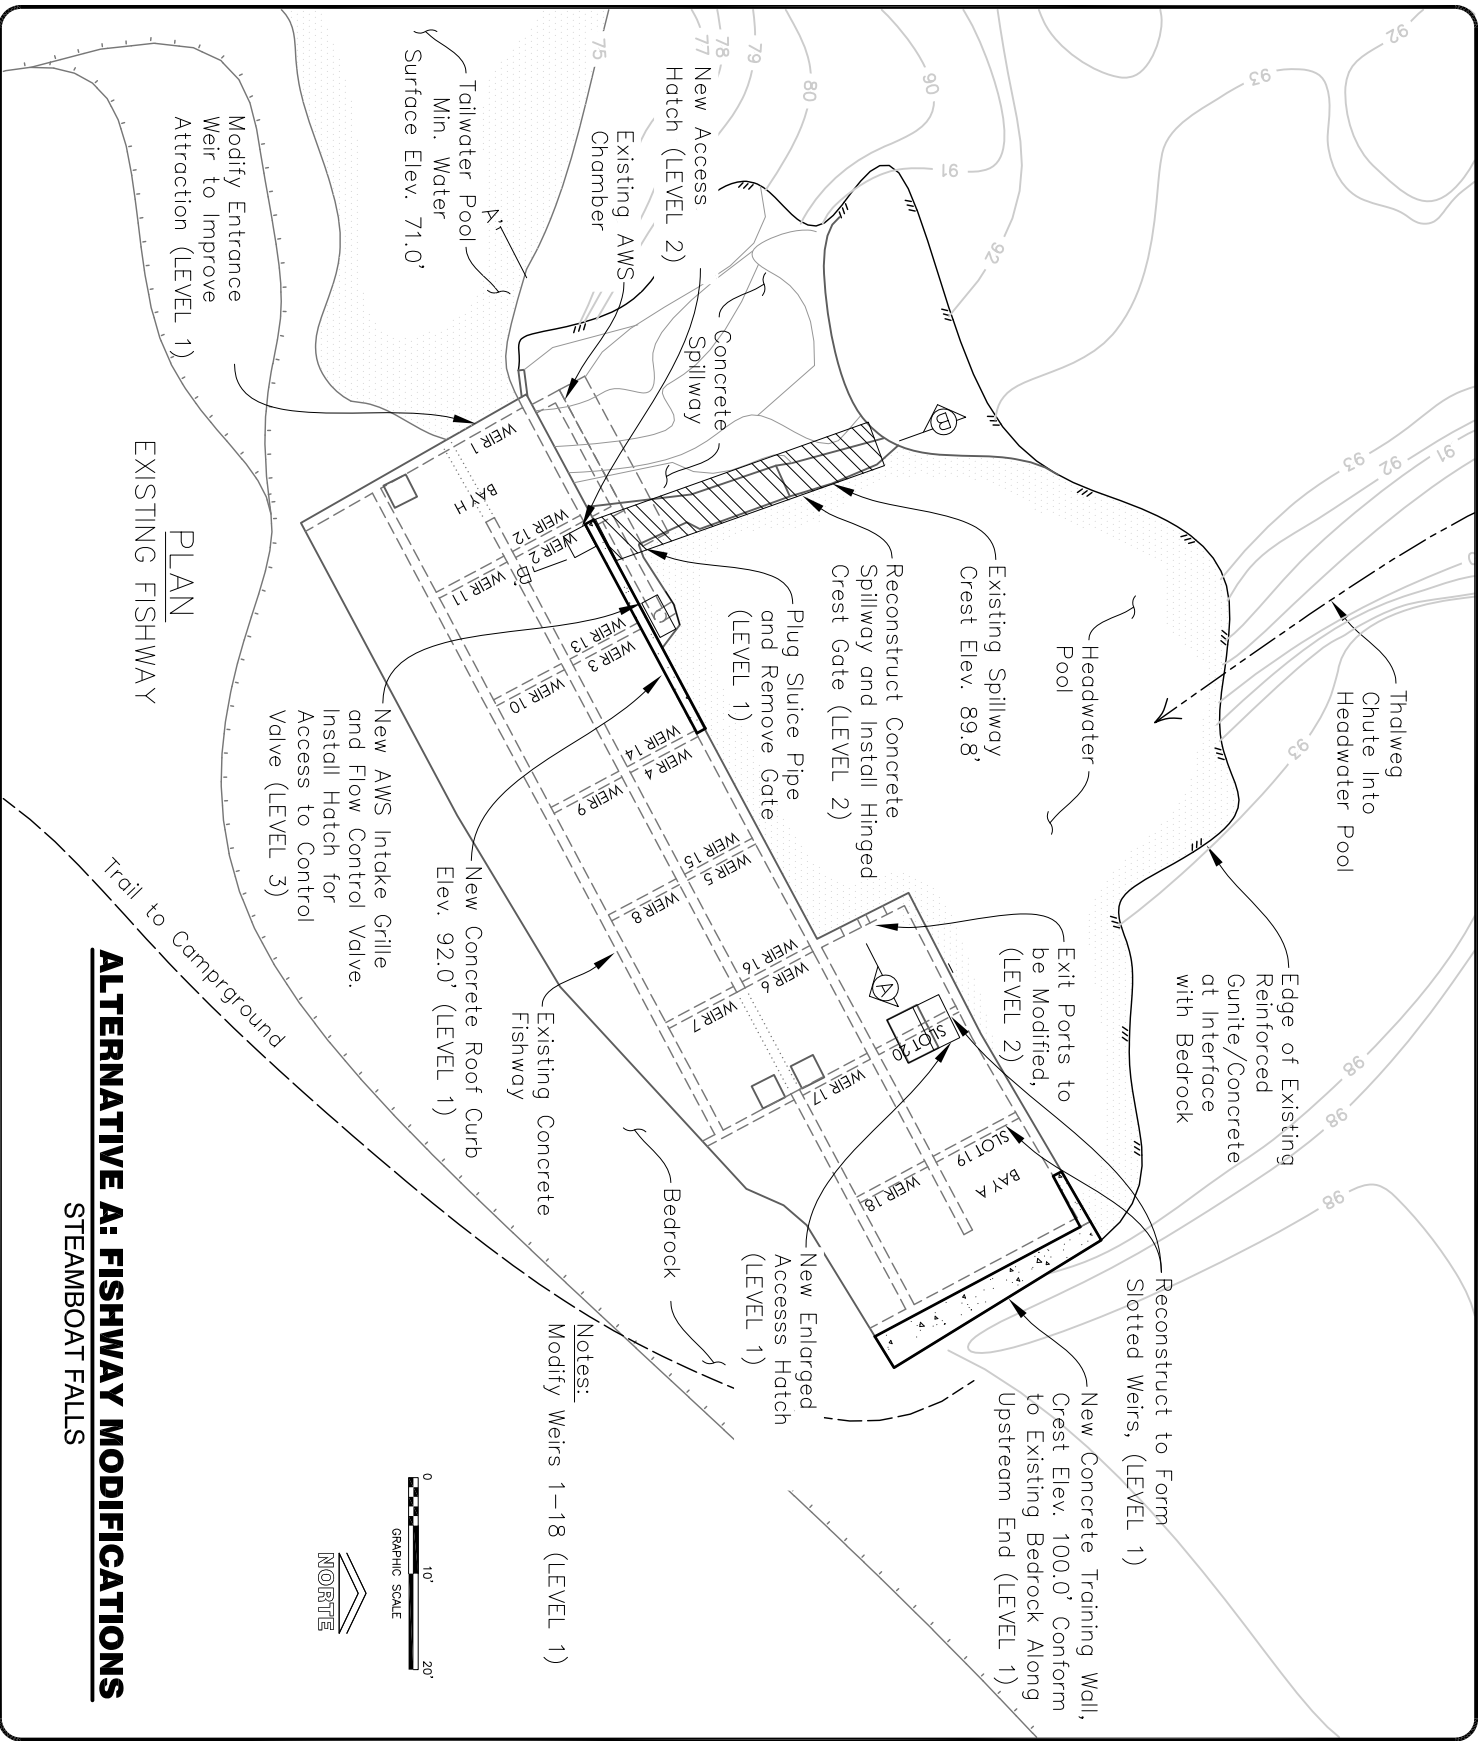
DATE	Dec. 2009
SUBMITTAL	CONCEPT
DESIGN	LOVE / LIANOS
DRAWN	LIANOS
FIGURE	6-1

Figure 6-1. Alternative A - Level 1-3 modifications identified on plan view of fishway.

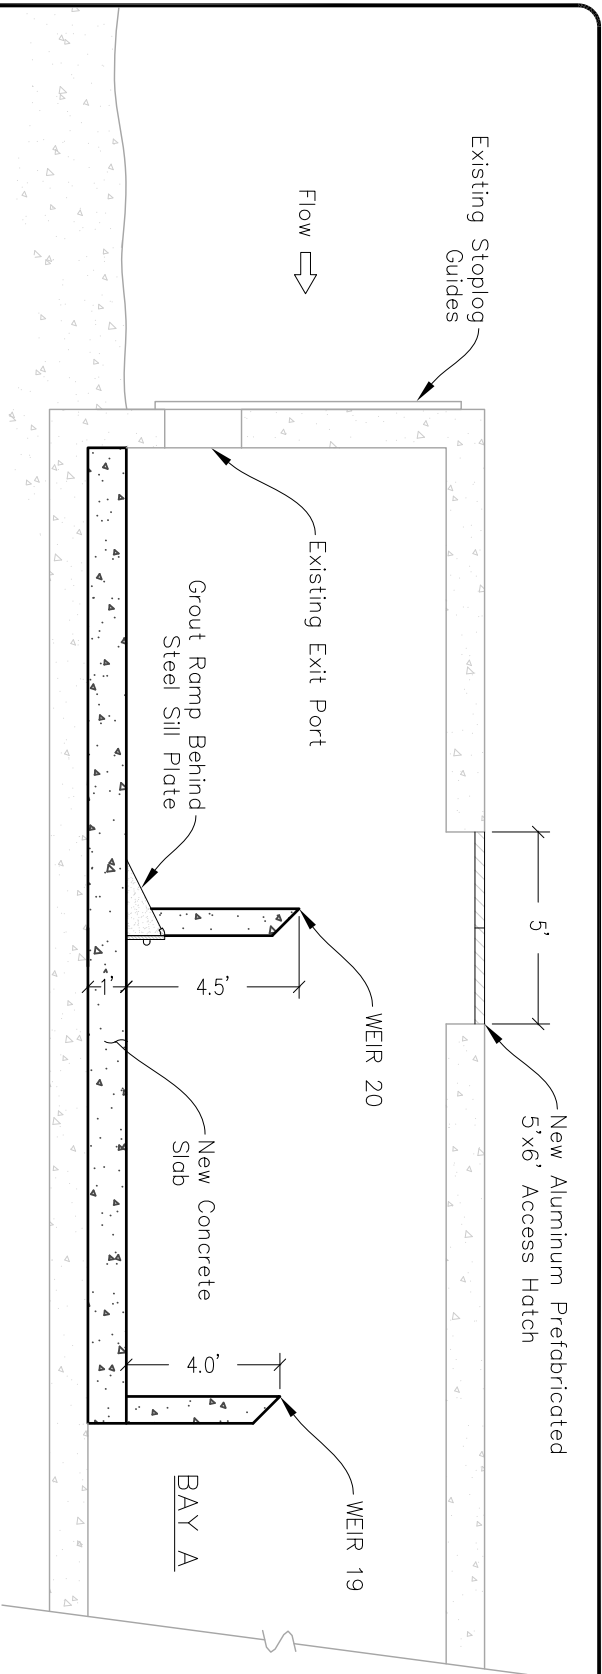
### FISHWAY EXIT PROFILE

Figure 6-3. Alternative A - Level 1 modifications to fishway exit channel.

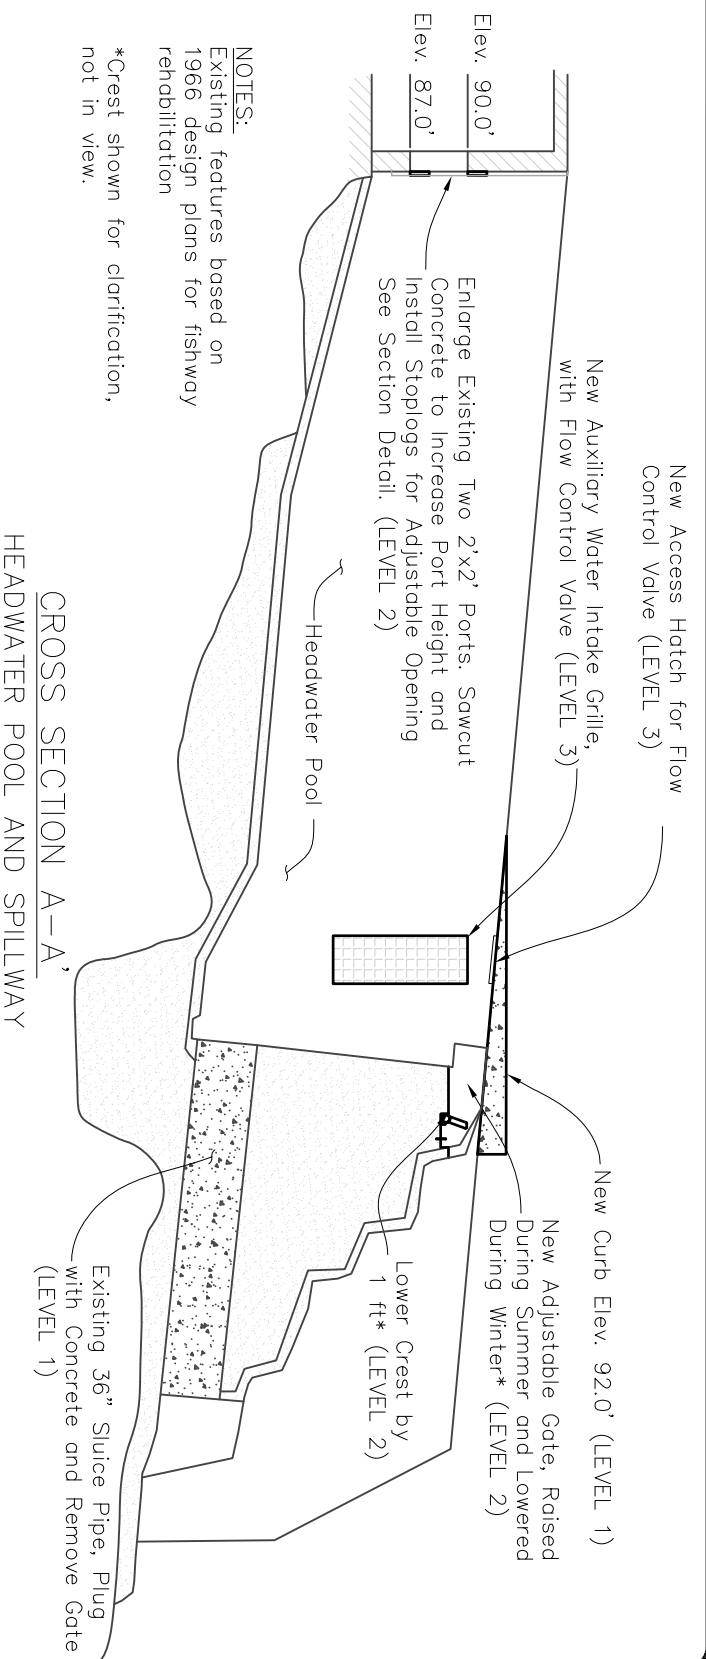
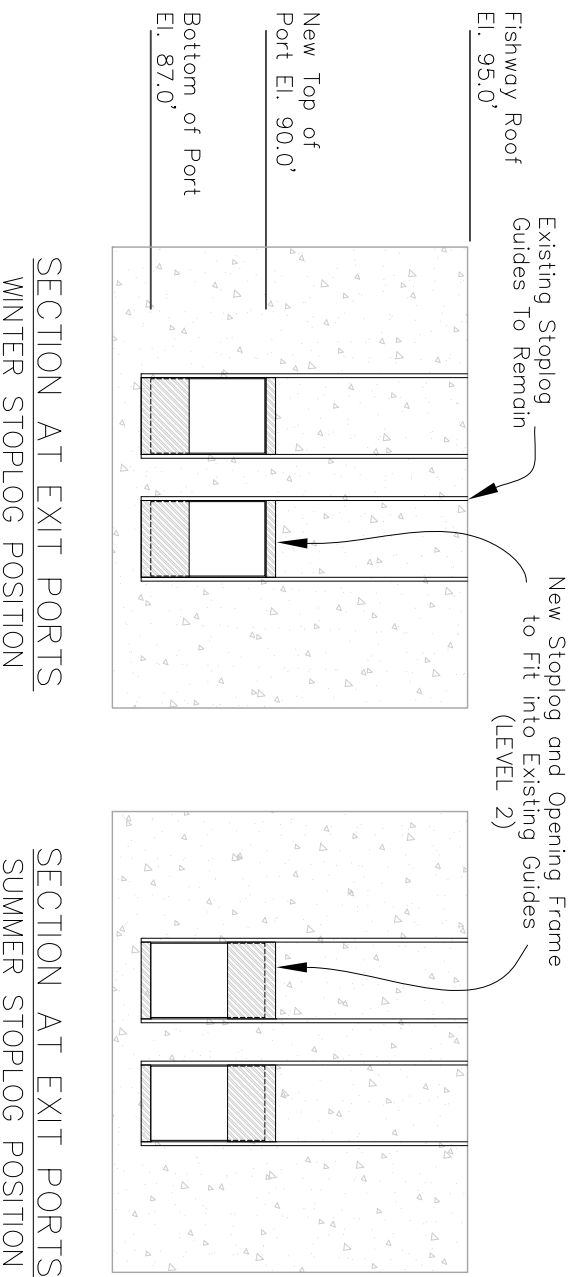
Figure 6-4. Alternative A - Level 1-3 modifications to the existing exit port, spillway and AWS.

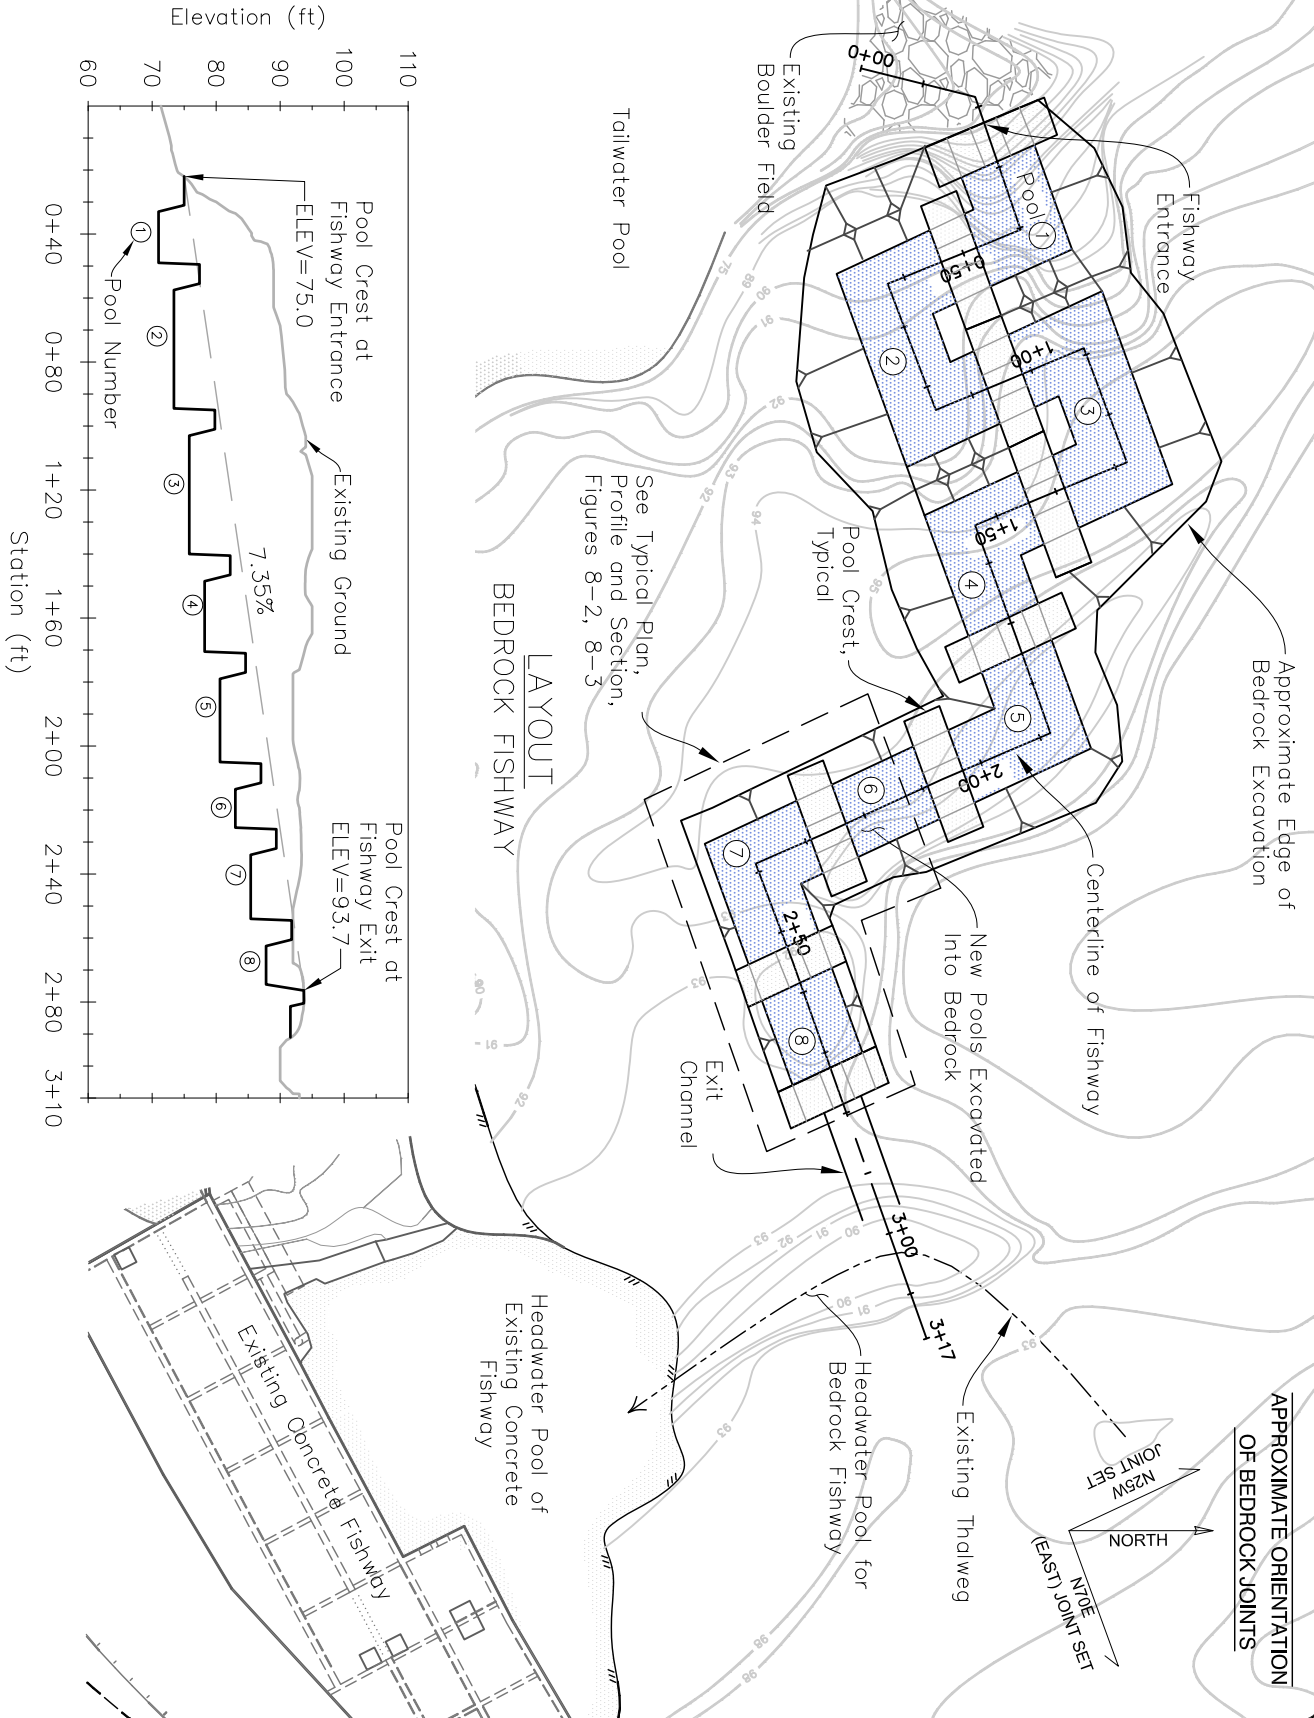
DATE	Dec. 2009
SUBMITAL	Concept
DESIGN	Love / Llanos
DRAWN	Llanos
FIGURE	7-1

PROFILE ALONG FISHWAY CENTERLINE  
BEDROCK FISHWAY

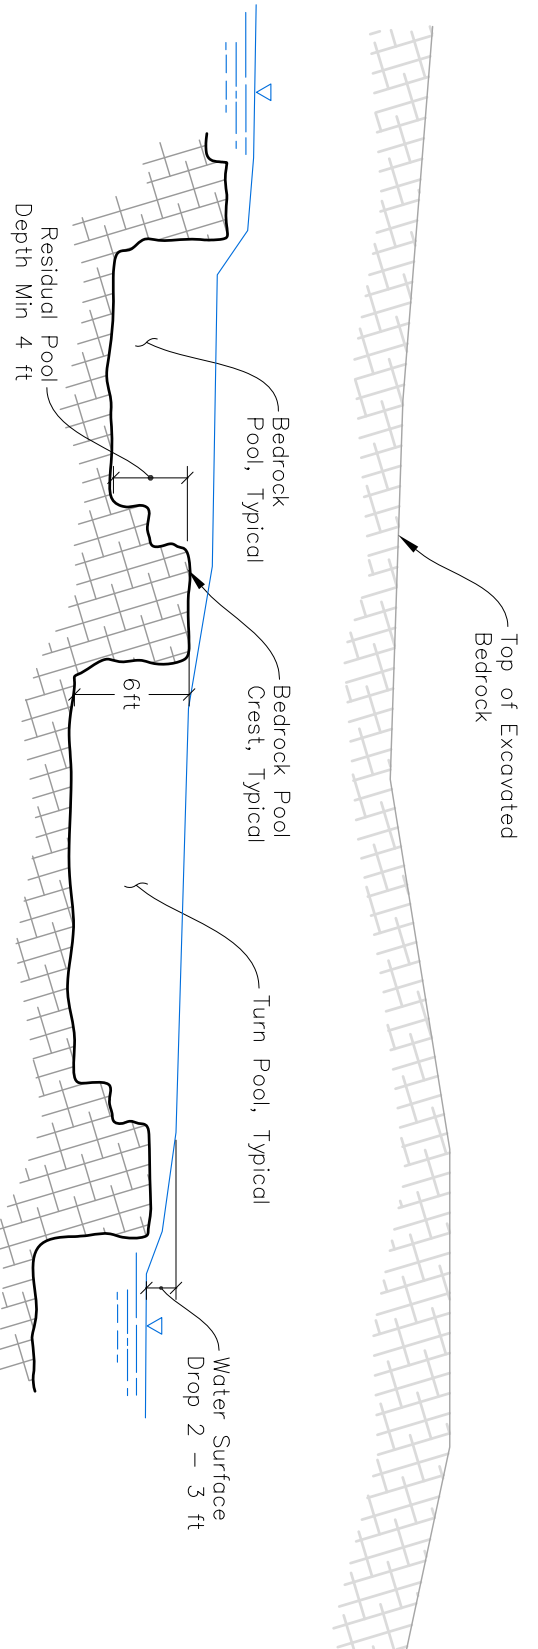
TYPICAL PROFILE  
BEDROCK POOLS  
(Not to Scale)

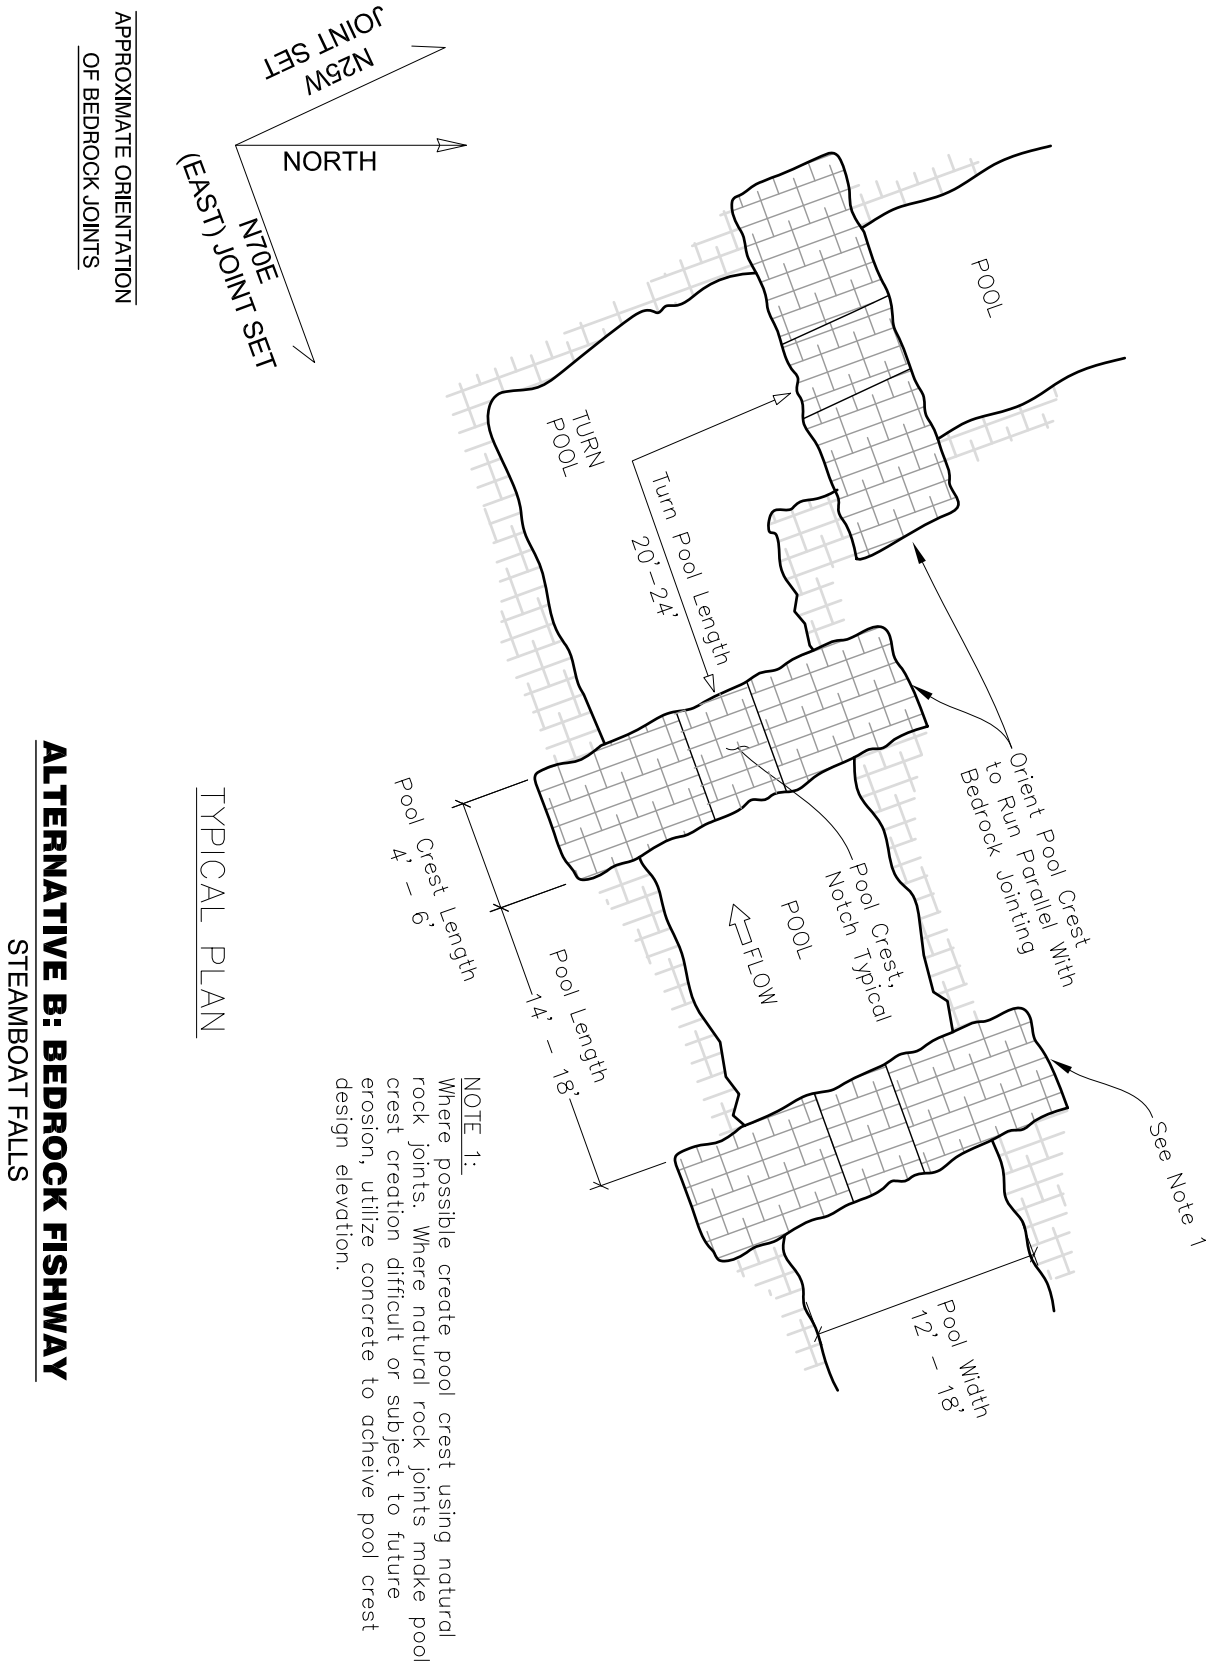
DATE	Dec. 2009
SUBMITTAL	Concept
DESIGN	Love / Llanos
DRAWN	Llanos
FIGURE	7-3

Figure 7-3. Idealized plan view of Alternative B Bedrock Fishway.

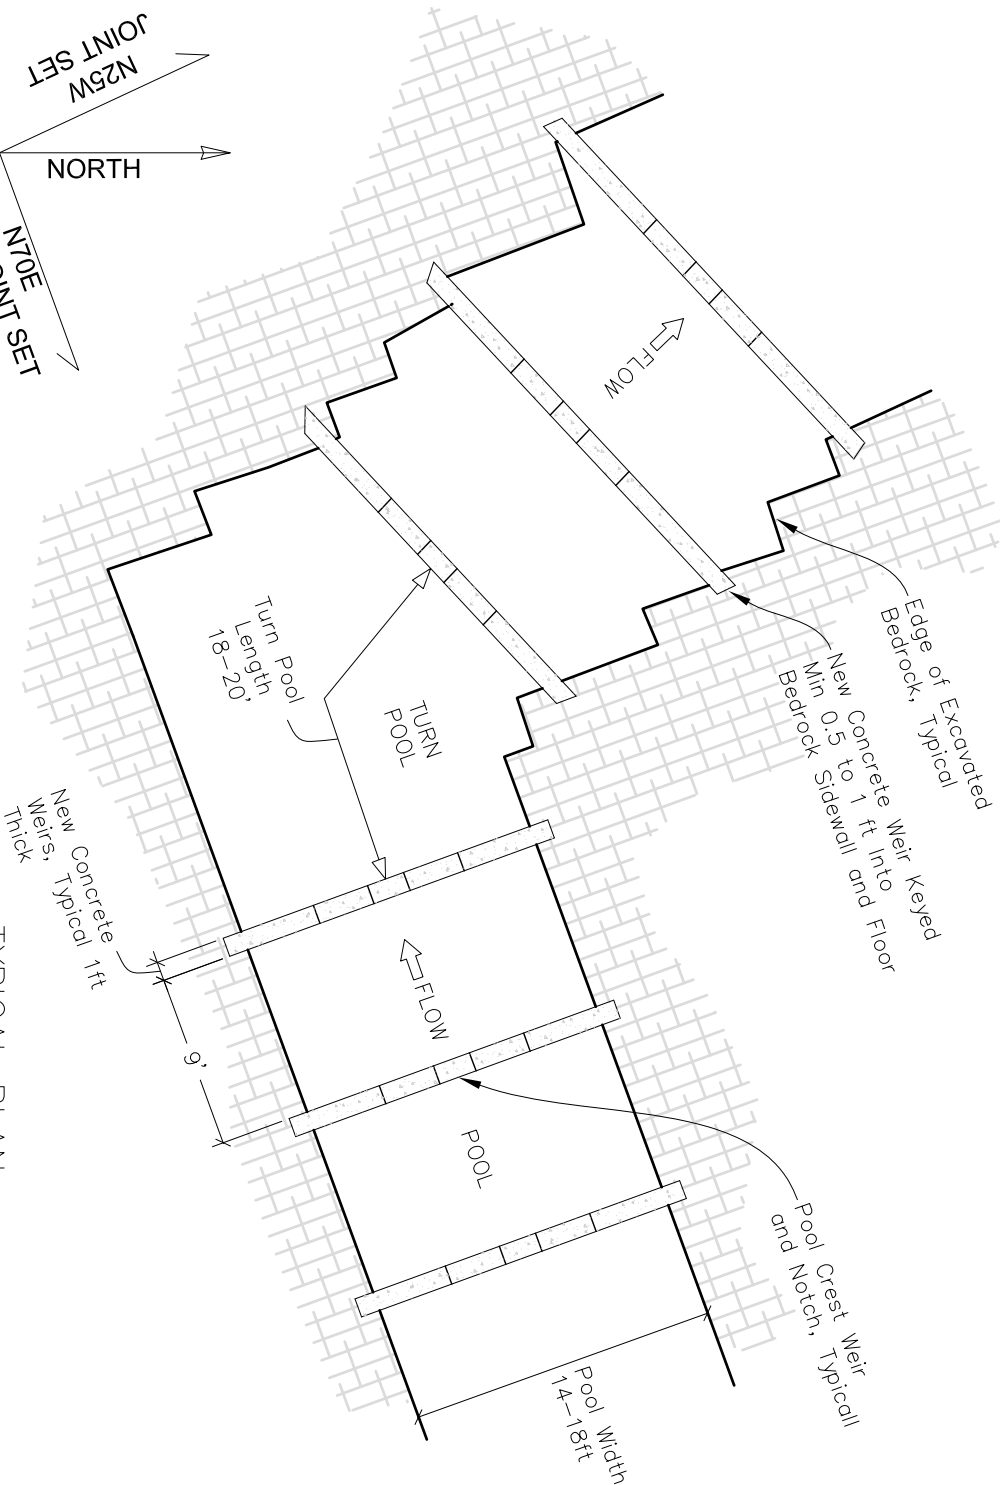
8-3

APPROXIMATE ORIENTATION  
OF BEDROCK JOINTS

**ALTERNATIVE C: BEDROCK-CONCRETE FISHWAY**  
STEAMBOAT FALLS

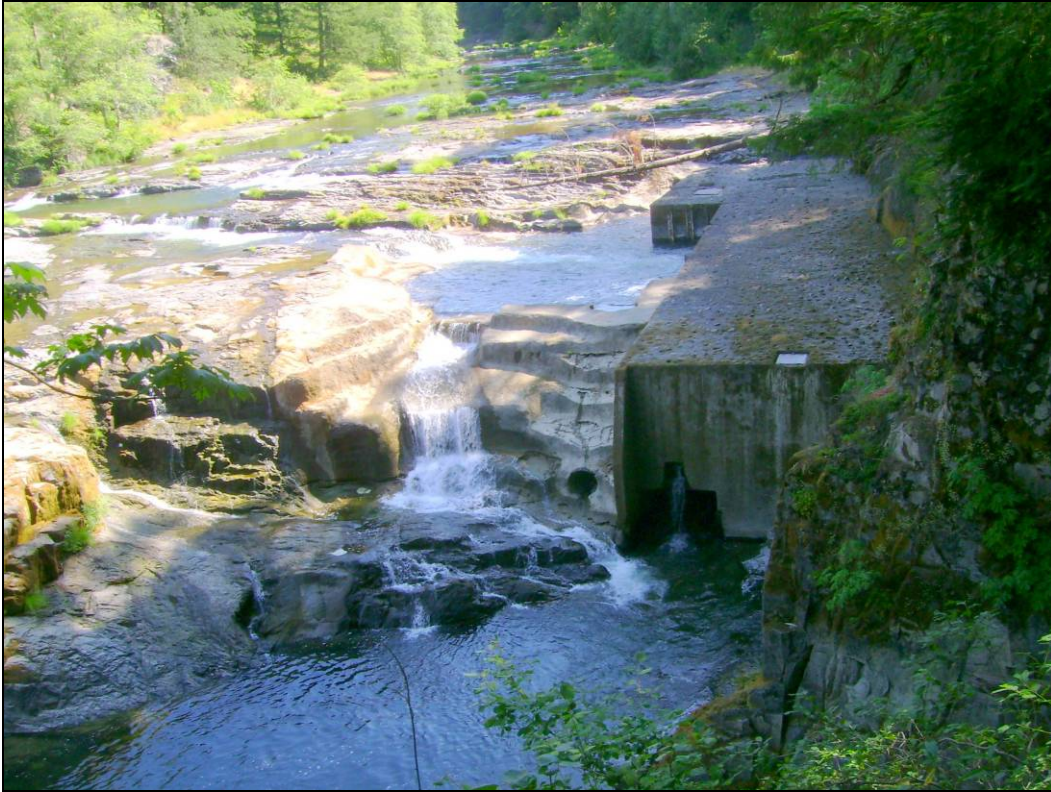
Photo 1. Looking upstream at the Steamboat Falls, the concrete spillway and headwater pool, and the fishway exit.
