## FINAL REPORT

# Steamboat Falls Fish Passage Evaluation and Alternatives Analysis

**The North Umpqua Foundation**

Michael Love & Associates  
PO Box 4477, Arcata CA 95501  
mlove@h2odesigns.com • 707-476-8938

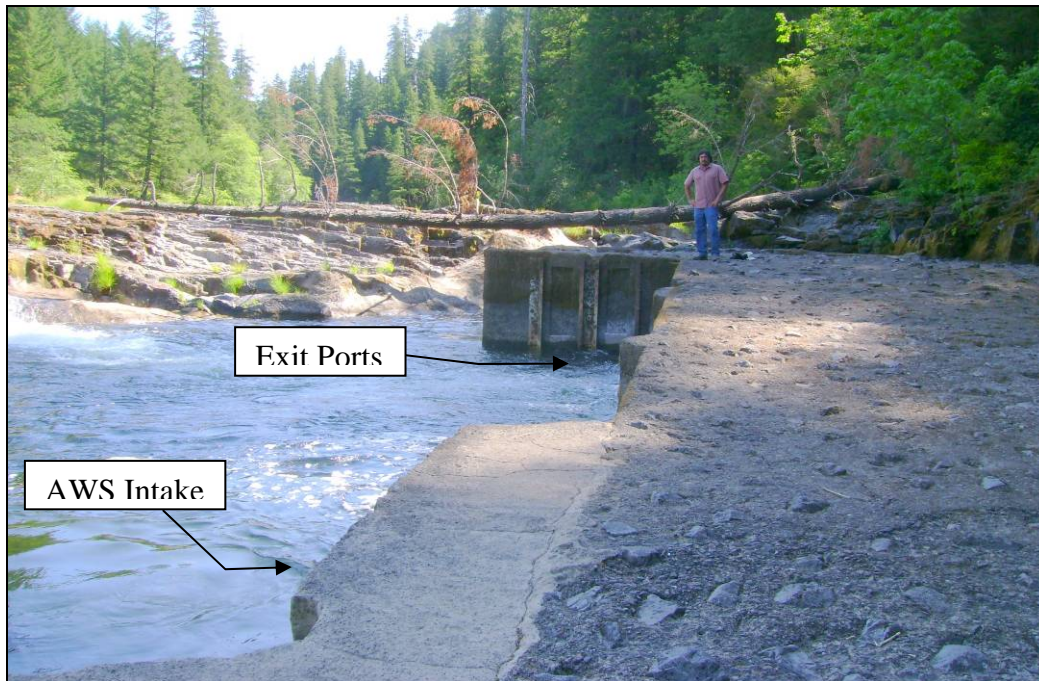
Photo 3. Looking upstream at the fishway roof, exit ports (under water) and location of the AWS intake, which is currently sealed shut.

ODFW continues to perform minor repairs to the concrete spillway to keep exposed rebar from becoming a public hazard (L. Jackson Per. Com., 2009). Additionally, ODFW has largely sealed off the AWS intake with a steel plate to reduce impingement of juvenile salmonids and lamprey.

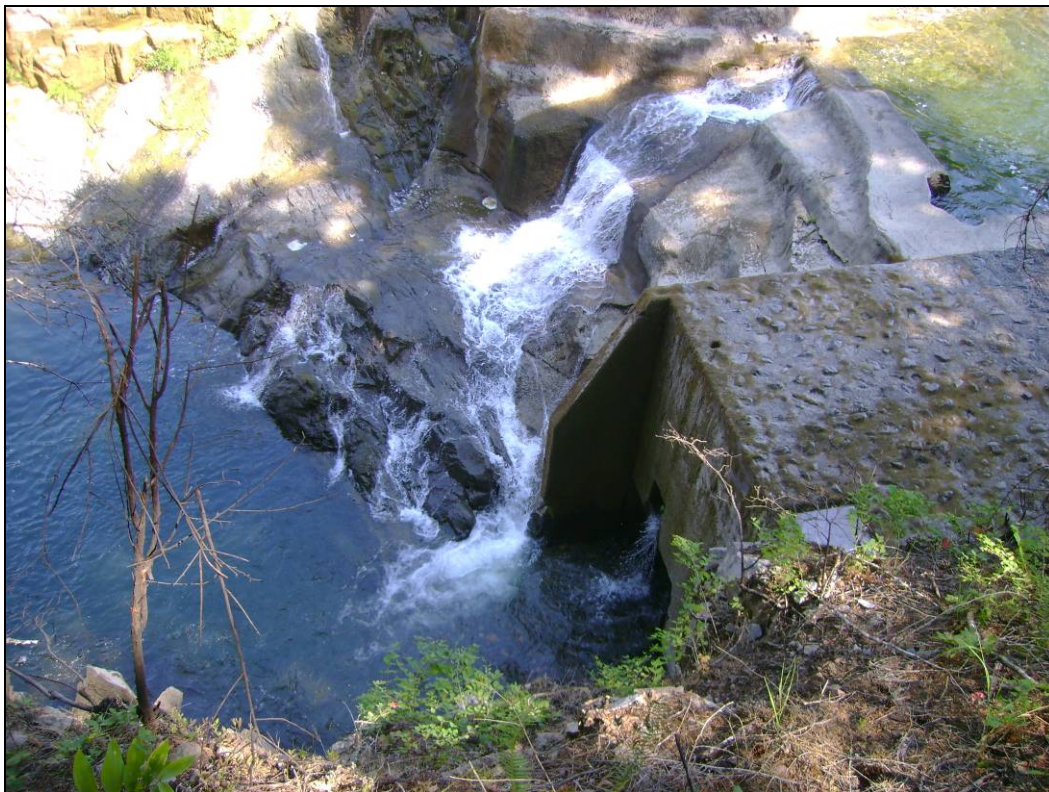
Photo 4. Looking down from the adjacent campground to the fishway entrance. At low flows the water going over the spillway is directed towards the entrance, which is likely beneficial for attraction.

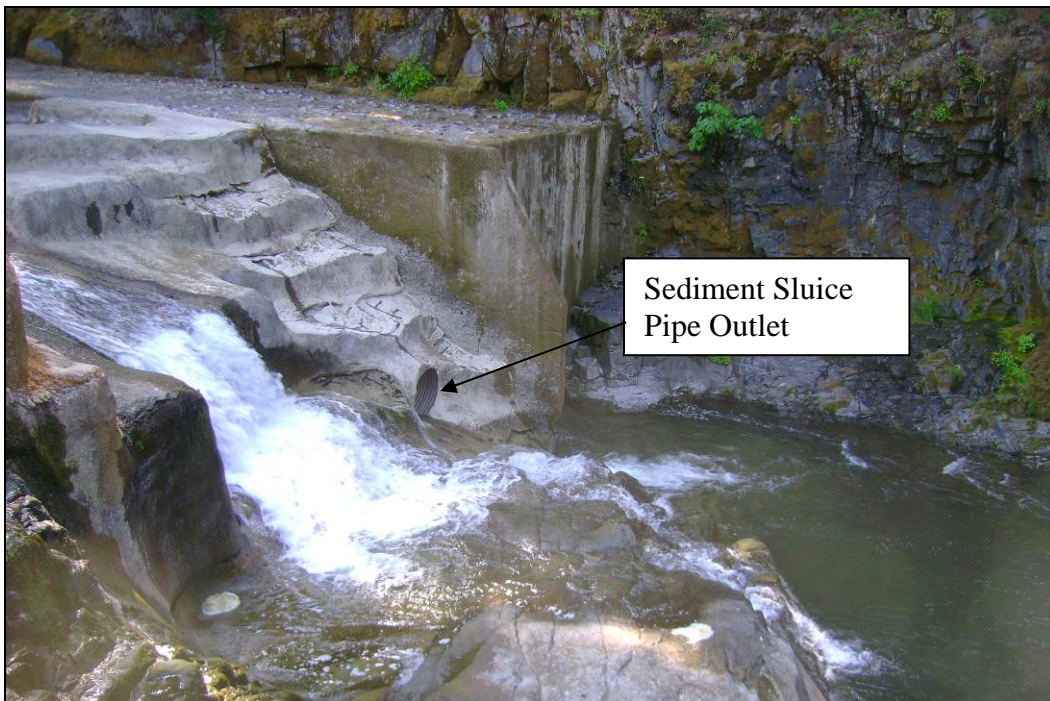
Photo 6. Fishway entrance and spillway. Note the outfall of the sediment sluice pipe for the headwater pool.

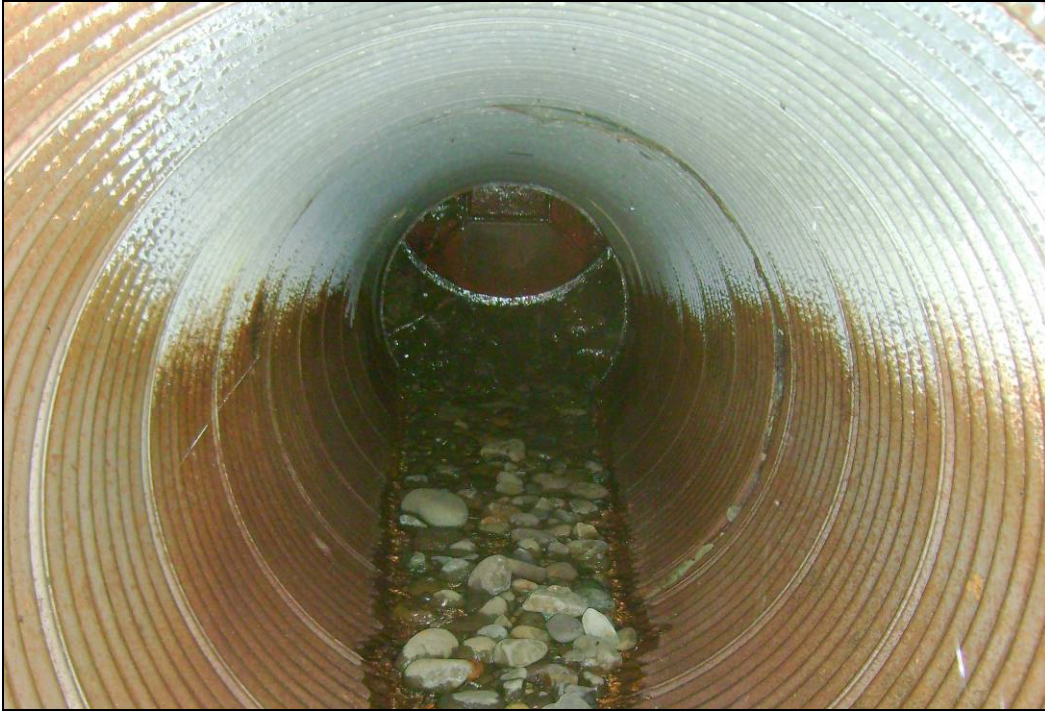
Photo 7. Looking up the sediment sluice pipe at partially opened slide gate plugged with sediment.

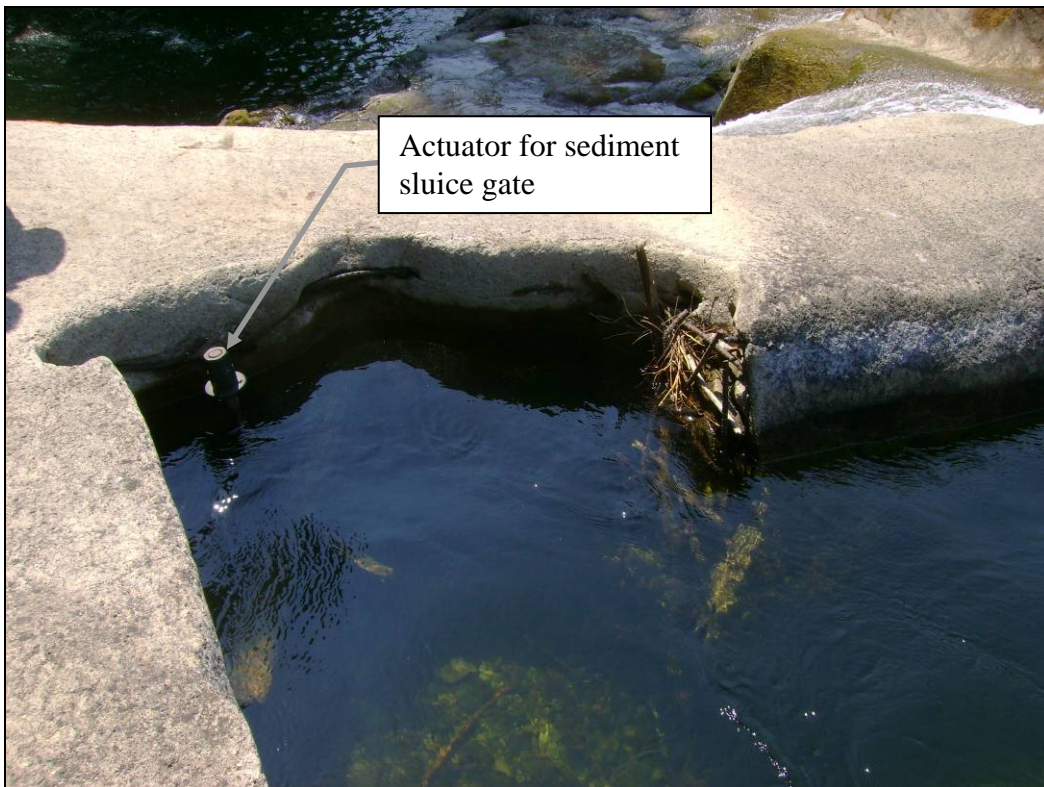
Photo 8. Damaged actuator for the sediment sluice gate on the spillway crest.

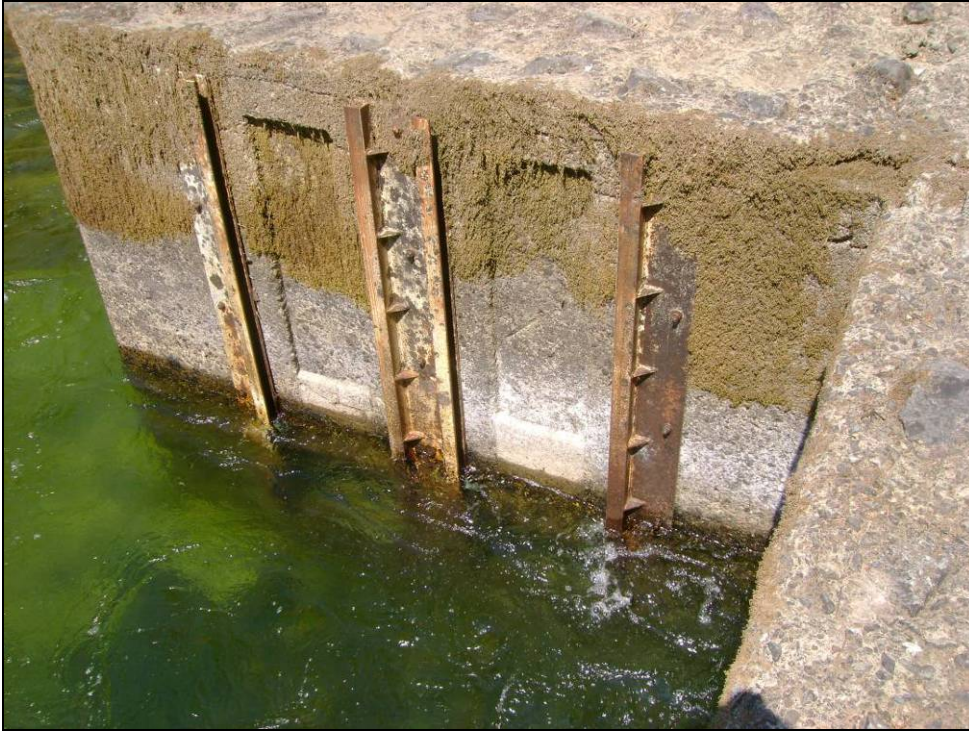
Photo 9. Exit ports (underwater) and stoplog guides in headwater pool.

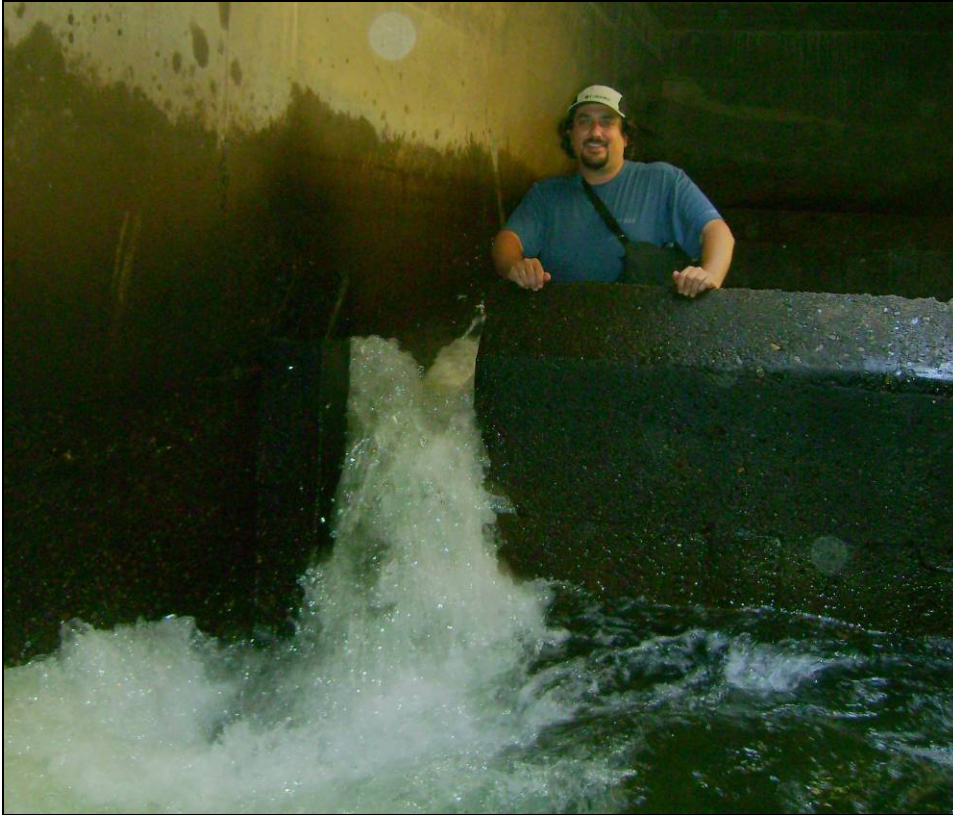
Photo 11. Slotted concrete weir with nearly 3-foot drop in the water surface due to large cobbles clogging the bottom of the slot.

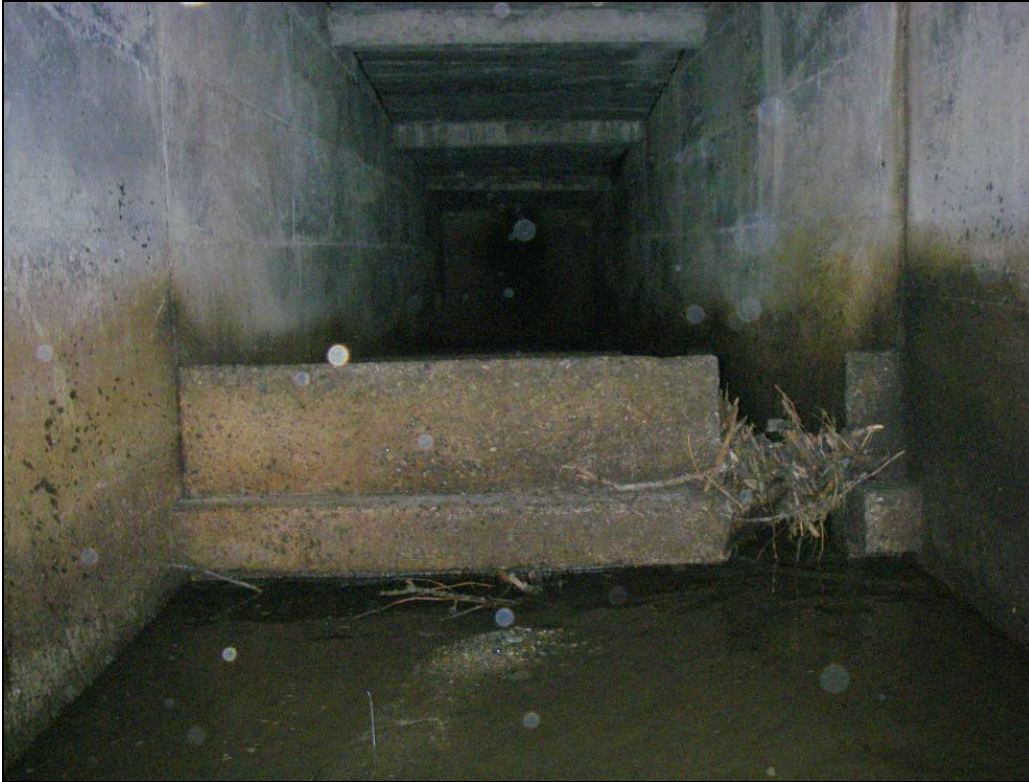
Photo 13. Small woody debris clogging Slotted Weir 18, taken during annual cleanout on July 3, 2009. (photo courtesy of ODFW).

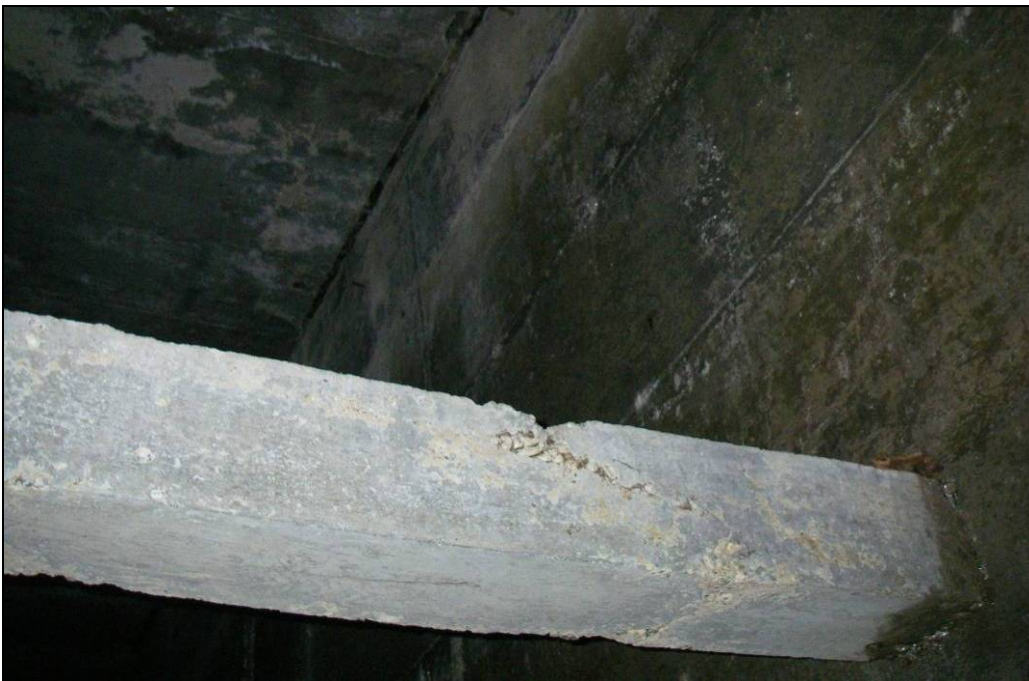
Photo 14. Spalled concrete on cross-member inside fishway (photo courtesy of ODFW).

With any level of modification, a structural inspection of the fishway should be done as part of final design, and repairs to spalled or scoured concrete should be done during construction.

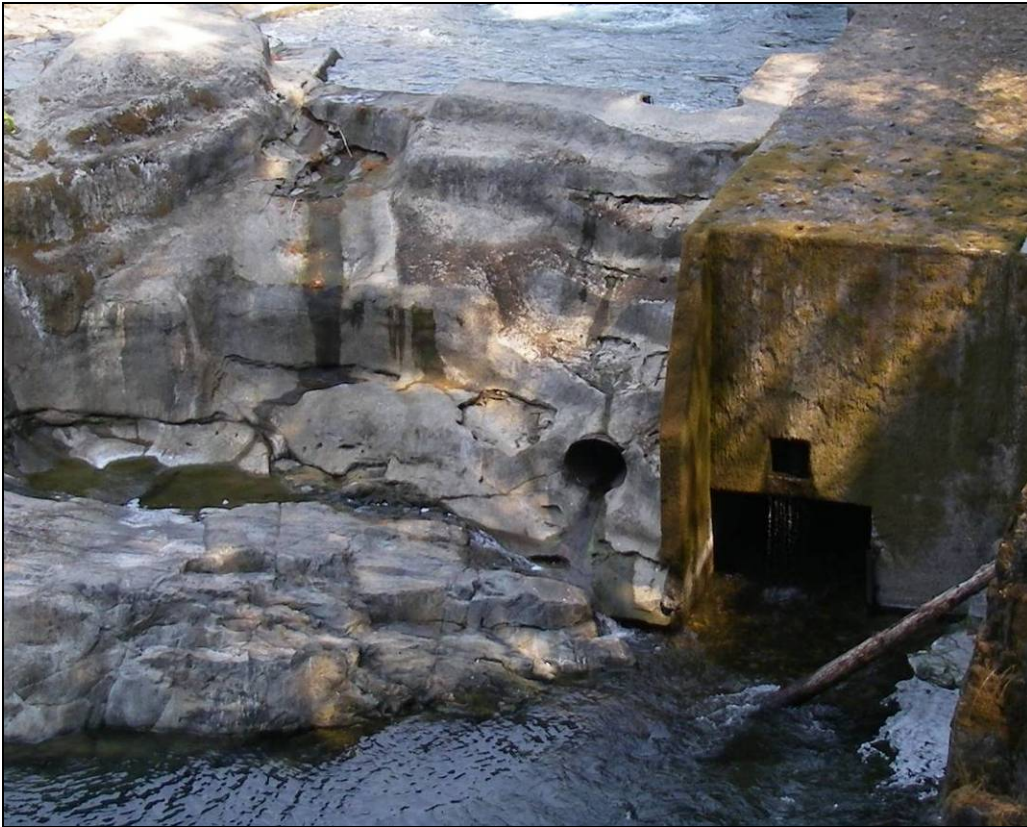
Photo 15. Concrete spillway and fishway exit at low flows, with all streamflow conveyed in fishway. Note spalled concrete and rebar exposed in numerous locations on the face of spillway.

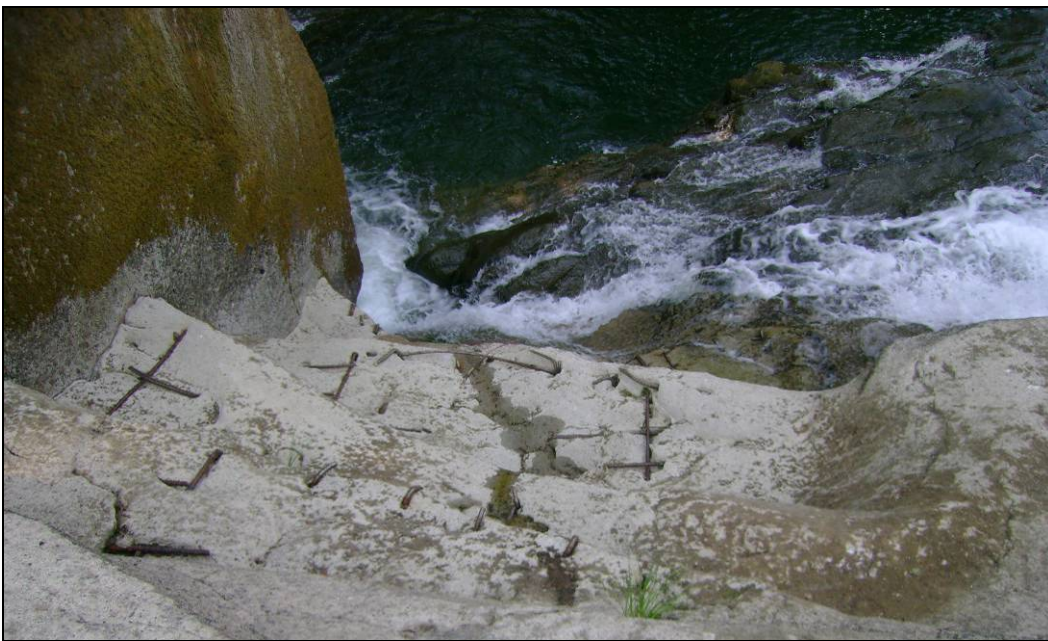
Photo 16. Rebar exposed on face of concrete spillway.

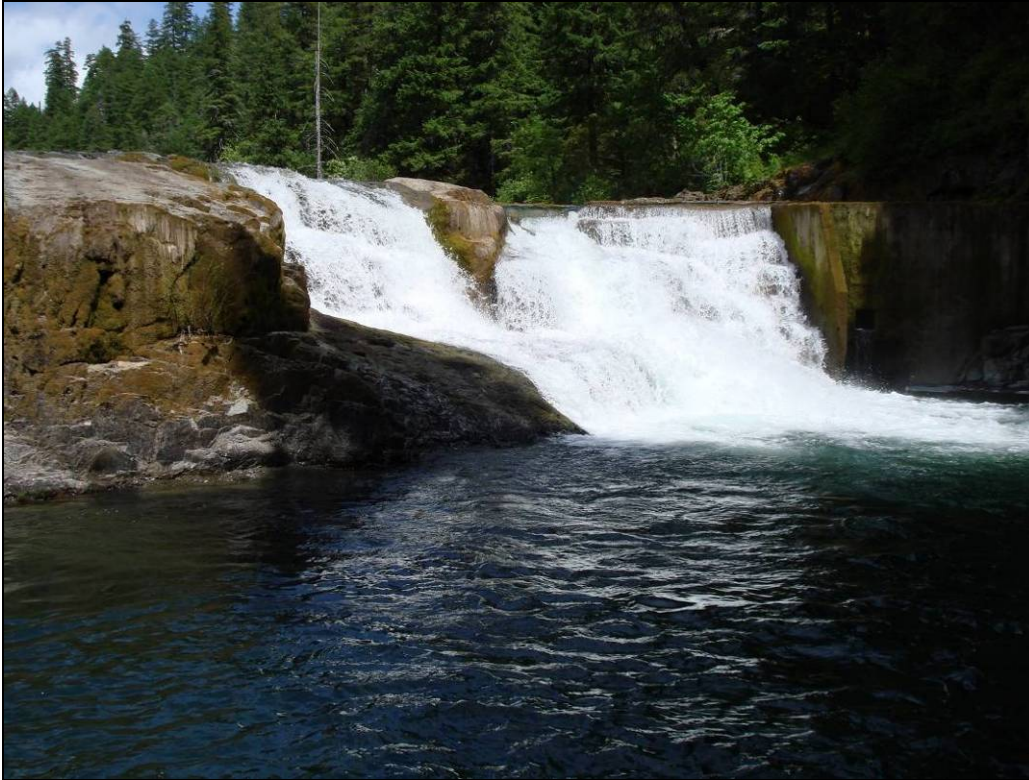
Photo 19. Estimated Flow of 123 cfs. Substantial proportion of streamflow bypassing spillway. No flow spilling off fishway roof.

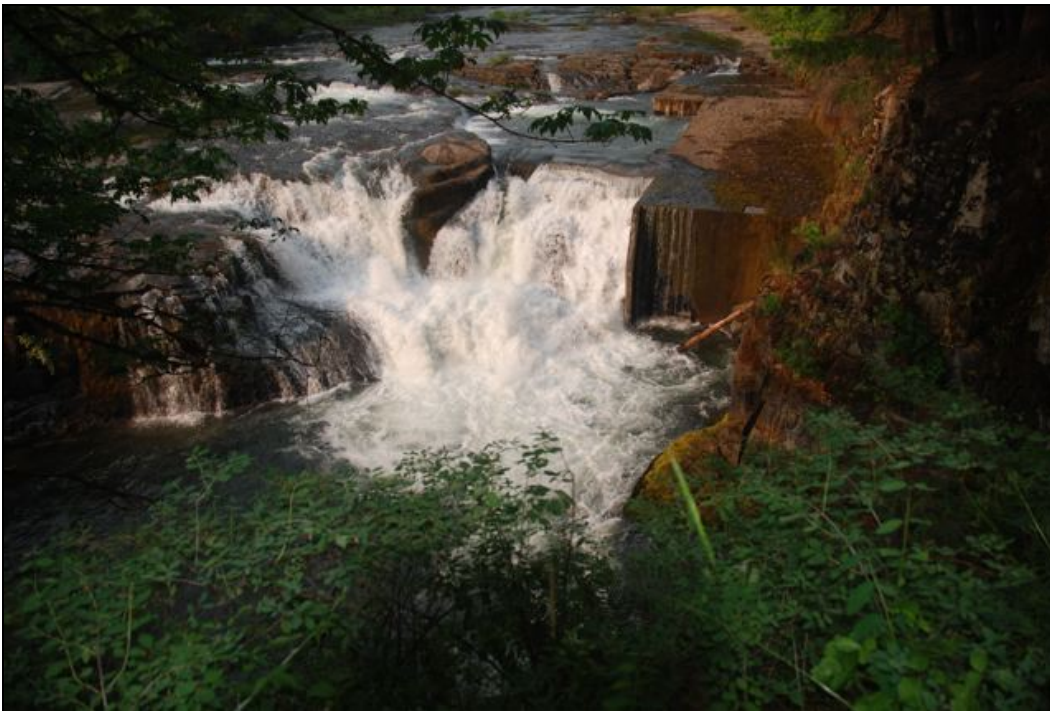
Photo 20. Estimated Flow of 151 cfs. Note flow beginning to overtop at both the upstream end and downstream end of the fishway roof. Nearly half the flow is bypassing the headwater pool as it goes over the falls.

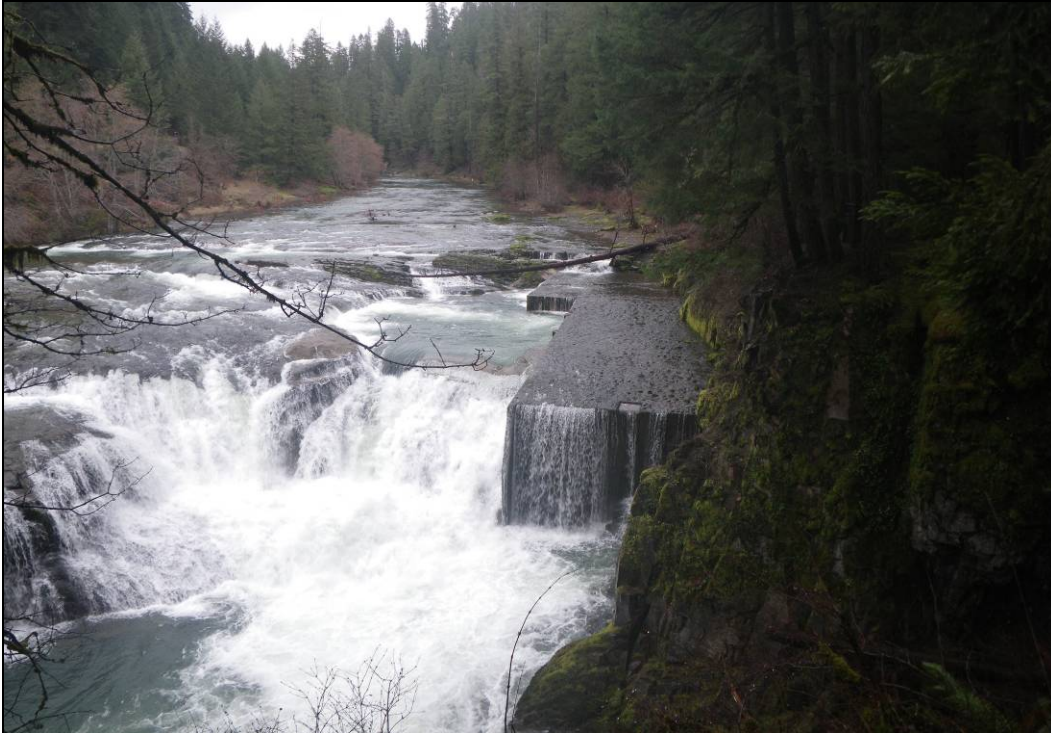
Photo 21. Estimated Flow of 400 cfs. Approximately the high fish passage streamflow for Alternative A, Level 1 Modifications.

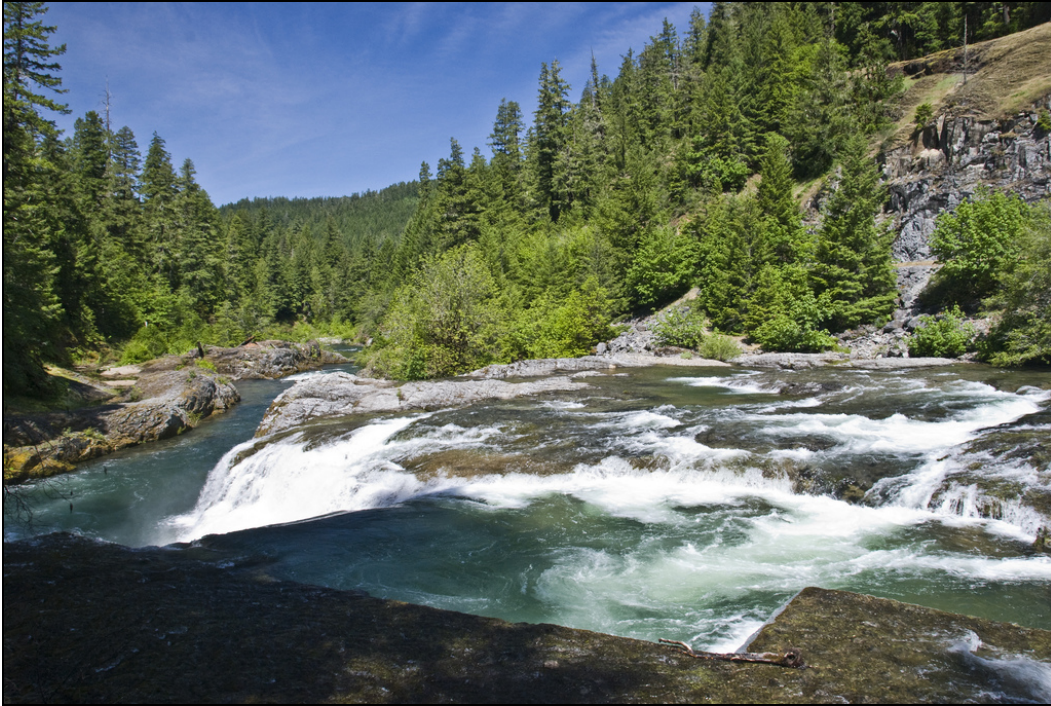
Photo 23. Estimated Flow of 451 cfs. Note that flow over the northern section of falls is minimal (top of photo).

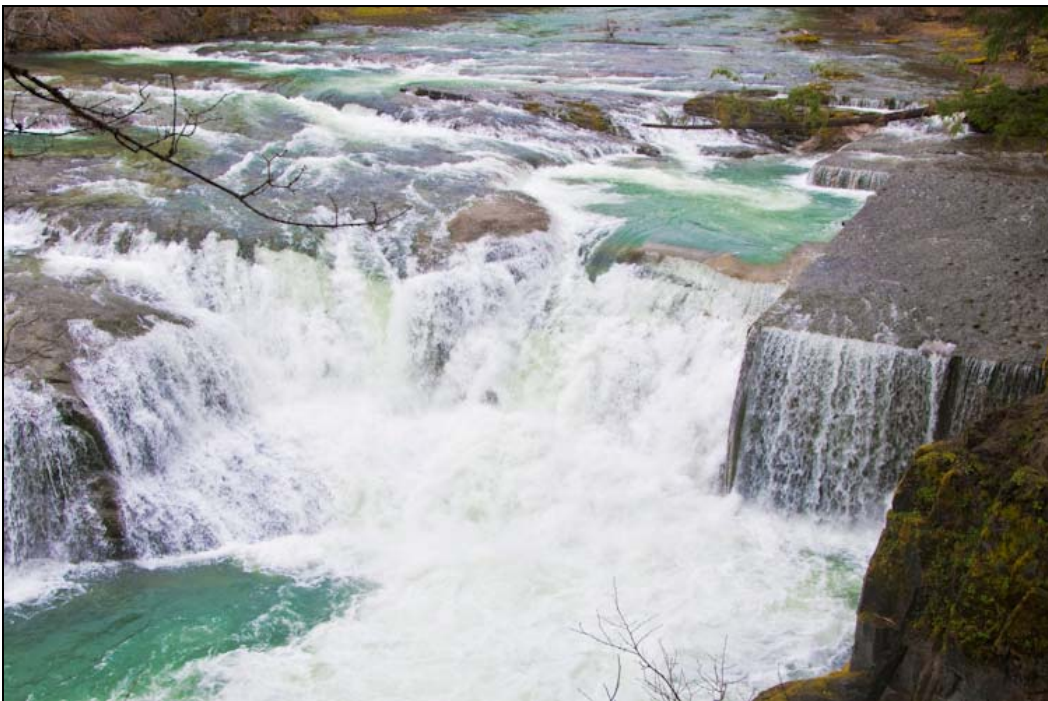
Photo 24. Estimated Flow of 519 cfs. Note the turbulence at the fishway entrance.

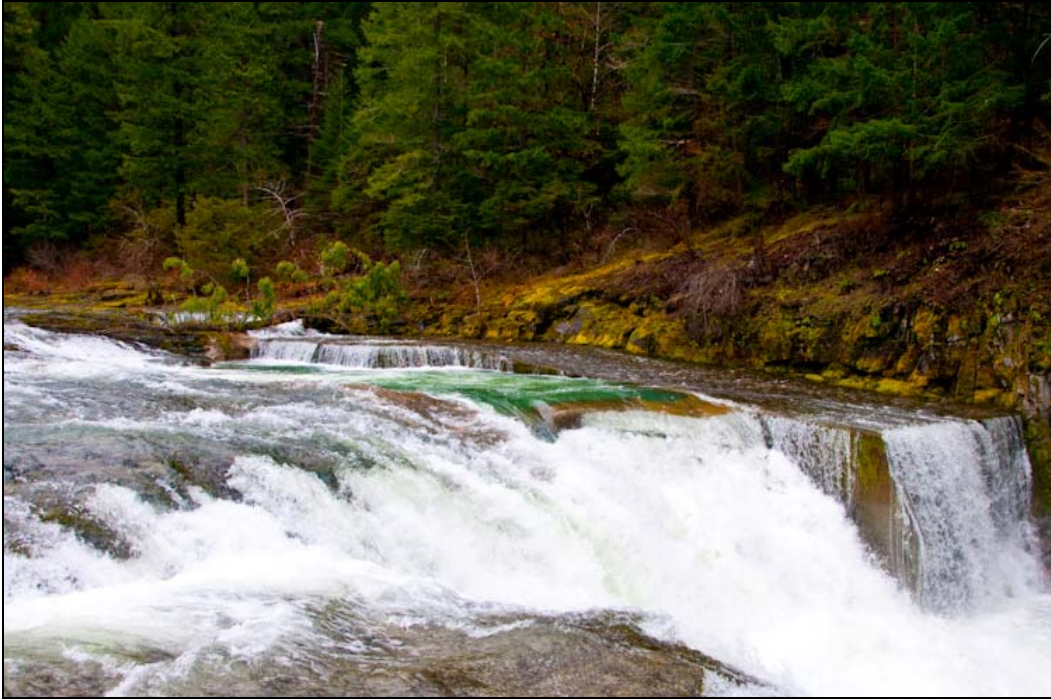
Photo 25. Estimated Flow of 519 cfs. Note the water flowing onto the fishway roof from upstream.

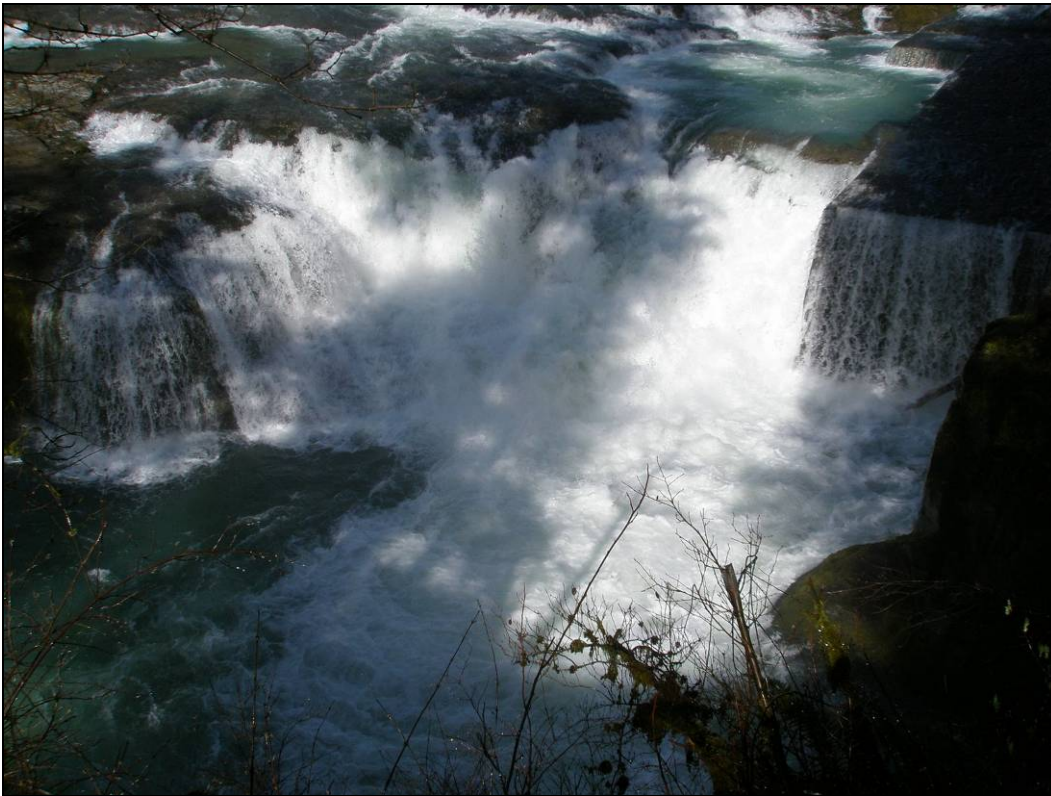
Photo 26. Estimated Flow of 744 cfs. Note the extreme turbulence near the fishway entrance.

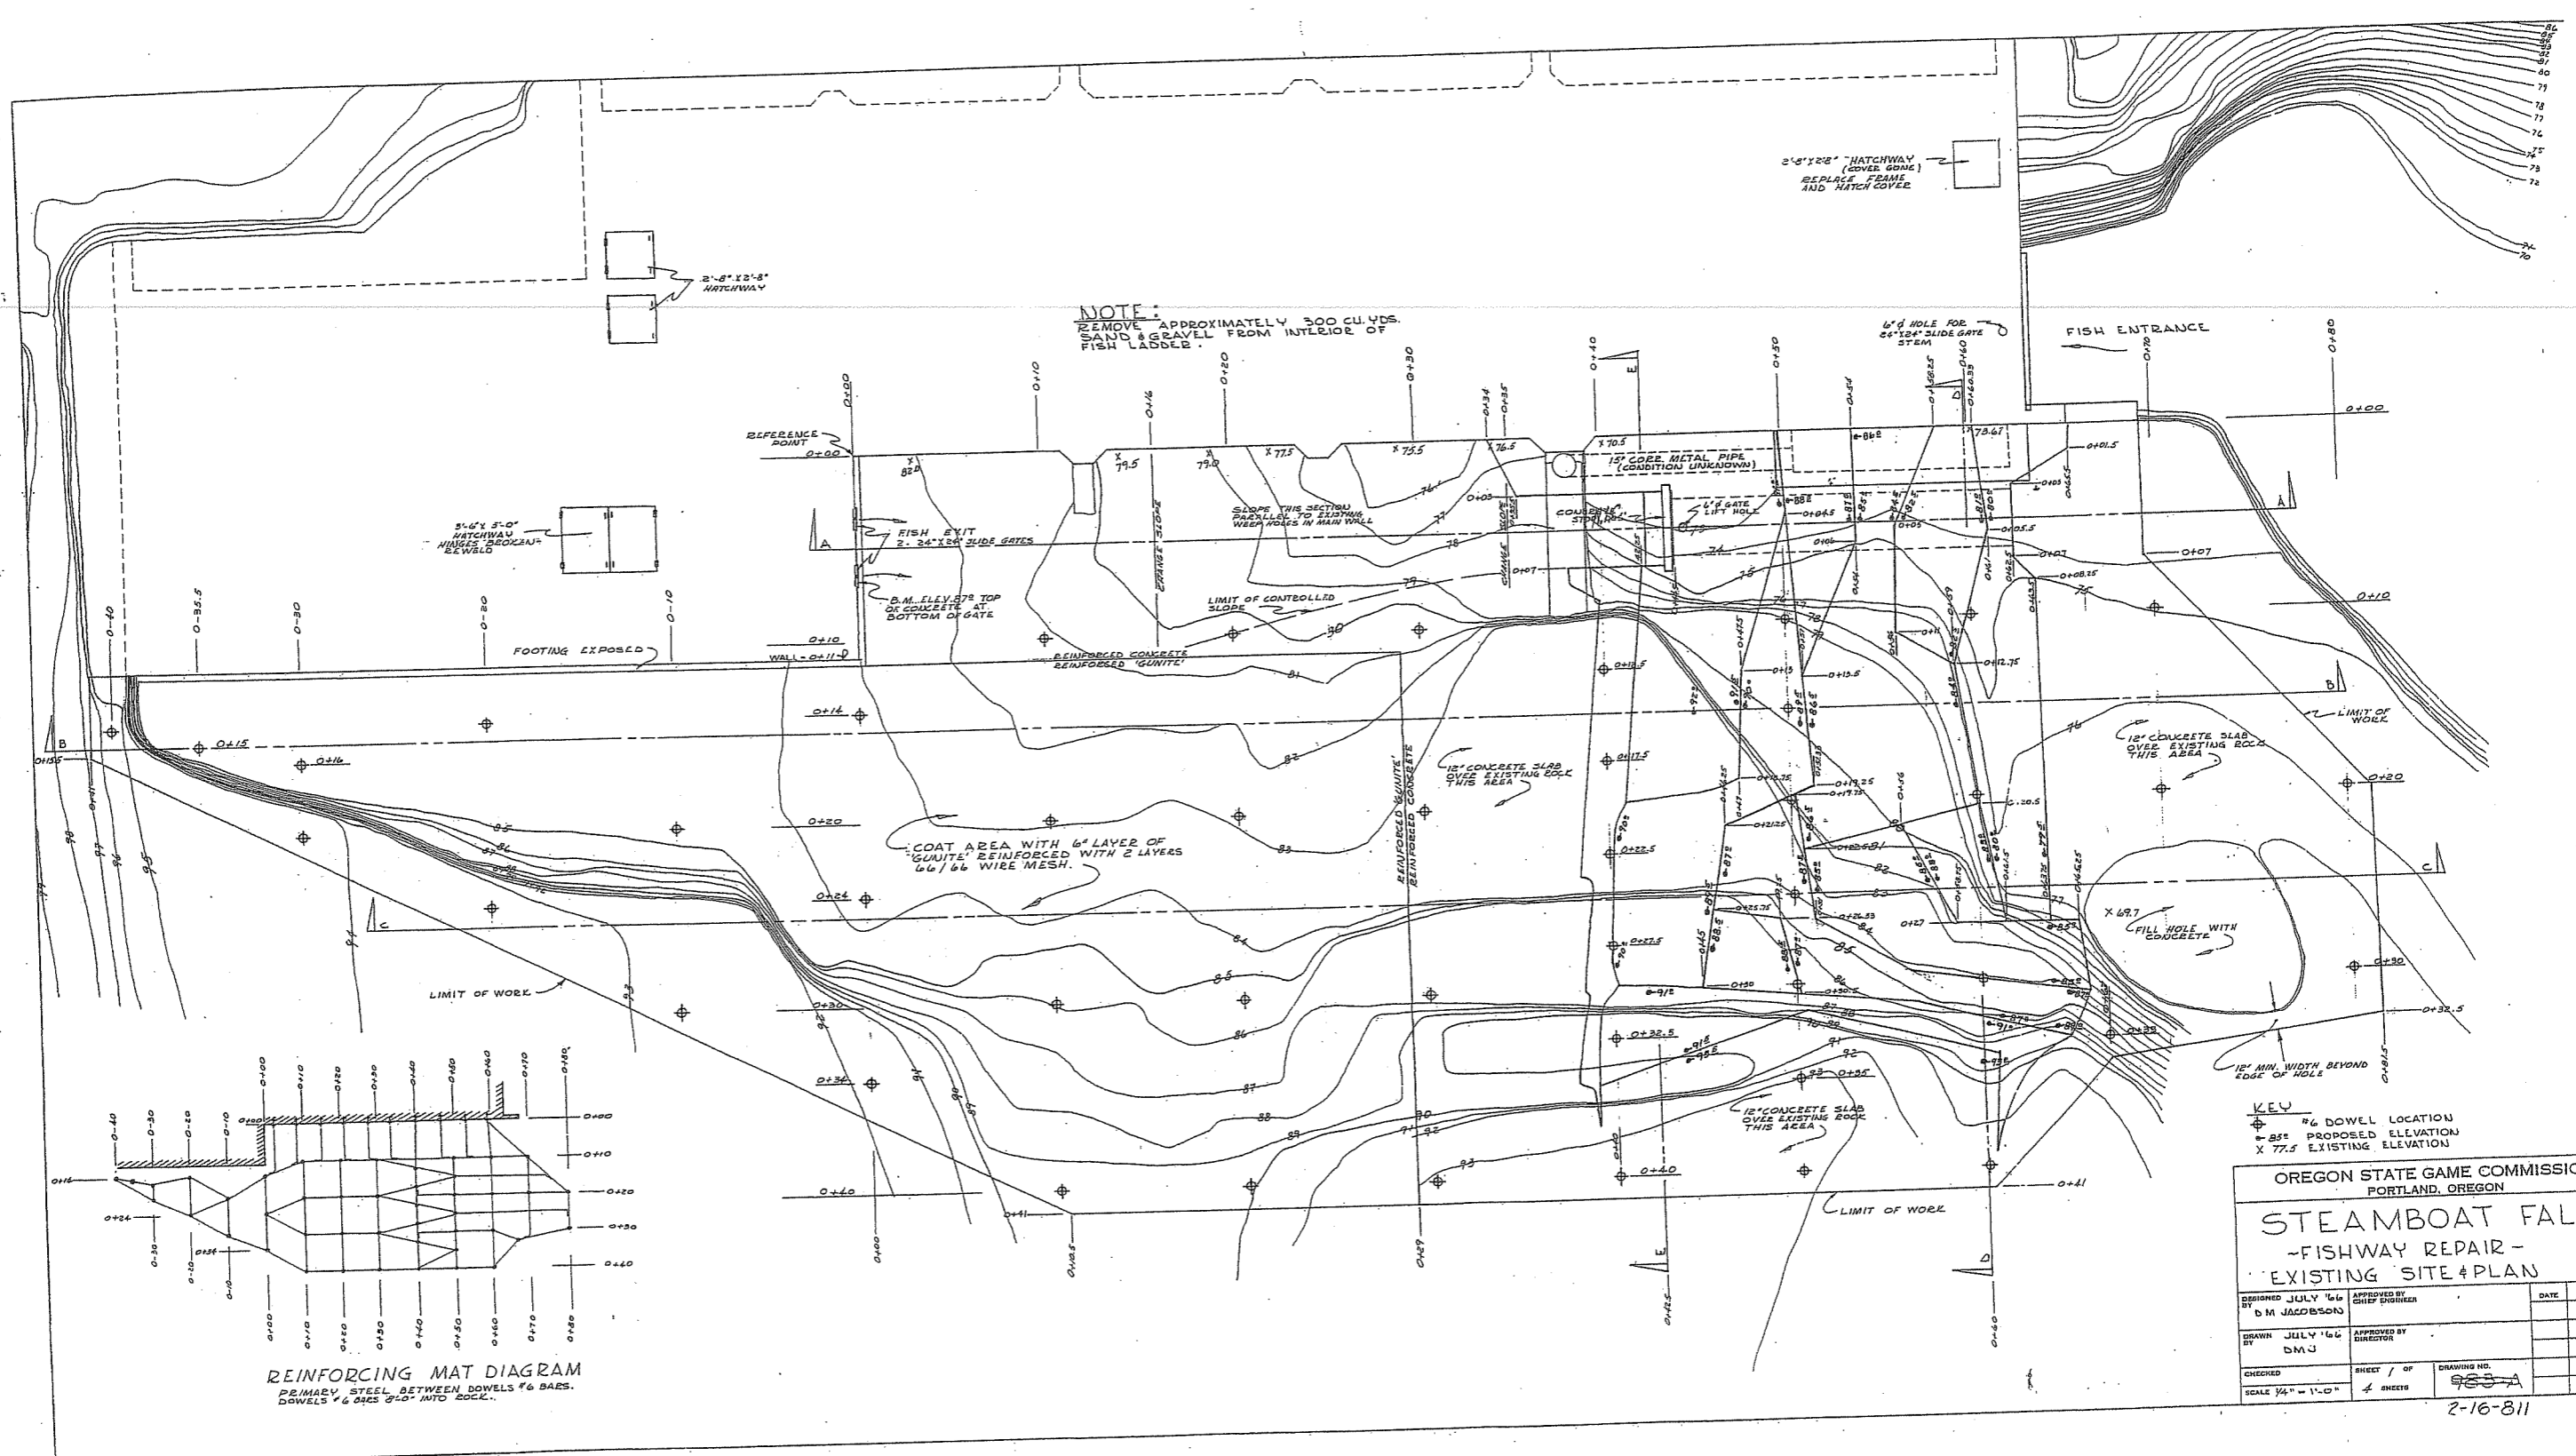
NOTE:  
REMOVE APPROXIMATELY 300 CU. YDS.  
SAND & GRAVEL FROM INTERIOR OF  
FISH LADDER.

REINFORCING MAT DIAGRAM  
PRIMARY STEEL BETWEEN DOWELS #6 BARS.  
DOWELS #6 @ 25' 3-0" INTO ROCK.

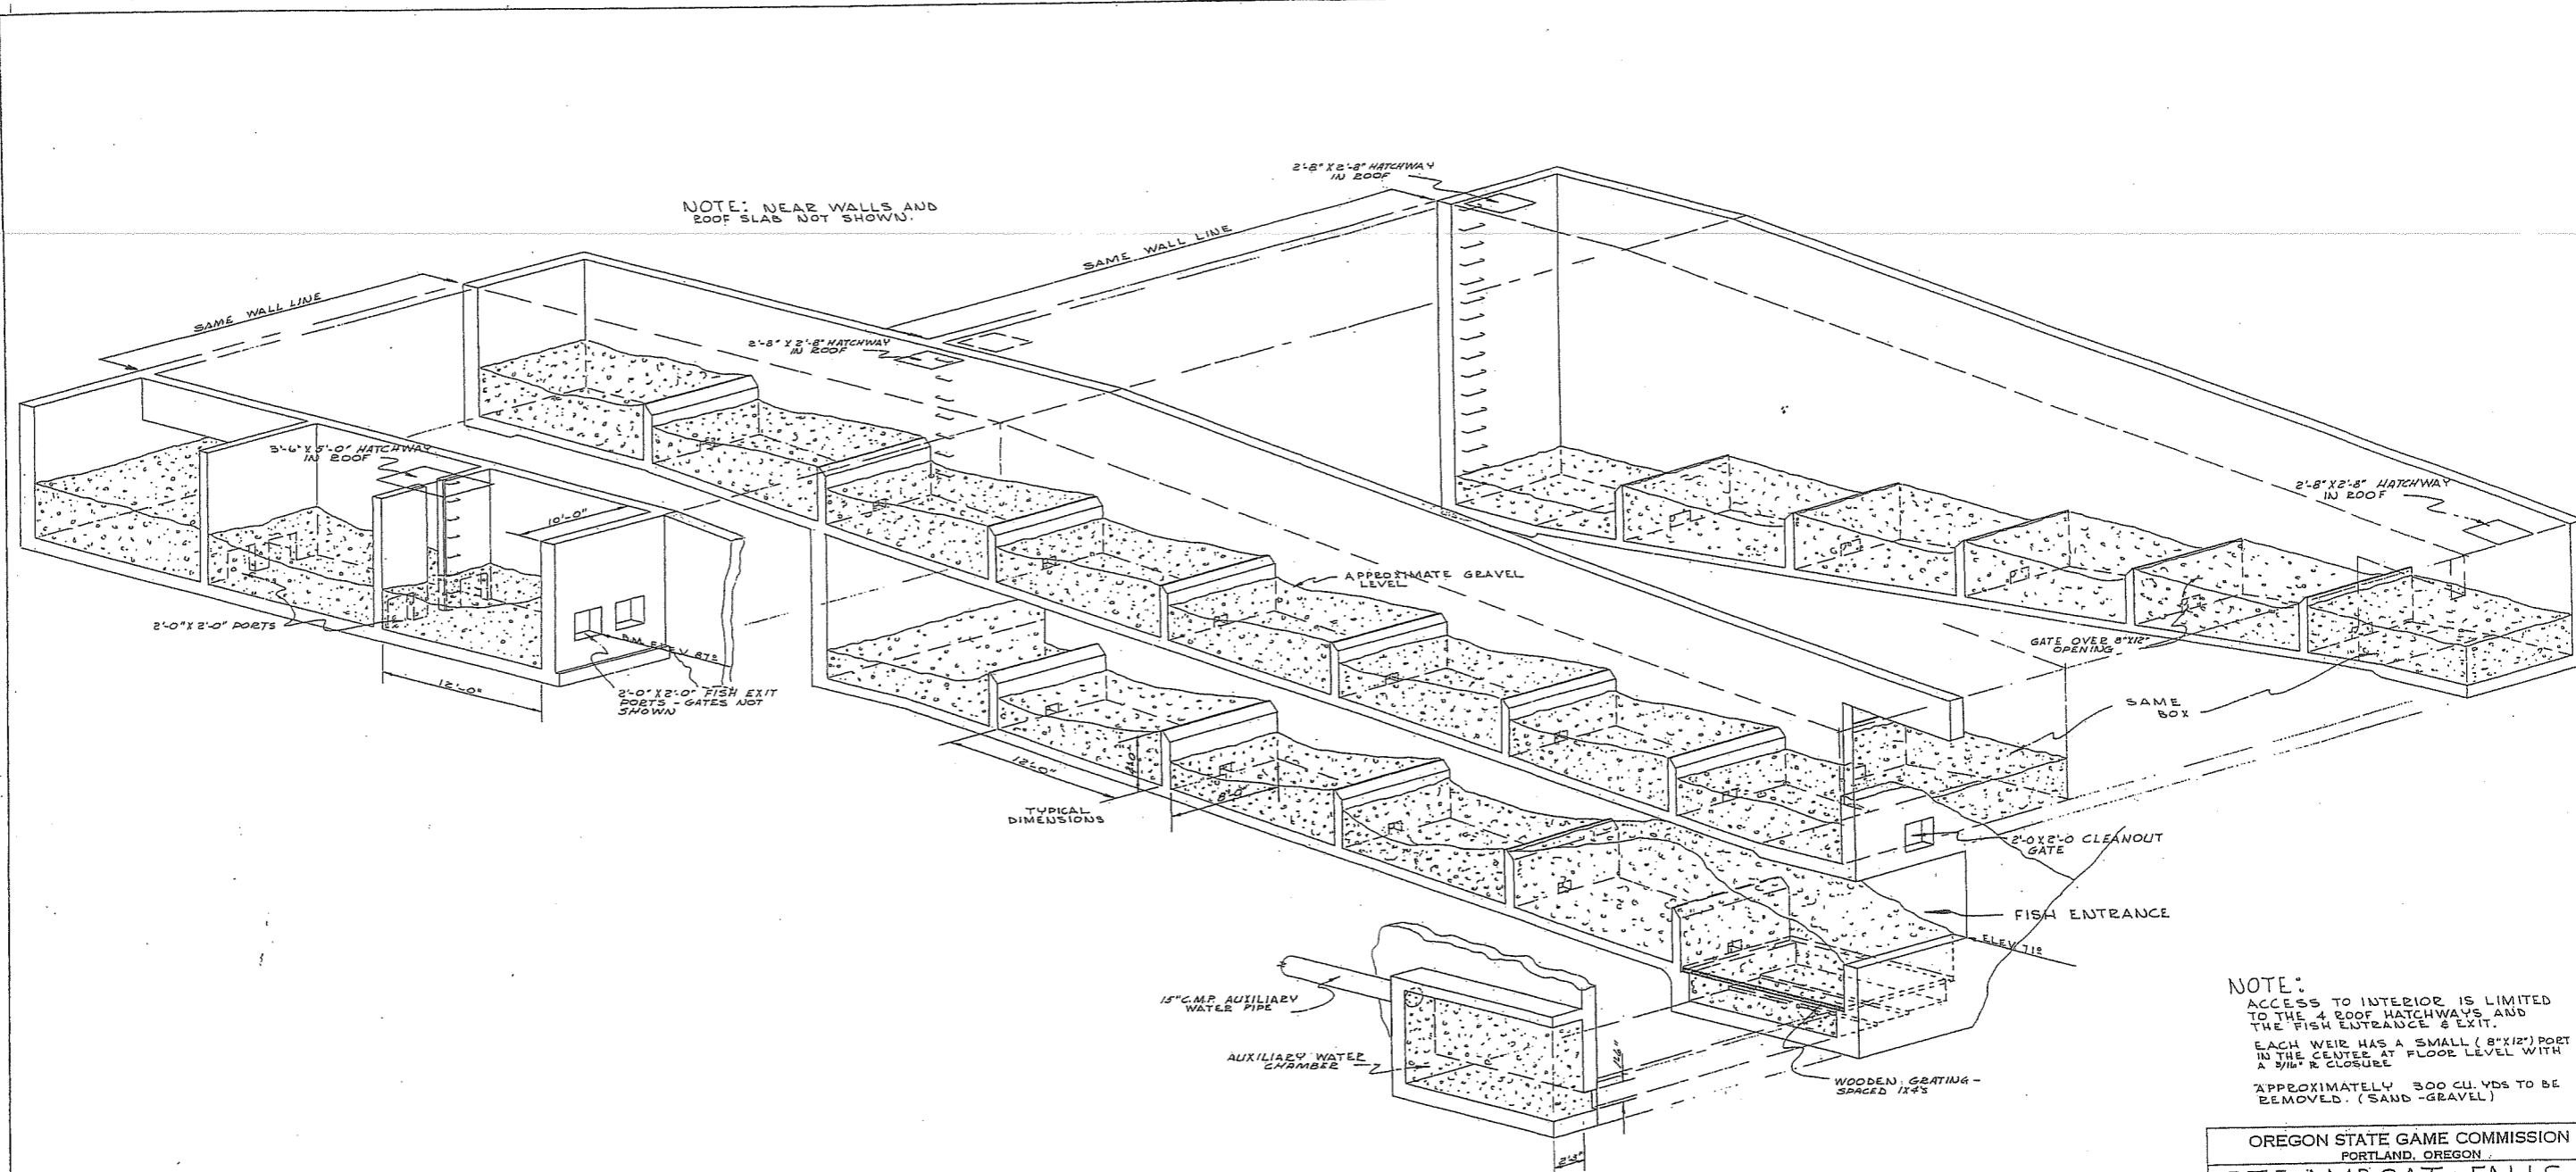
NOTE:  
 ACCESS TO INTERIOR IS LIMITED  
 TO THE 4 ROOF HATCHWAYS AND  
 THE FISH ENTRANCE & EXIT.  
 EACH WEIR HAS A SMALL (8"x12") PORT  
 IN THE CENTER AT FLOOR LEVEL WITH  
 A 3/16" R. CLOSURE  
 APPROXIMATELY 300 CU. YDS TO BE  
 REMOVED. (SAND-GRAVEL)
