## FINAL REPORT

# Steamboat Falls Fish Passage Evaluation and Alternatives Analysis

**The North Umpqua Foundation**

Michael Love & Associates  
PO Box 4477, Arcata CA 95501  
mlove@h2odesigns.com • 707-476-8938

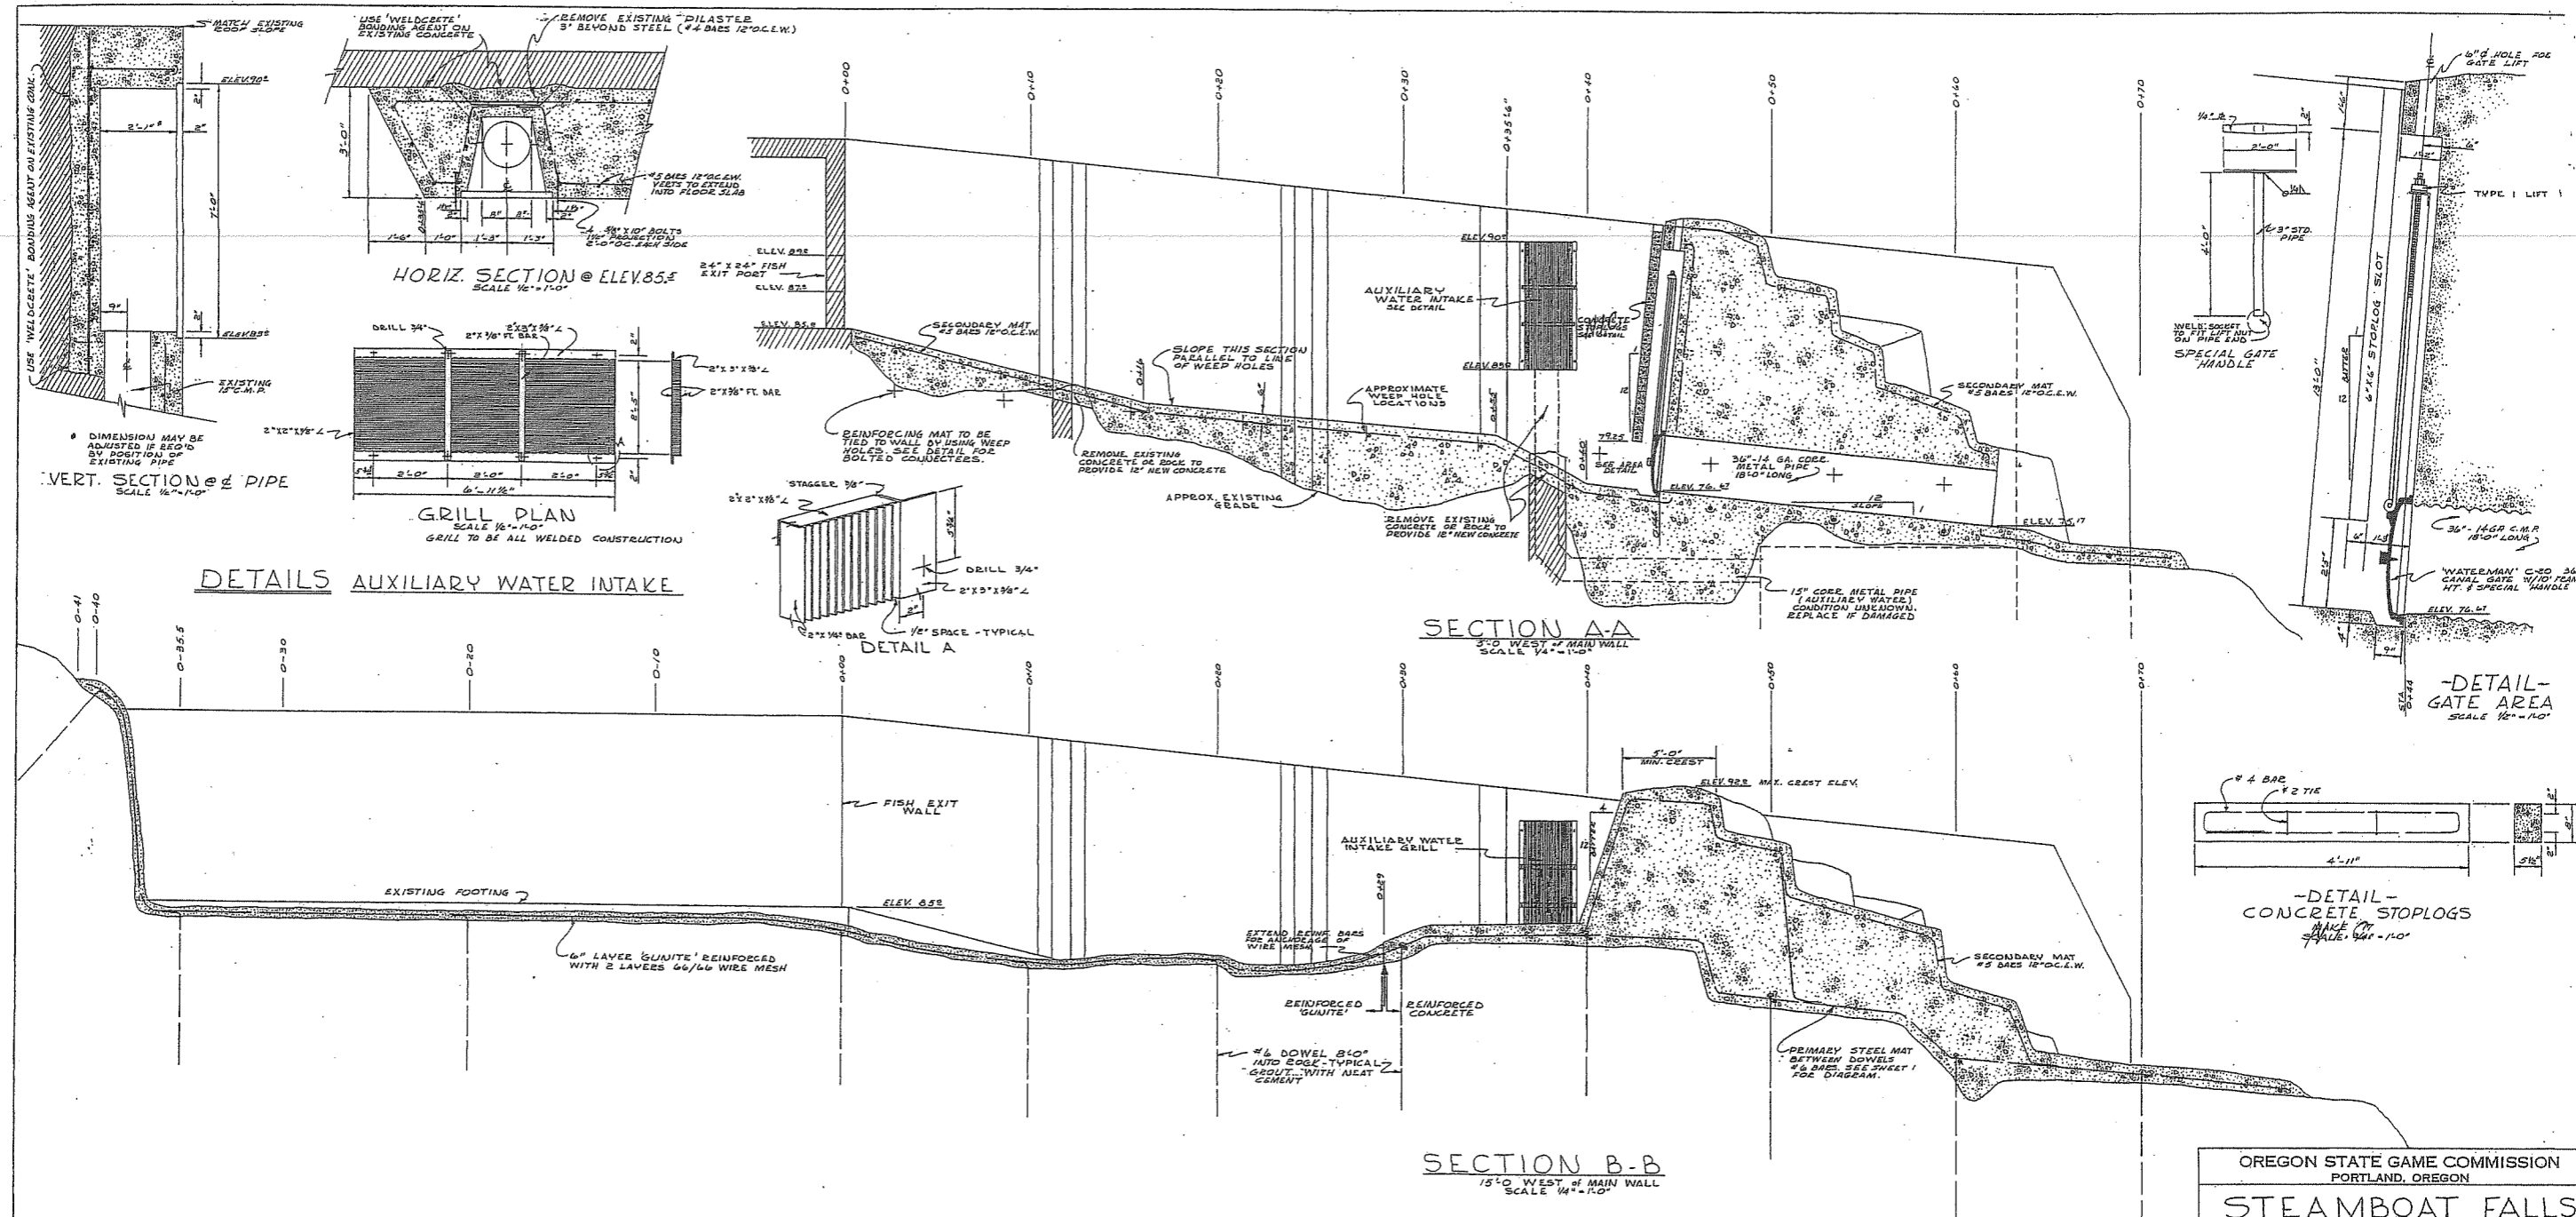
NOTE:  
PRIMARY STEEL MAT OF #6 BARS TIES DOWELS TOGETHER. SEE SHEET 1 FOR DIAGRAM.  
SECONDARY STEEL MAT OF #5 BARS 12" O.C.E.W. FOLLOWS THE CONFIGURATION OF THE CONCRETE SURFACE 6" BELOW SURFACE.  
GROUT DOWELS WITH NEAT CEMENT

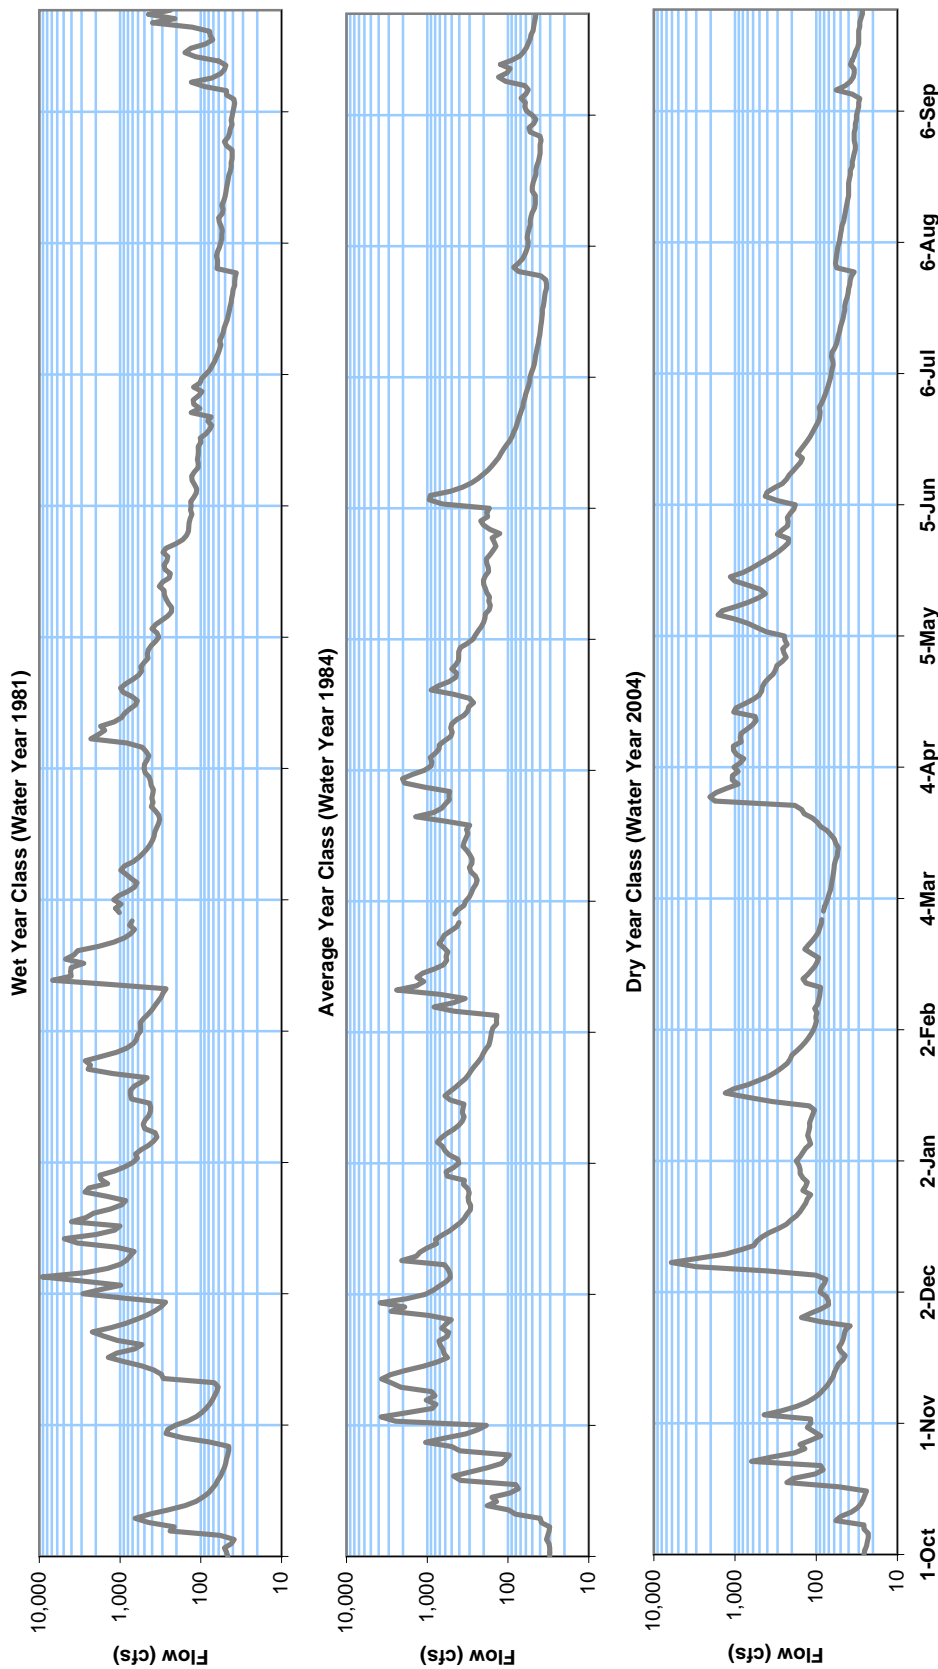
\* Hydrographs constructed using daily average flows recorded at Steamboat Creek Nr Glide, OR (USGS Gaging Station No. 14316700), scaled to the drainage area at Steamboat Falls. (Drainage Area at Gage = 227 mi<sup>2</sup> / Drainage Area at Falls = 133 mi<sup>2</sup> )
