AN ALTERNATIVES ANALYSIS

**For Improving Fish Passage Conditions
at Four Road-Stream Crossings within
San Francisquito Creek Watershed, California**

February 13, 2004

The San Francisquito Watershed Council

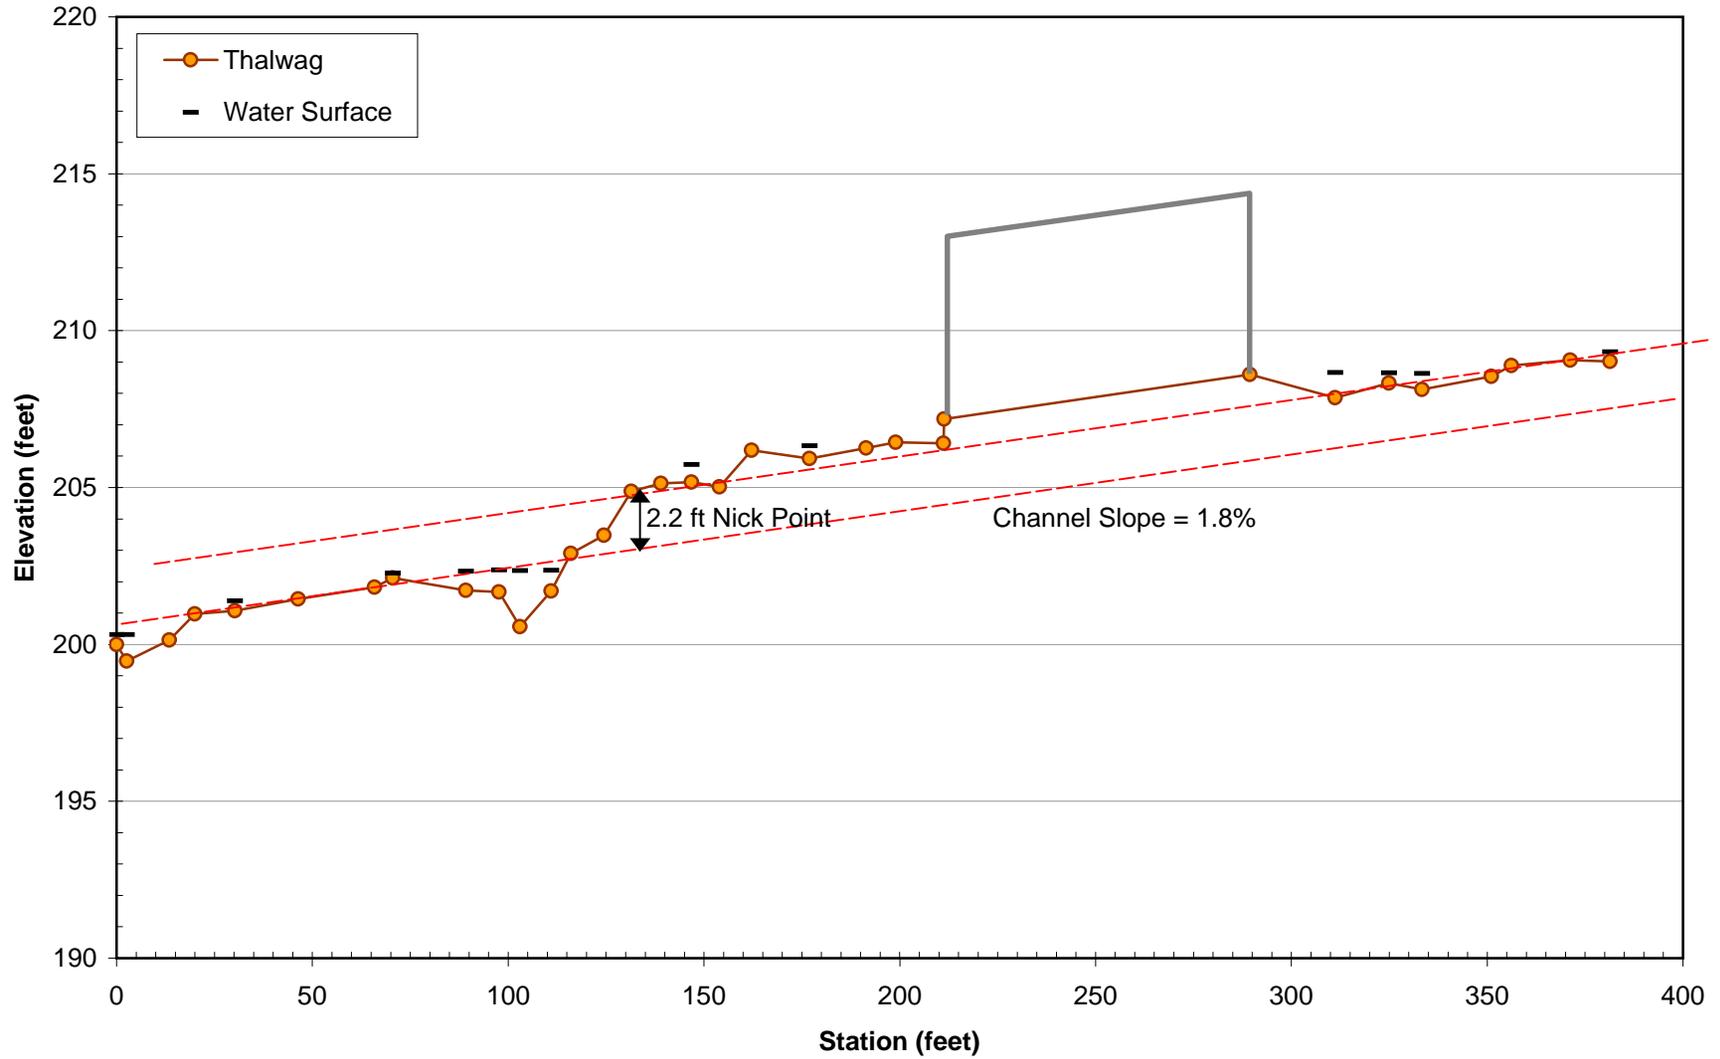
Barrier LT 6 Los Trancos Road Double Box Culvert

Existing Conditions at Fish Passage Design Flows

Note: Outlet Drop is the difference between the water surface elevation at the culvert outlet and the elevation of the tailwater.

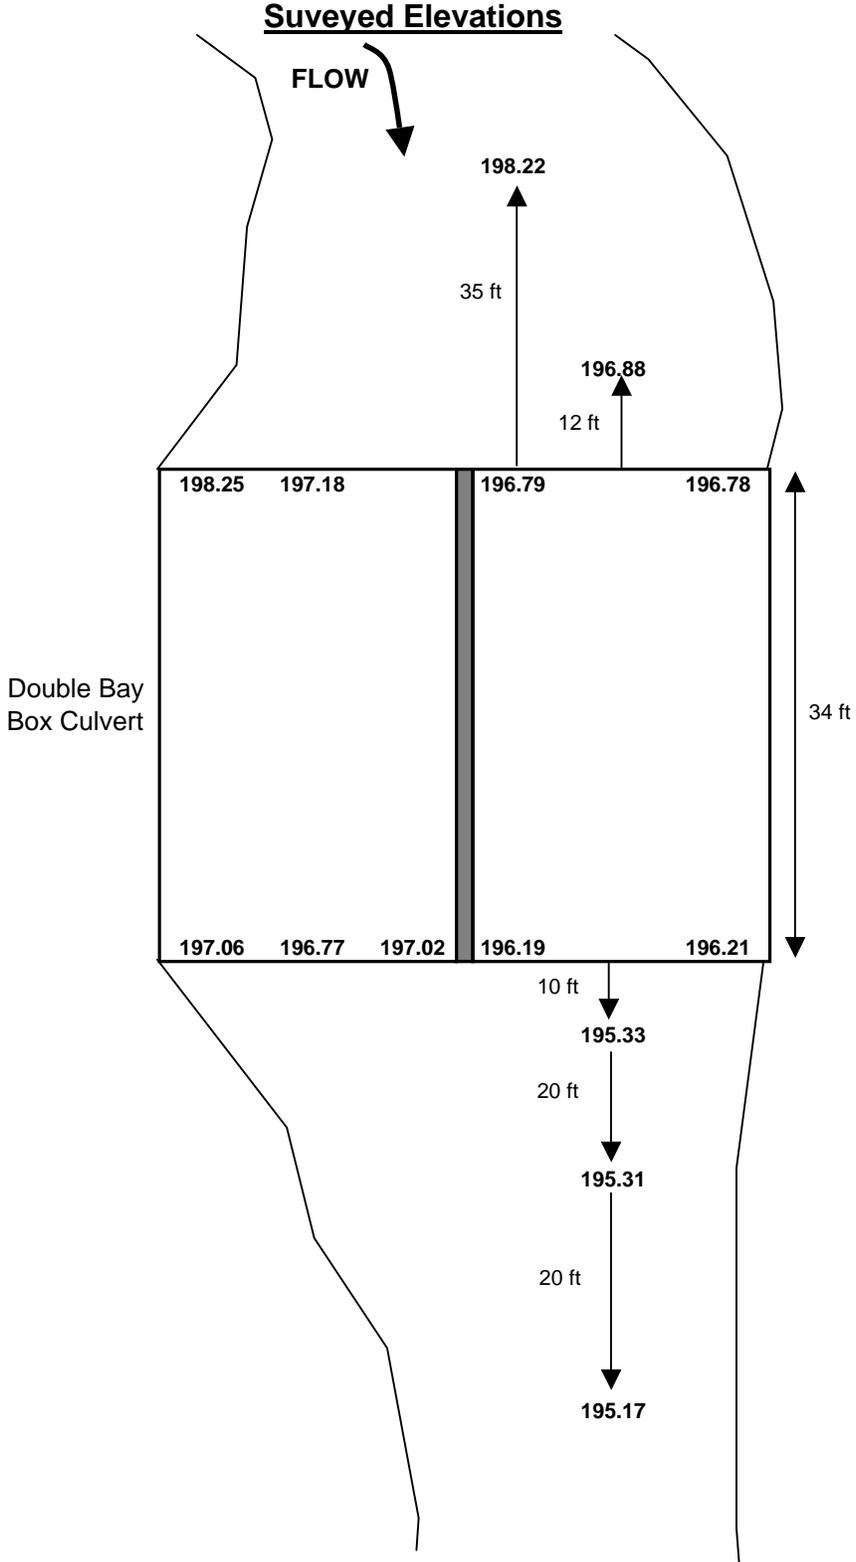
**Site: LT7 - Los Trancos Creek
Road: Fire Access Road**

Existing Conditions at Fish Passage Design Flows

Note: Outlet Drop is the difference between the water surface elevation at the culvert outlet and the elevation of the tailwater.

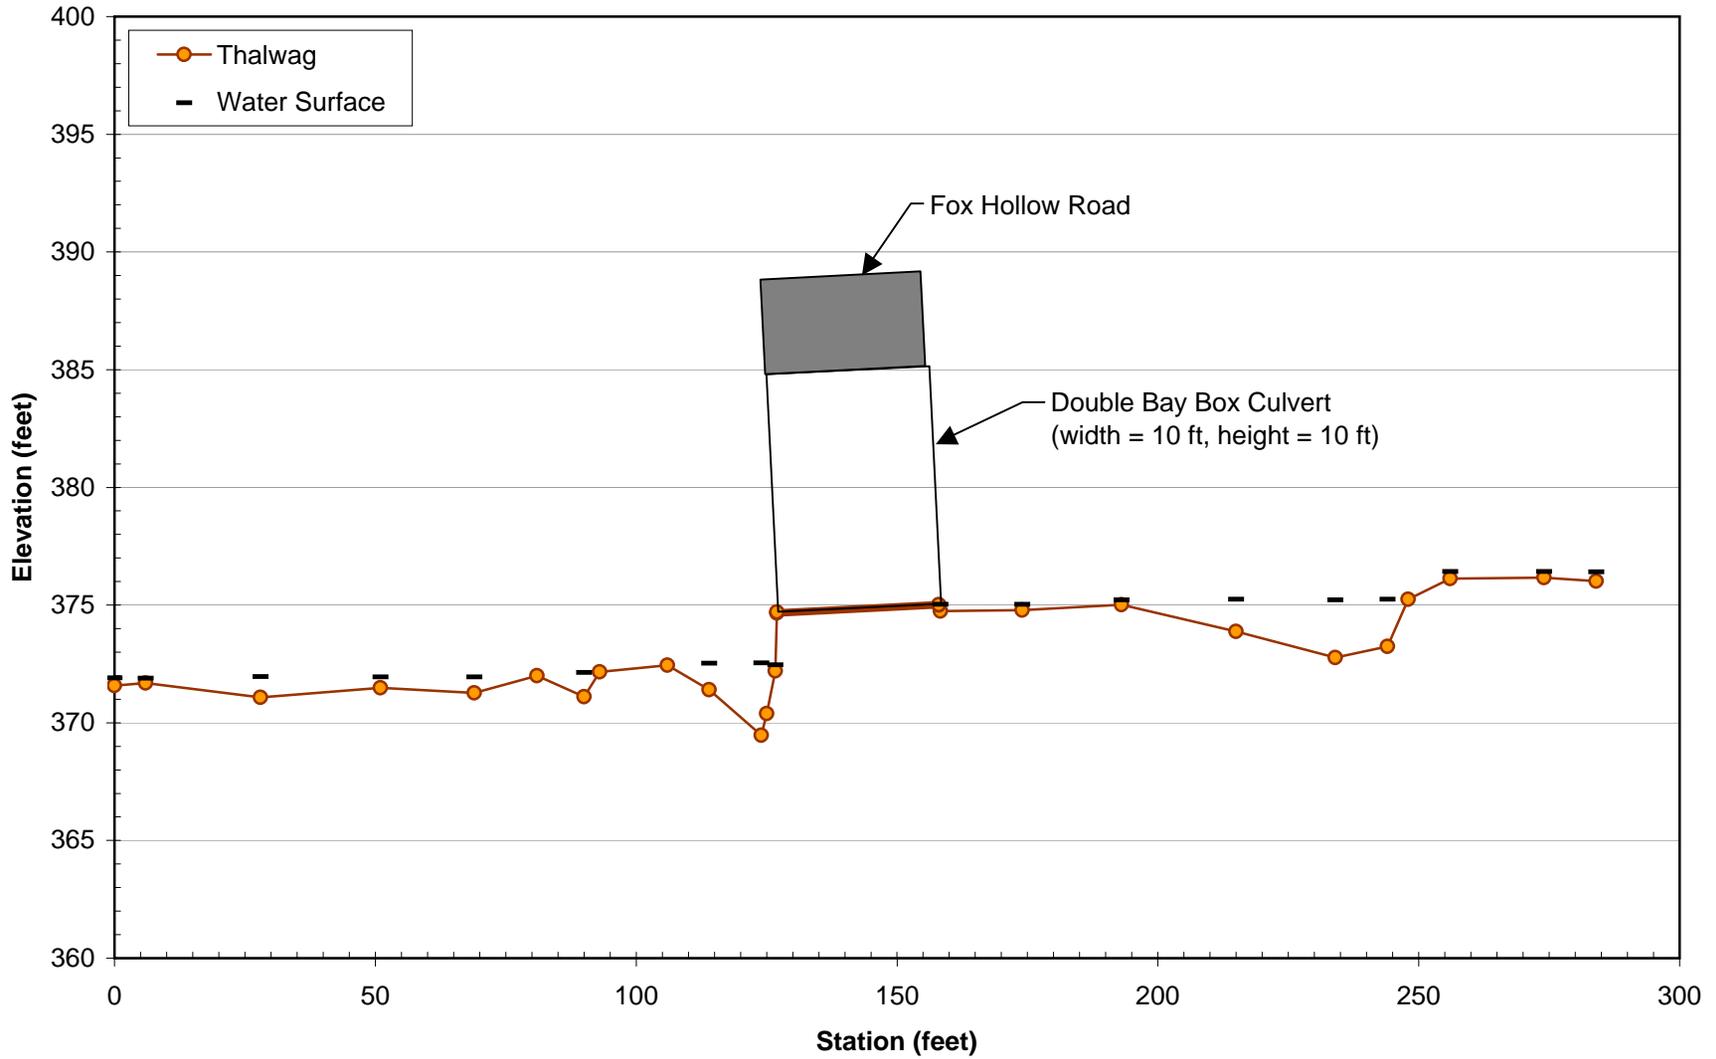
Barrier BE 10 Fox Hollow Road - Bear Gulch Creek

Existing Conditions at Fish Passage Design Flows

Note: Outlet Drop is the difference between the water surface elevation at the culvert outlet and the elevation of the tailwater.

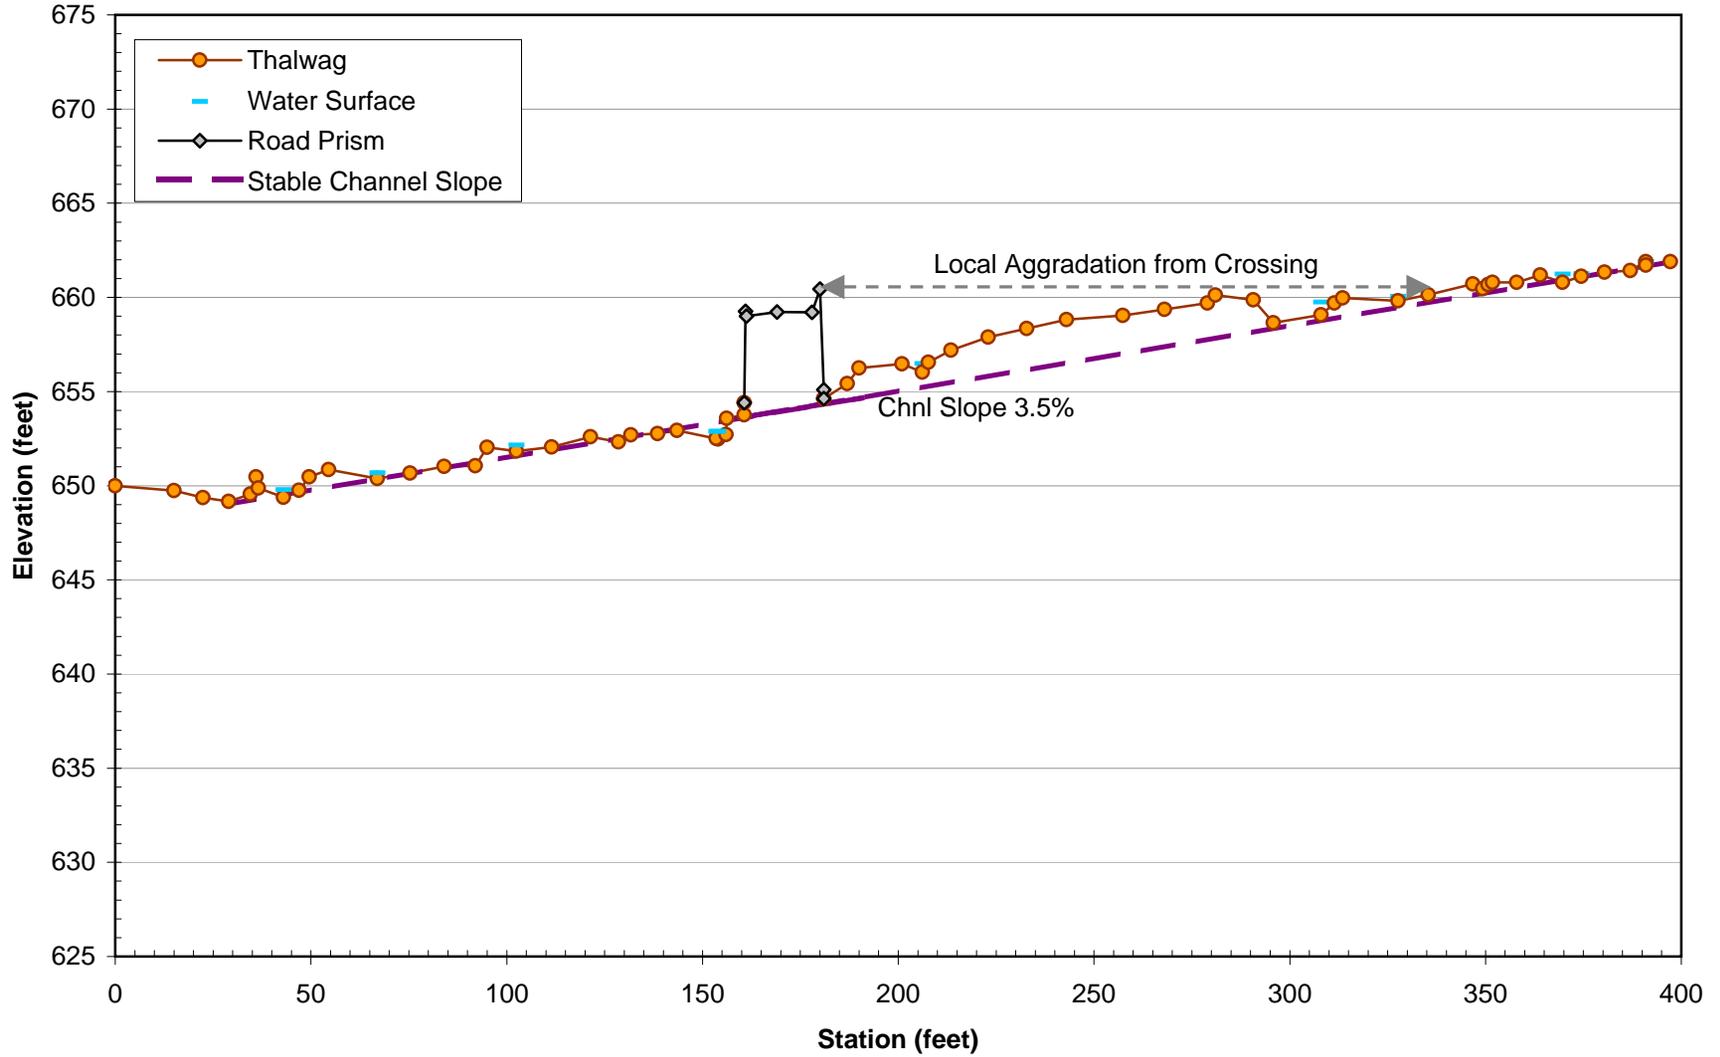
Barrier MG2 - McGarvey Gulch

Note 2: Outlet Drop is the difference between the water surface elevation at the culvert outlet and the elevation of the tailwater, without accounting for the outlet apron. Tailwater submerges downstream apron edge at 14.5 cfs
