Gaviota Creek

Fish Passage and Geomorphic Assessment

Prepared for
California Department of Fish and Game
And
Pacific States Marine Fisheries Commission

Prepared by
Michael Love and Associates
PO Box 4477
Arcata CA 95518

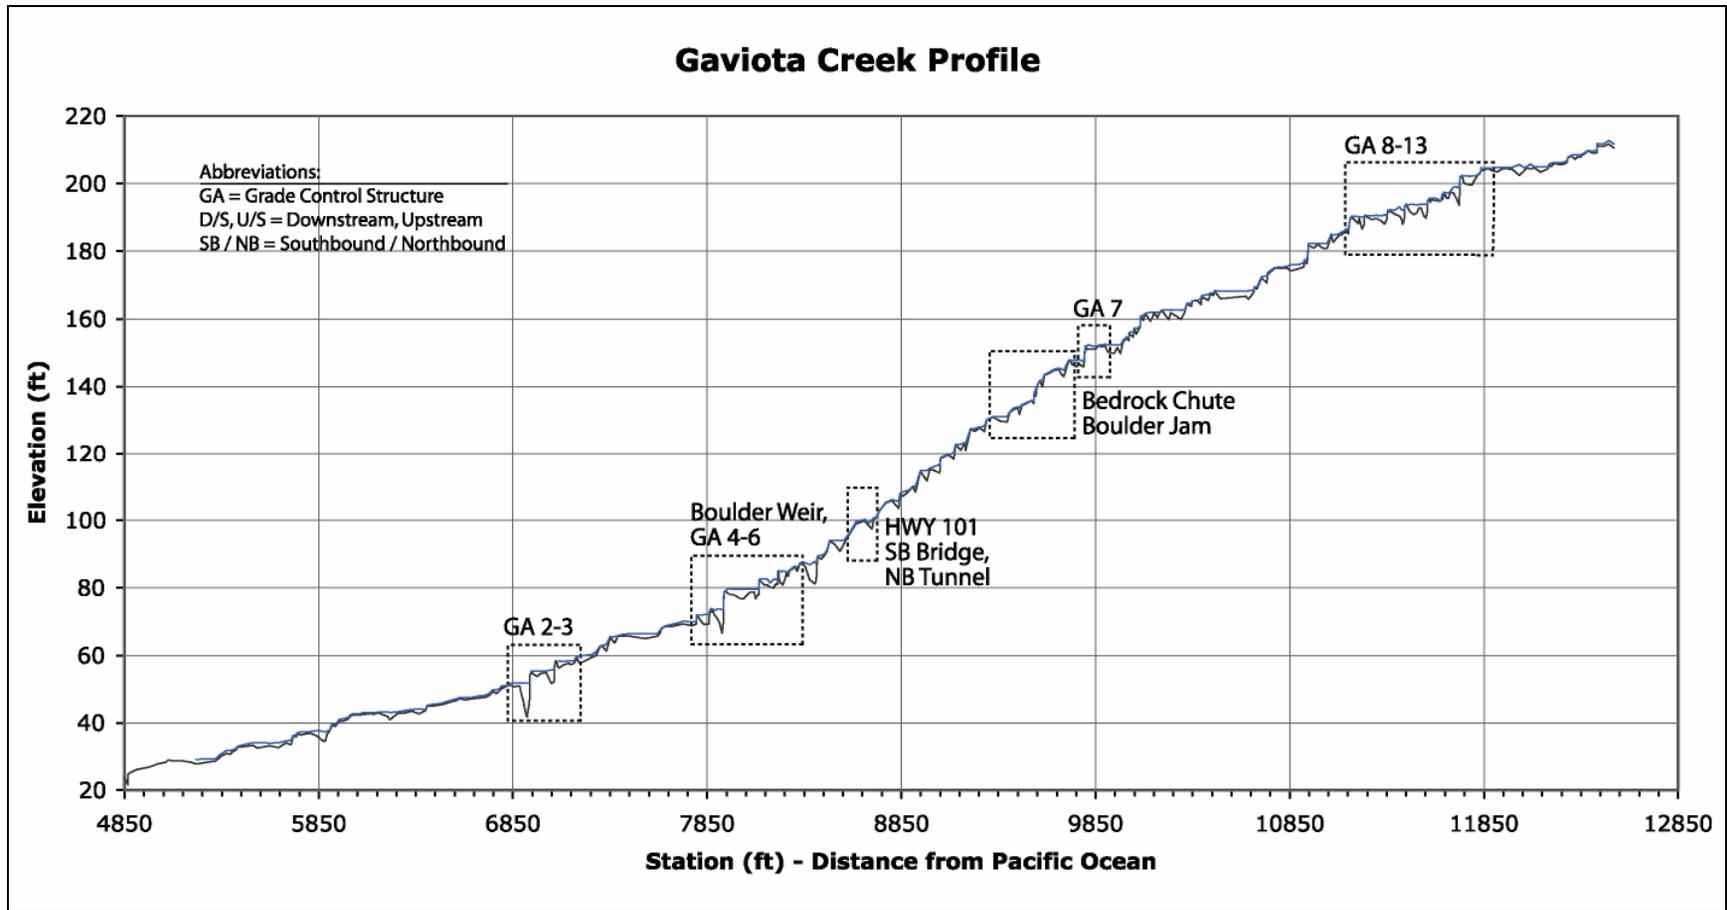
Fish passage conditions for 12 concrete grade control structures, one constructed boulder weir, one boulder jam, and a bedrock chute were analyzed for this study. Table 1.1 lists the identification codes and location for each analyzed structure. As shown in the longitudinal profile (Figure 4.1), the grade control structures are located in four distinct clusters, or groups:

Figure 4.1 – Longitudinal Profile of Gaviota Creek Study Reach. 1.45 miles were surveyed from river mile 0.92 (from the ocean) to river mile 2.37.

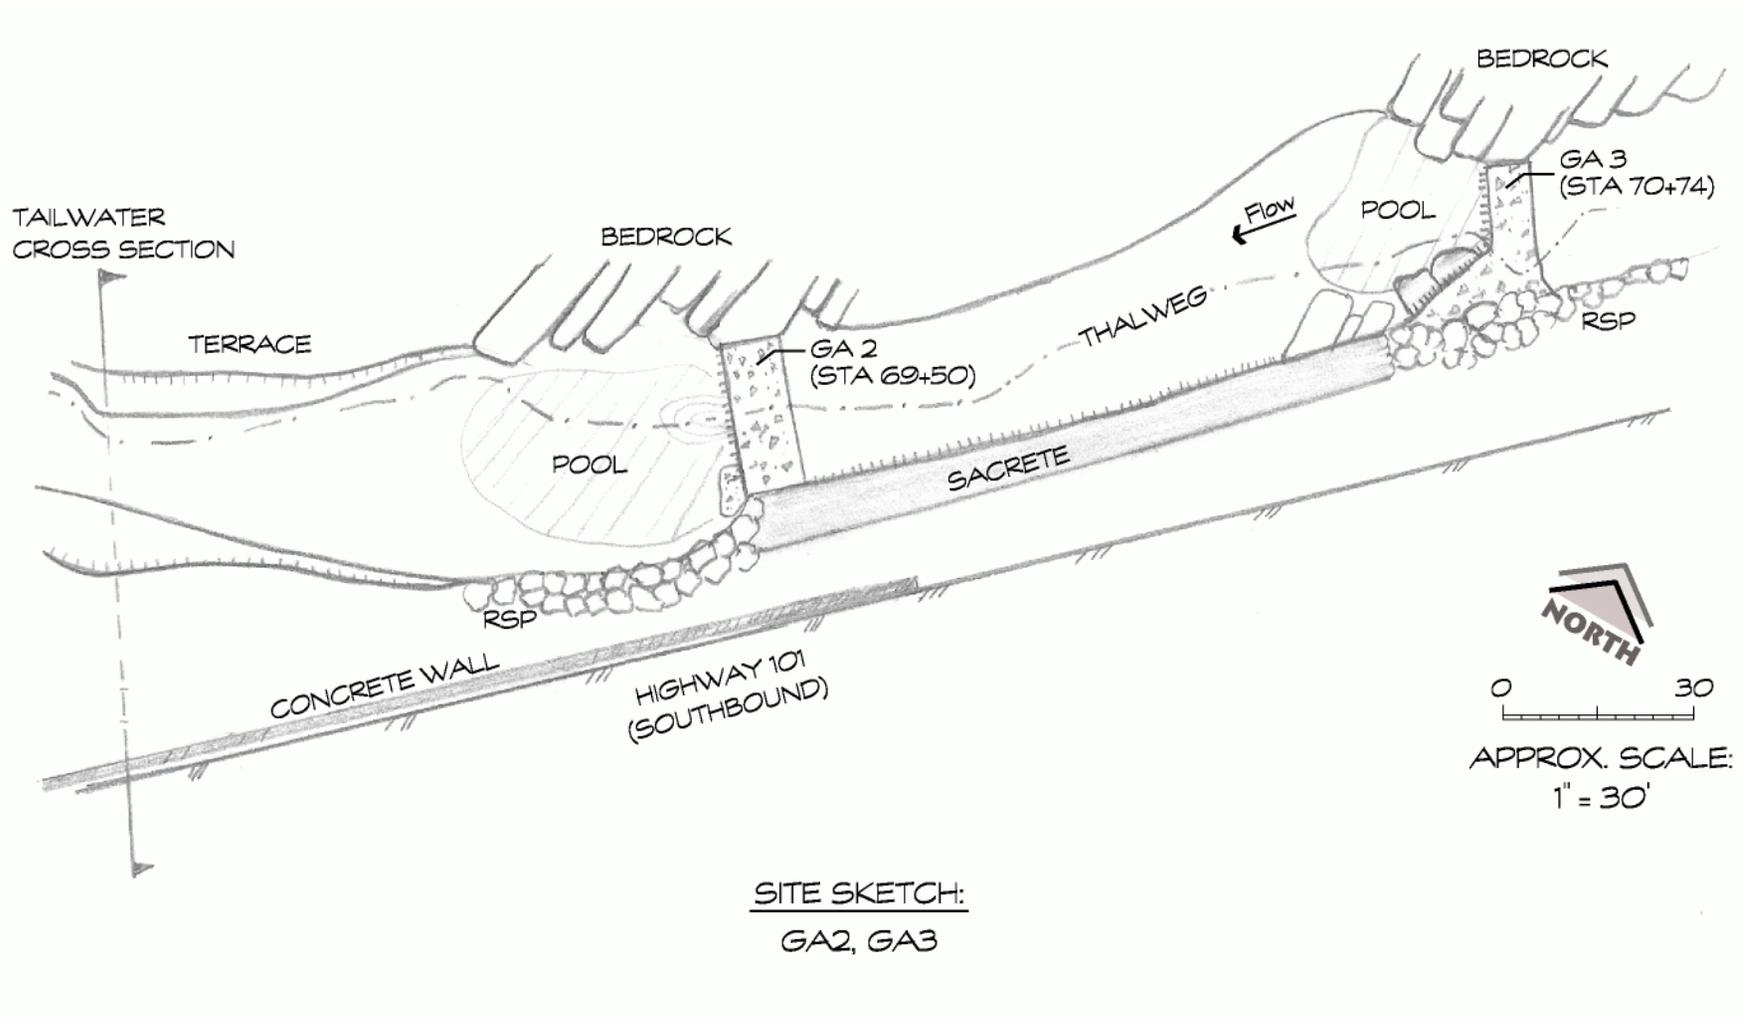
GA 3 (Sta 70+74) is located 125 feet upstream of GA2. GA 3 is 5 feet wide and anchored to the left bank sacrete revetment. (Figure 4.3). The spillway is located on the left bank along the apron of the sacrete wall. The tailwater below GA3 is hydraulically controlled by GA2, forming a 124 feet long pool (Figure 4.5). The pool width is confined by exposed bedrock along the right bank and the road embankment lined with sacrete along the left bank. The pool has a residual depth of 3.8 feet and contains boulders and bedrock is visible in the bottom. The water is slow moving in the pool and fosters a dense growth of cattails and algae during summer months.

Figure 4.4 – Plan map drawing of the channel reach containing GA2 and GA3.

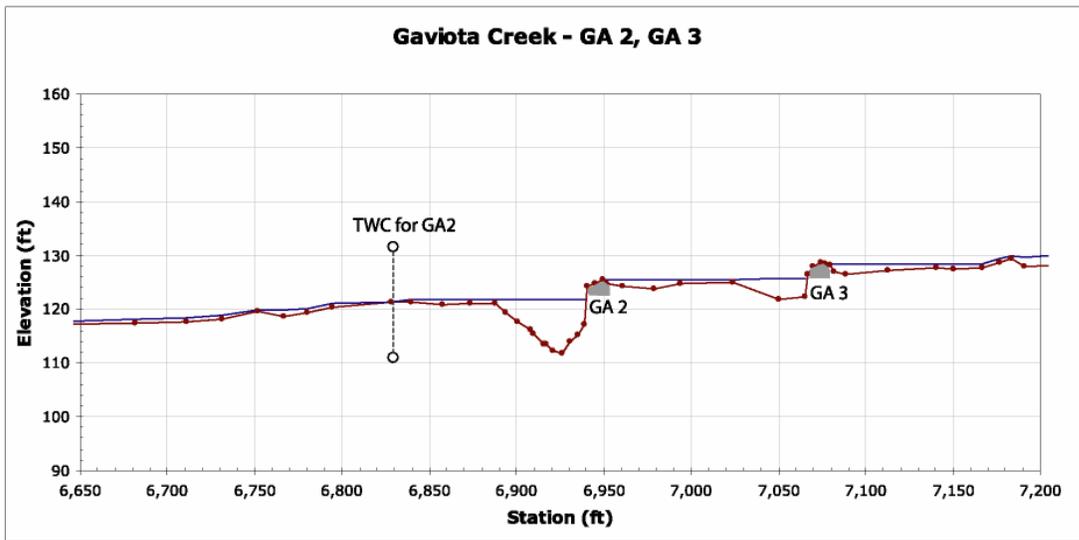
Figure 4.5 – Longitudinal profile showing location of grade controls GA2 and GA3 and the tailwater control (TWC) for GA2. (Note: elevations shown are based on arbitrary datum)

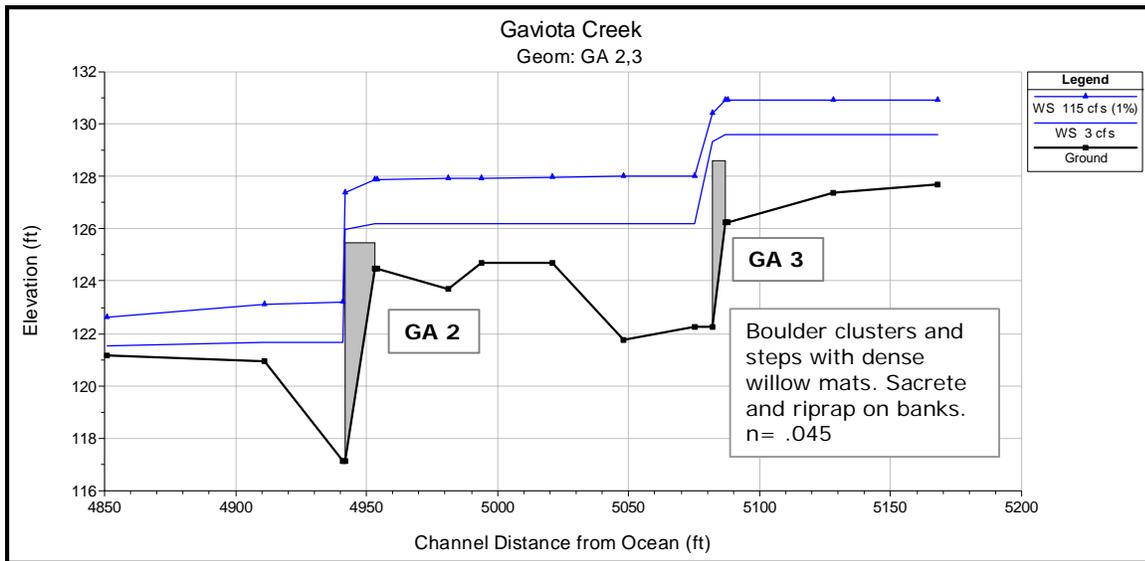
Model results predict the water surface drop over each grade control weir at typical adult steelhead passage flows and at the no-flow condition (Table 4.1). From 8.1 cfs to 115 cfs GA2 creates a drop of 4.7 ft. At these same flows the drop over GA3 ranges between 2.9 and 3.3 feet. Since the drop height over GA3 is directly influenced by GA2 (Figure 4.6), rising flows reduce the drop height.

Figure 4.6 – HEC-RAS results showing water surface profiles for GA2 and GA3 at 3 cfs and 115cfs (note: elevations used in model were based on an arbitrary datum).

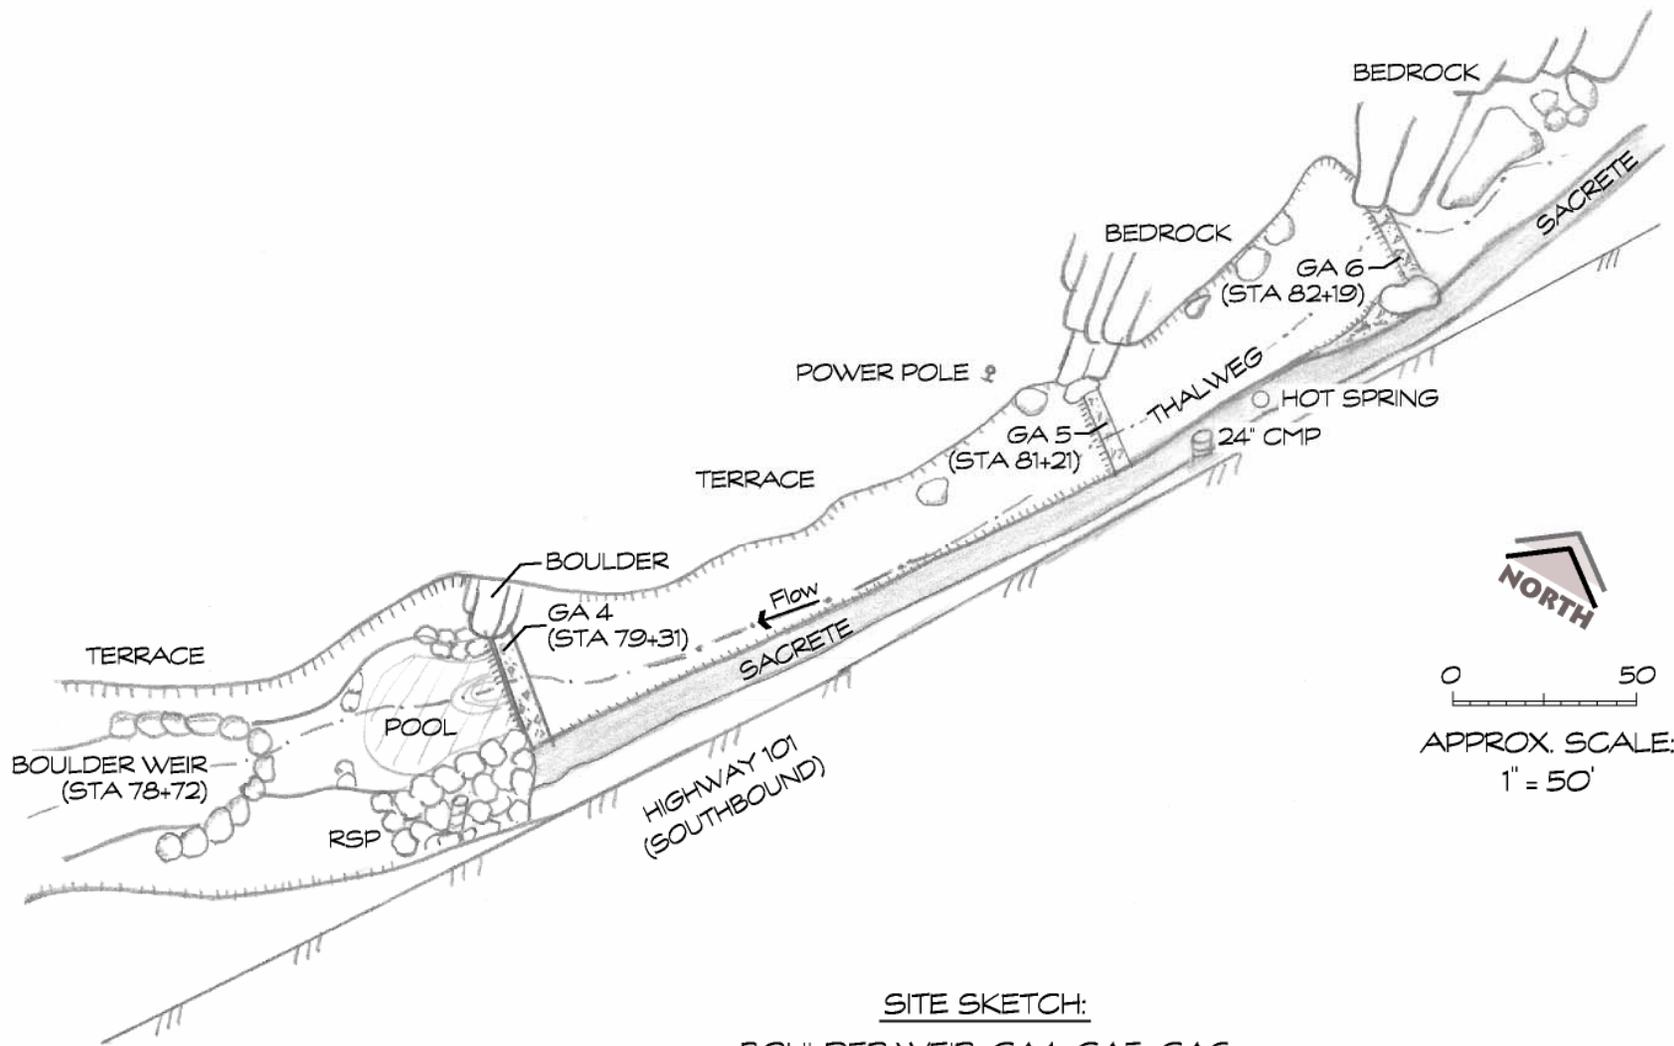
Figure 4.10 – Plan map drawing of the channel reach containing BOULDER WEIR, GA4, GA5, and GA6.

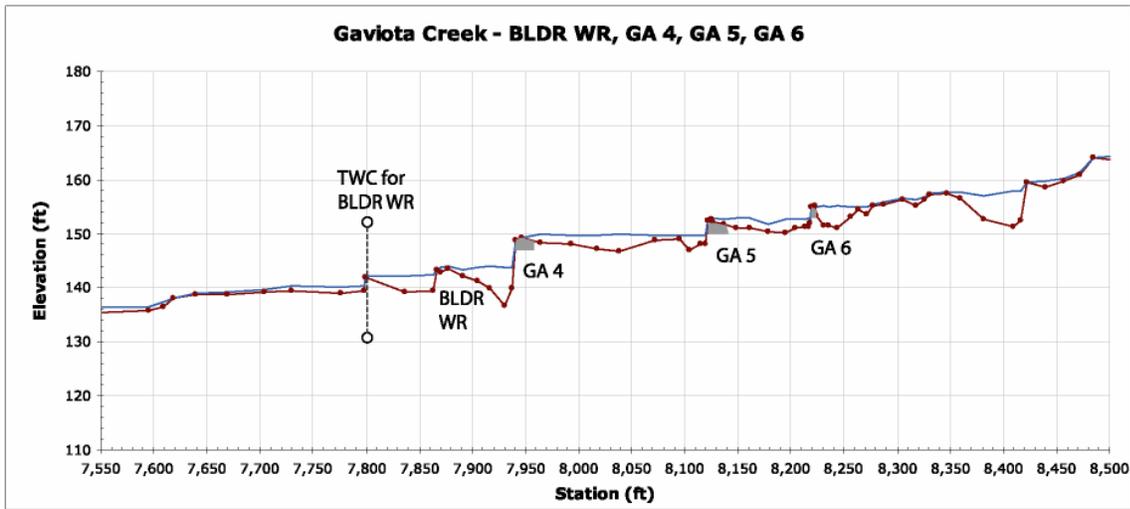
Figure 4.11 – Longitudinal profile showing location of the constructed boulder weir (BLDR_WR), grade controls GA4, GA5 and GA6, and the tailwater control (TWC) below the boulder weir. (Note: elevations shown are based on arbitrary datum)

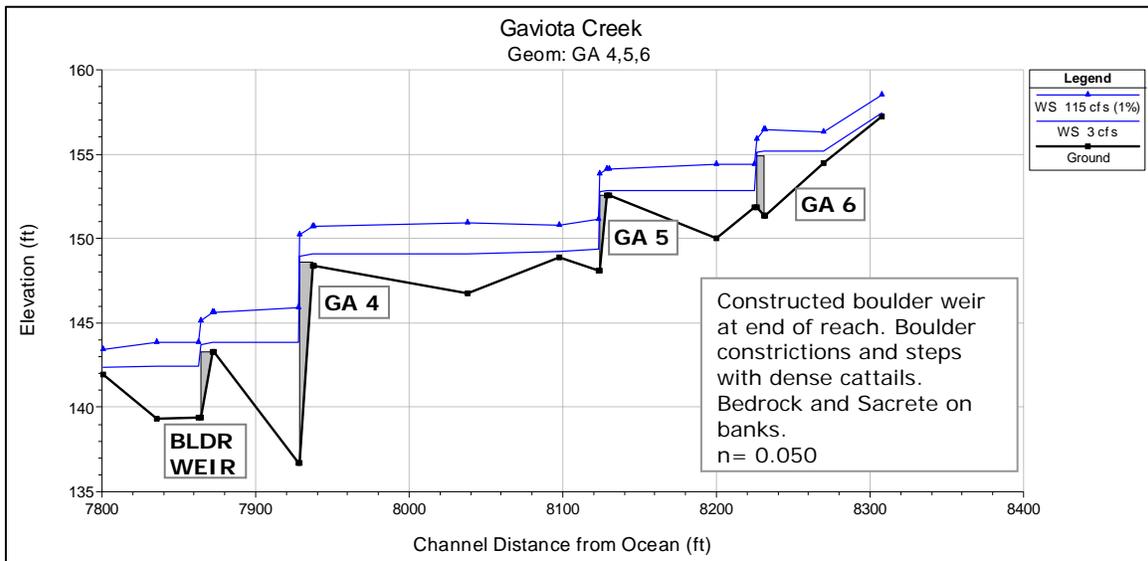
Model results predict the water surface drop over each grade control weir at typical adult steelhead passage flows and at the no-flow condition (Table 4.2). With the exception of the boulder weir, the drop heights over each of the grade control structures is controlled by the next downstream structure (Figure 4.12). From 8.1 cfs to 115 cfs the boulder weir maintains a drop of 1.3 ft, and GA4, GA5 and GA6 have average drop heights of 5.0 ft, 3.3 ft and 2.2 ft, respectively.

Figure 4.12 – HEC-RAS results showing water surface profiles for the constructed boulder weir, GA4, GA5, and GA6 at 3 cfs and 115cfs. Note the drop over each grade control is influenced by the next one downstream. (Note: elevations in model are based on arbitrary datum)

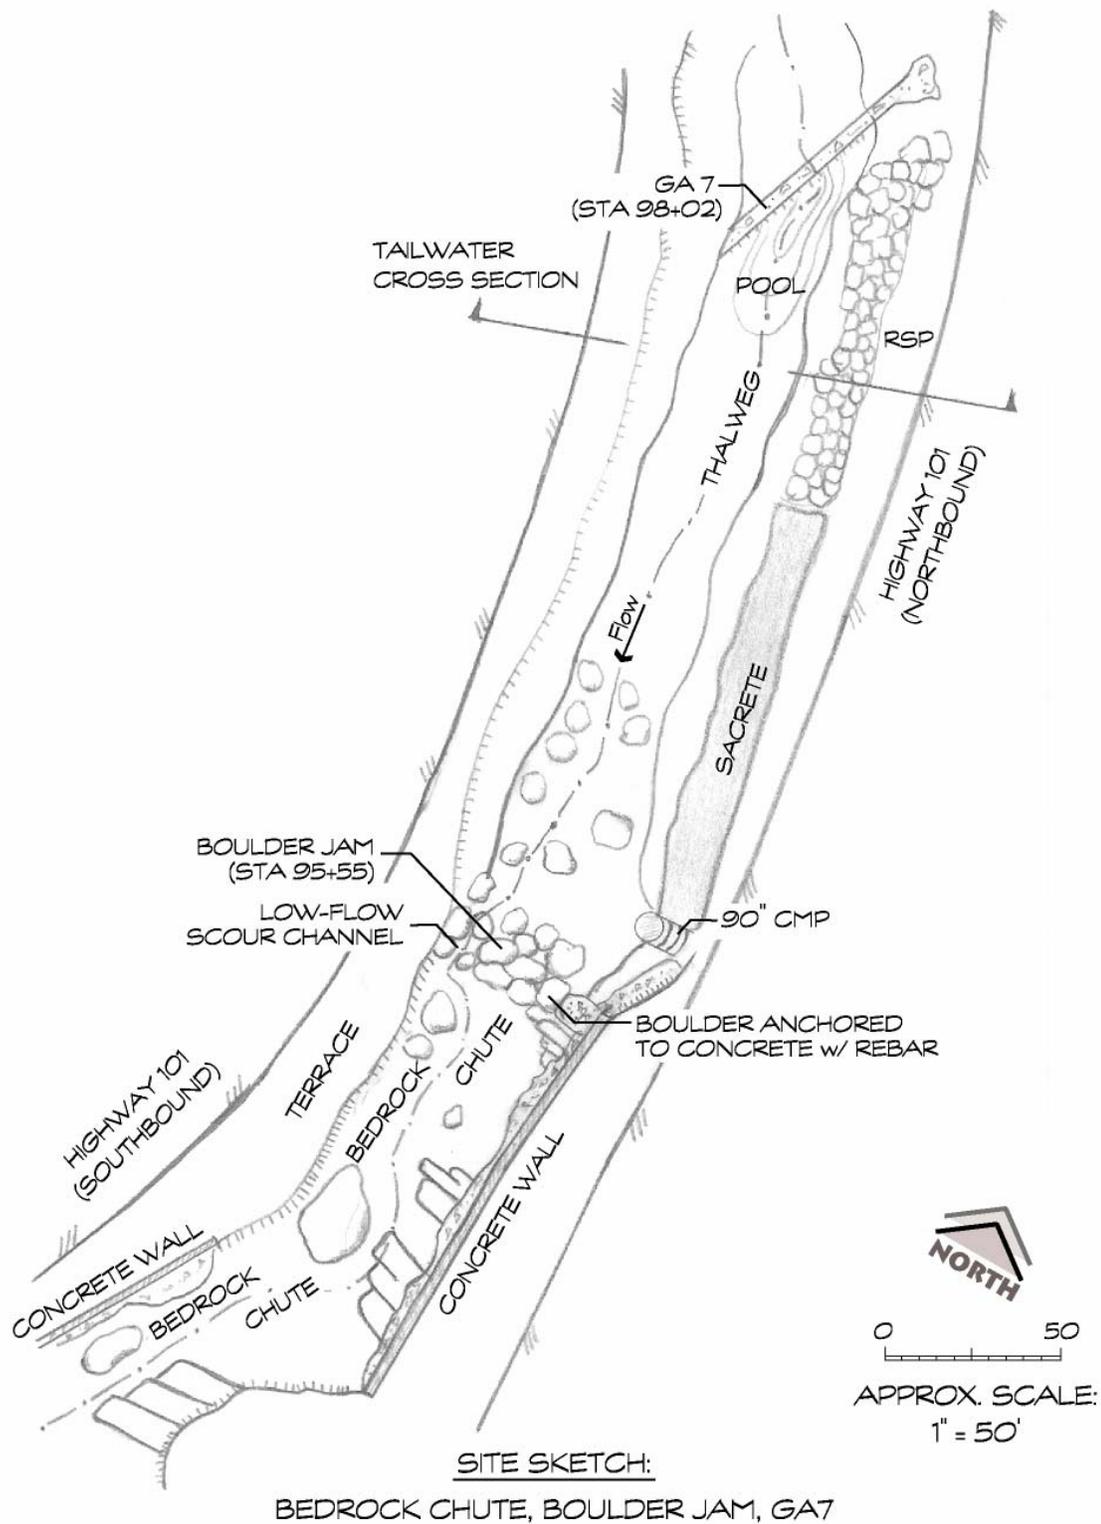
Figure 4.16 – Plan map drawing of the channel reach containing GA7

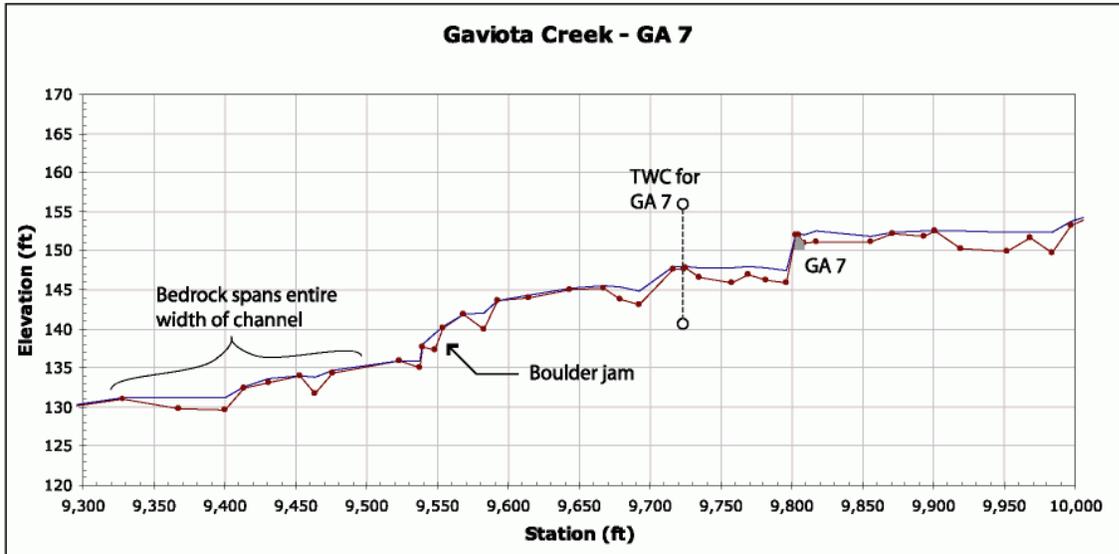
Figure 4.17 – Longitudinal profile showing location of the bedrock chute, boulder jam (BLDR JAM), and grade control GA7.

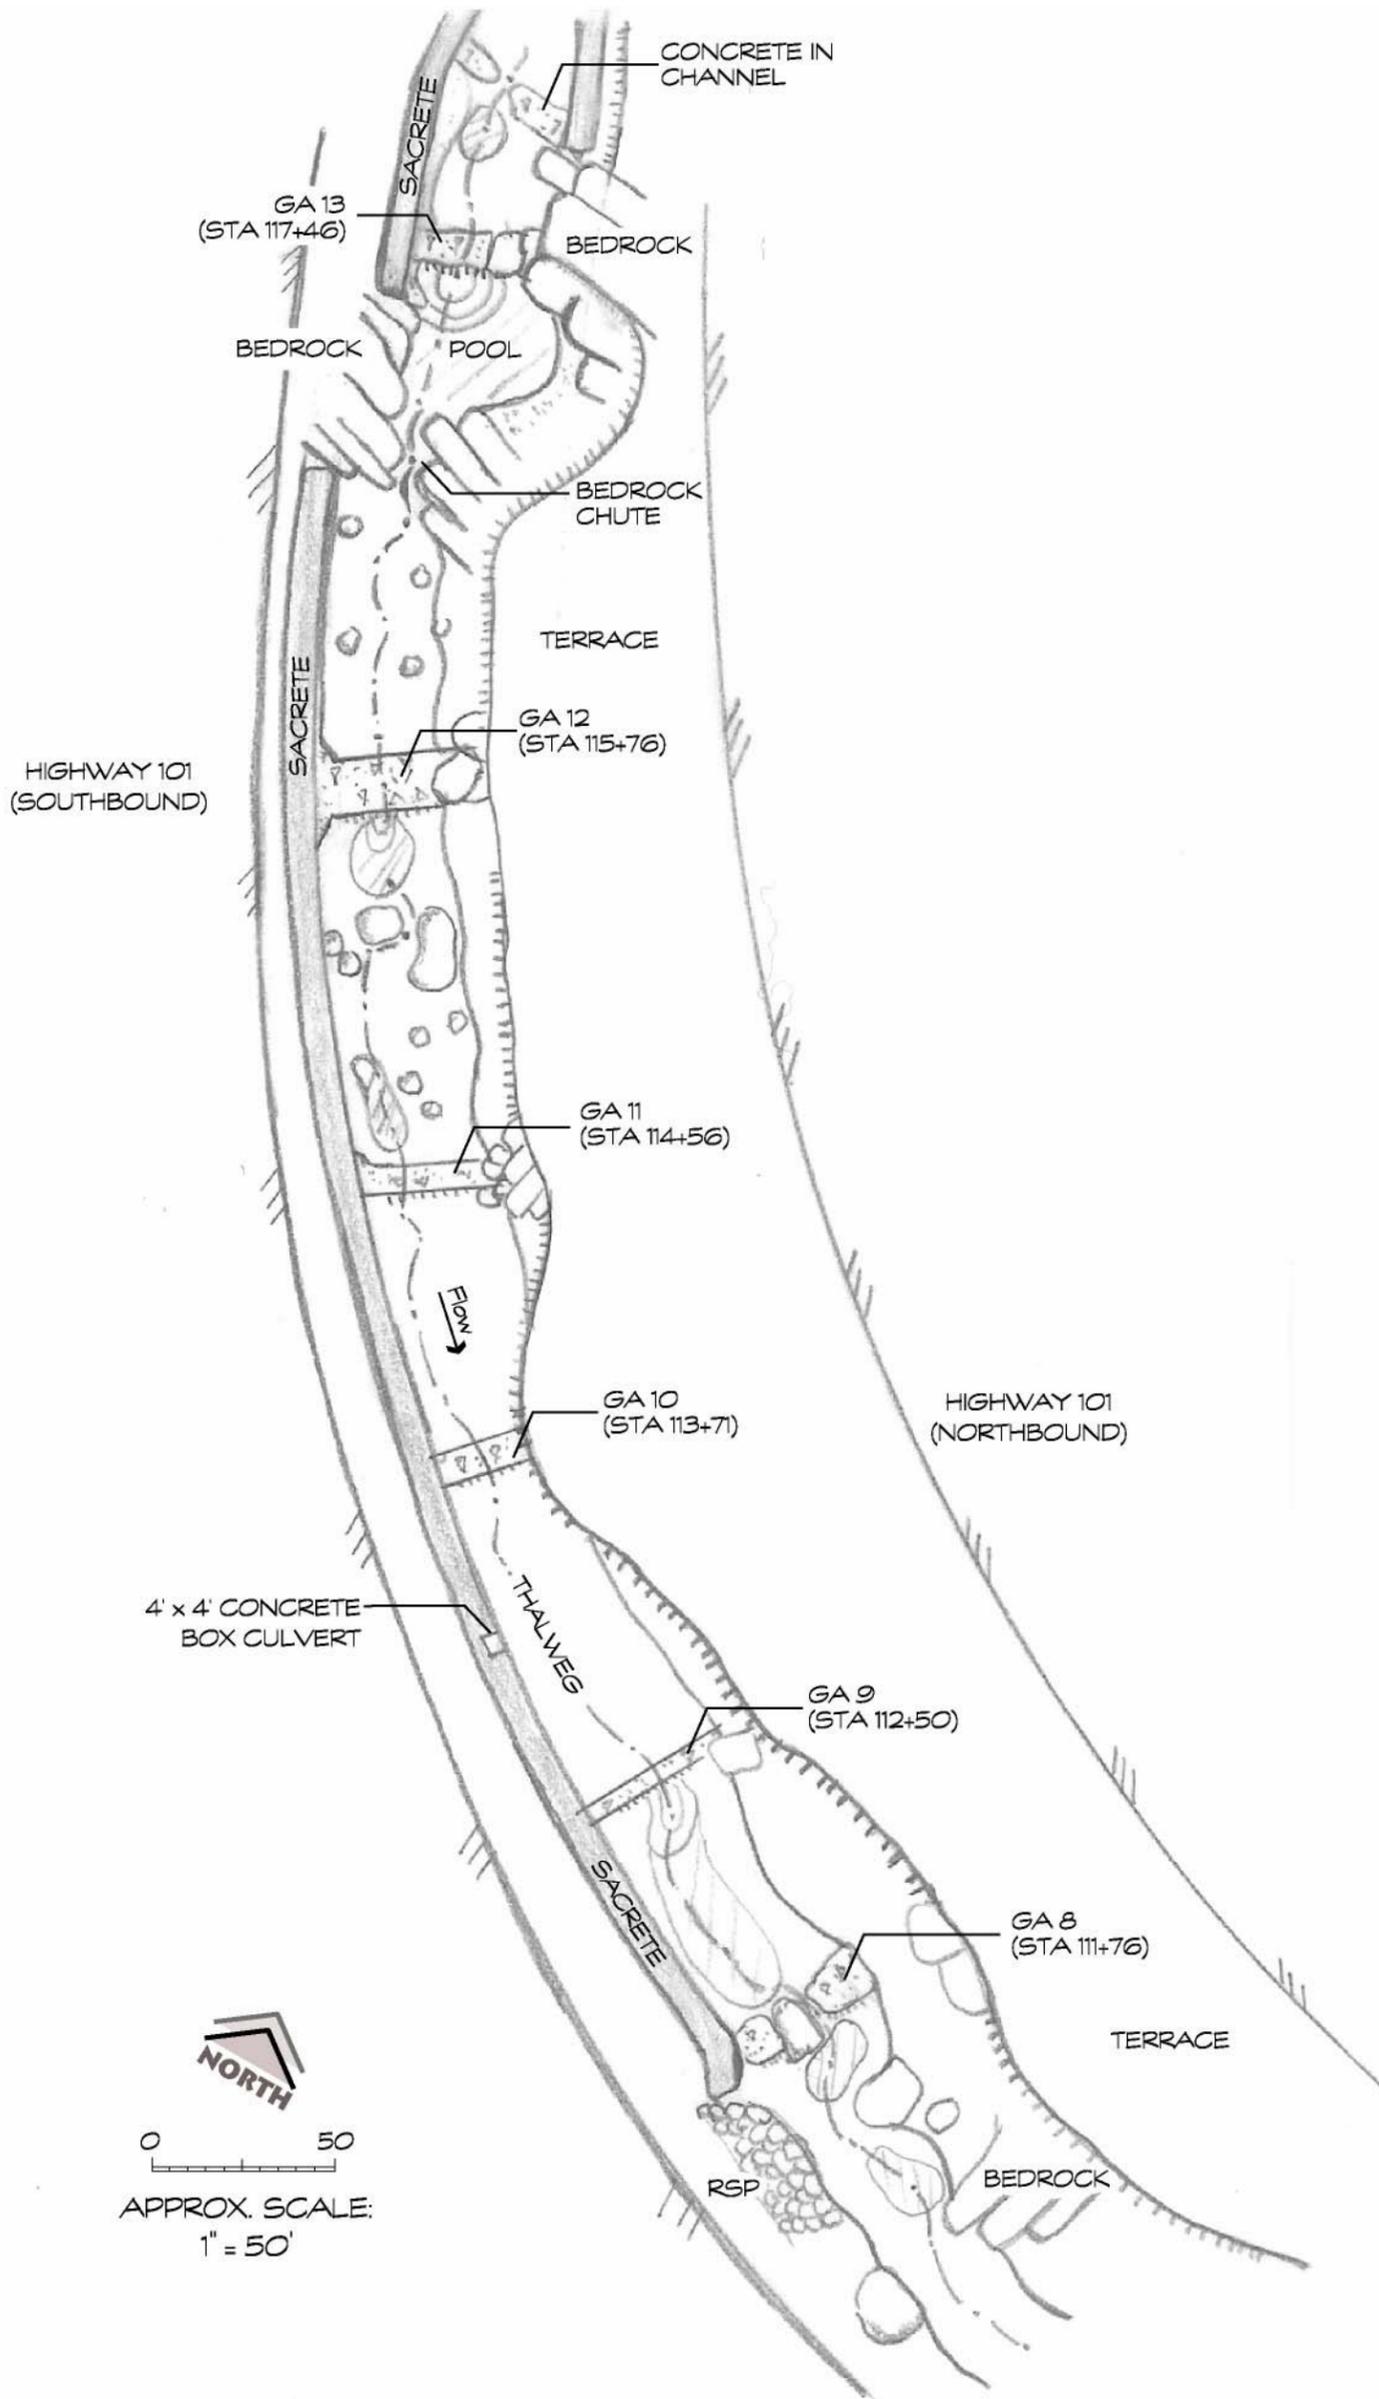
SITE SKETCH:
GA8, GA9, GA10, GA11, GA12, GA13

Figure 4.23 – Plan map drawing of the channel reach containing GA 8-13

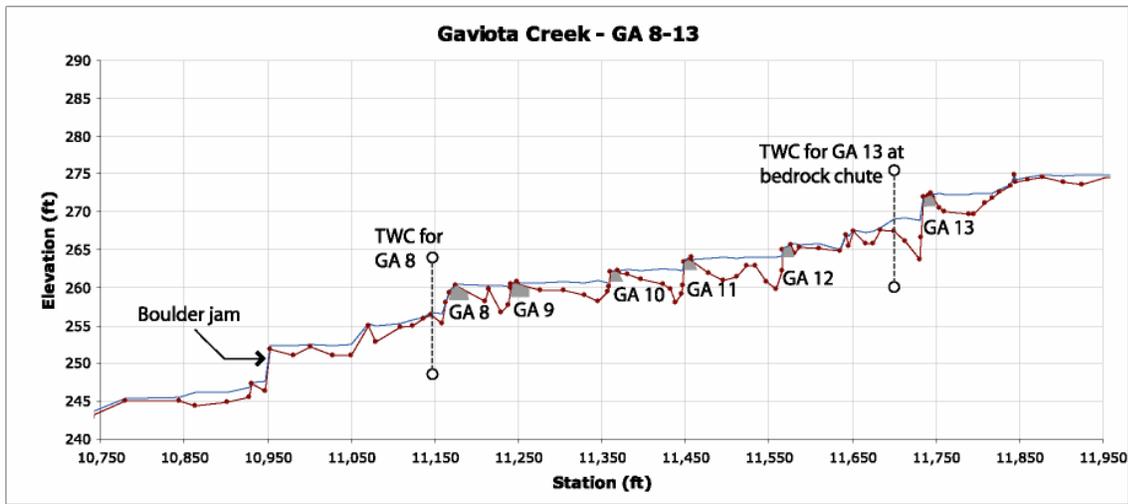
Figure 4.24 – Longitudinal profile showing location of the GA 8 through GA 13. (Note: elevations shown are based on arbitrary datum)

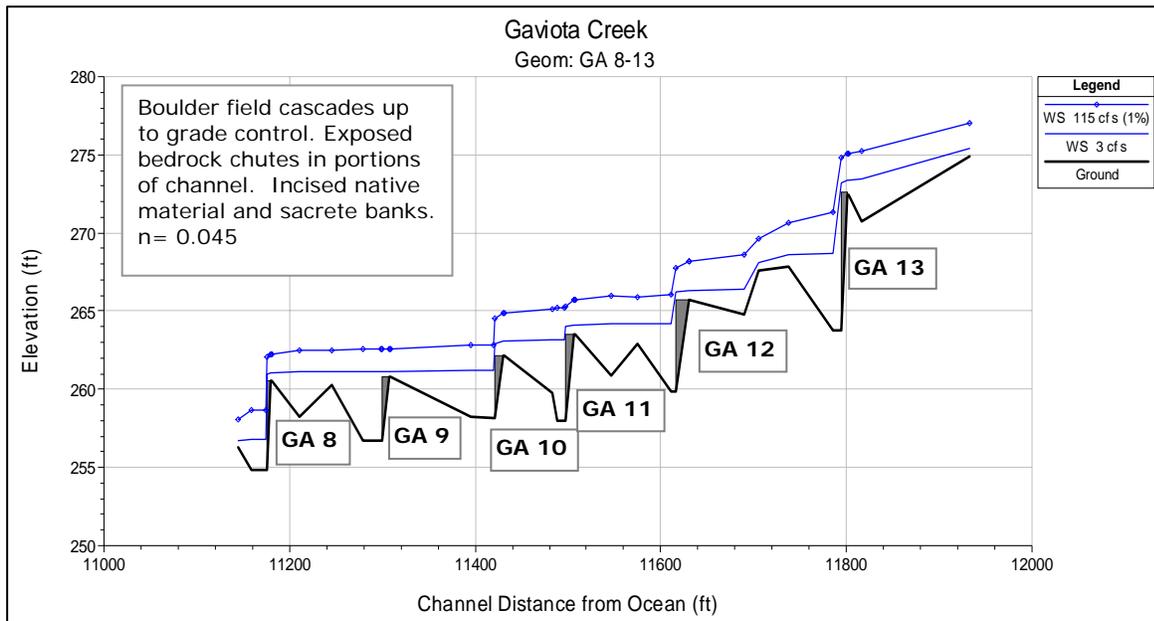
Figure 4.25 – HEC-RAS results showing water surface profiles for the constructed GA8, GA9, GA10, GA11, GA12 and GA13 at 3 cfs and 115cfs. (Note: elevations in model are based on arbitrary datum)

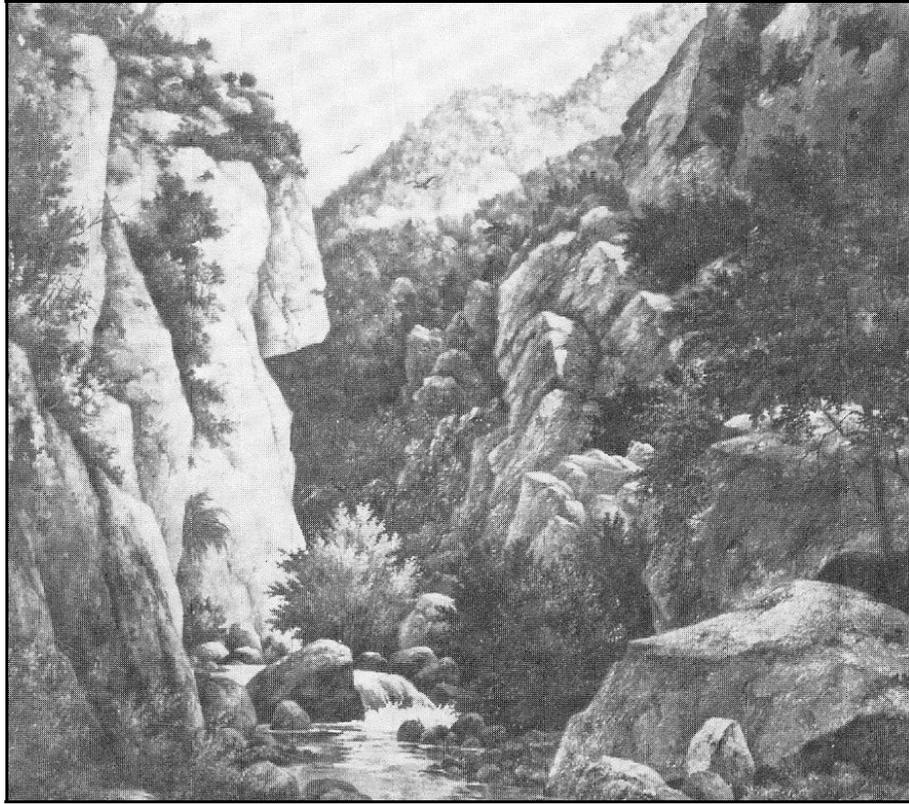
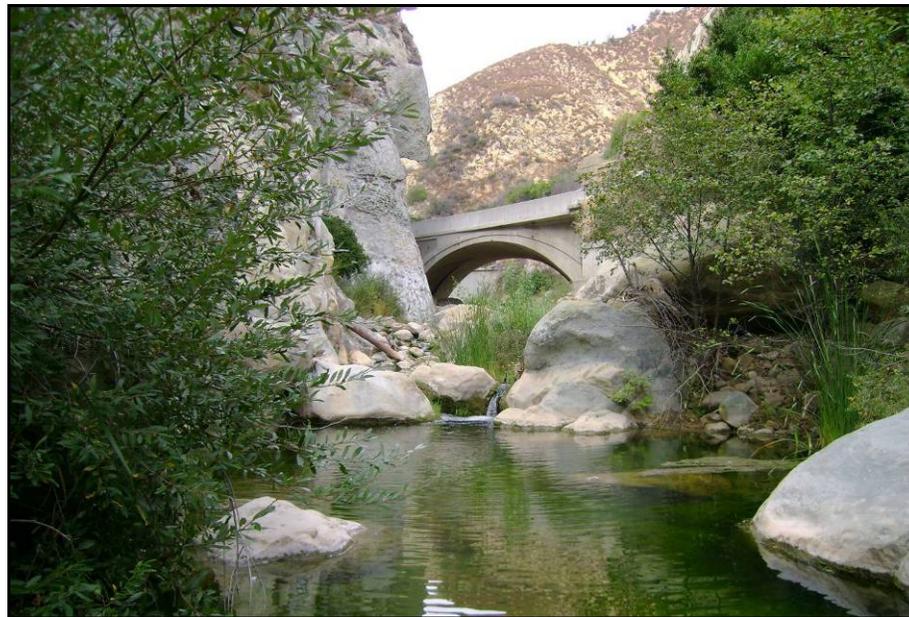
Figure 5.1 – Looking upstream at the “pass” in Gaviota Canyon, (a) illustrated during an early expedition prior to the first road (from Chesnut, 1993) and (b) under present conditions, with the southbound 101 bridge crossing the creek. Note the overhanging bedrock formation in the upper left in both images.

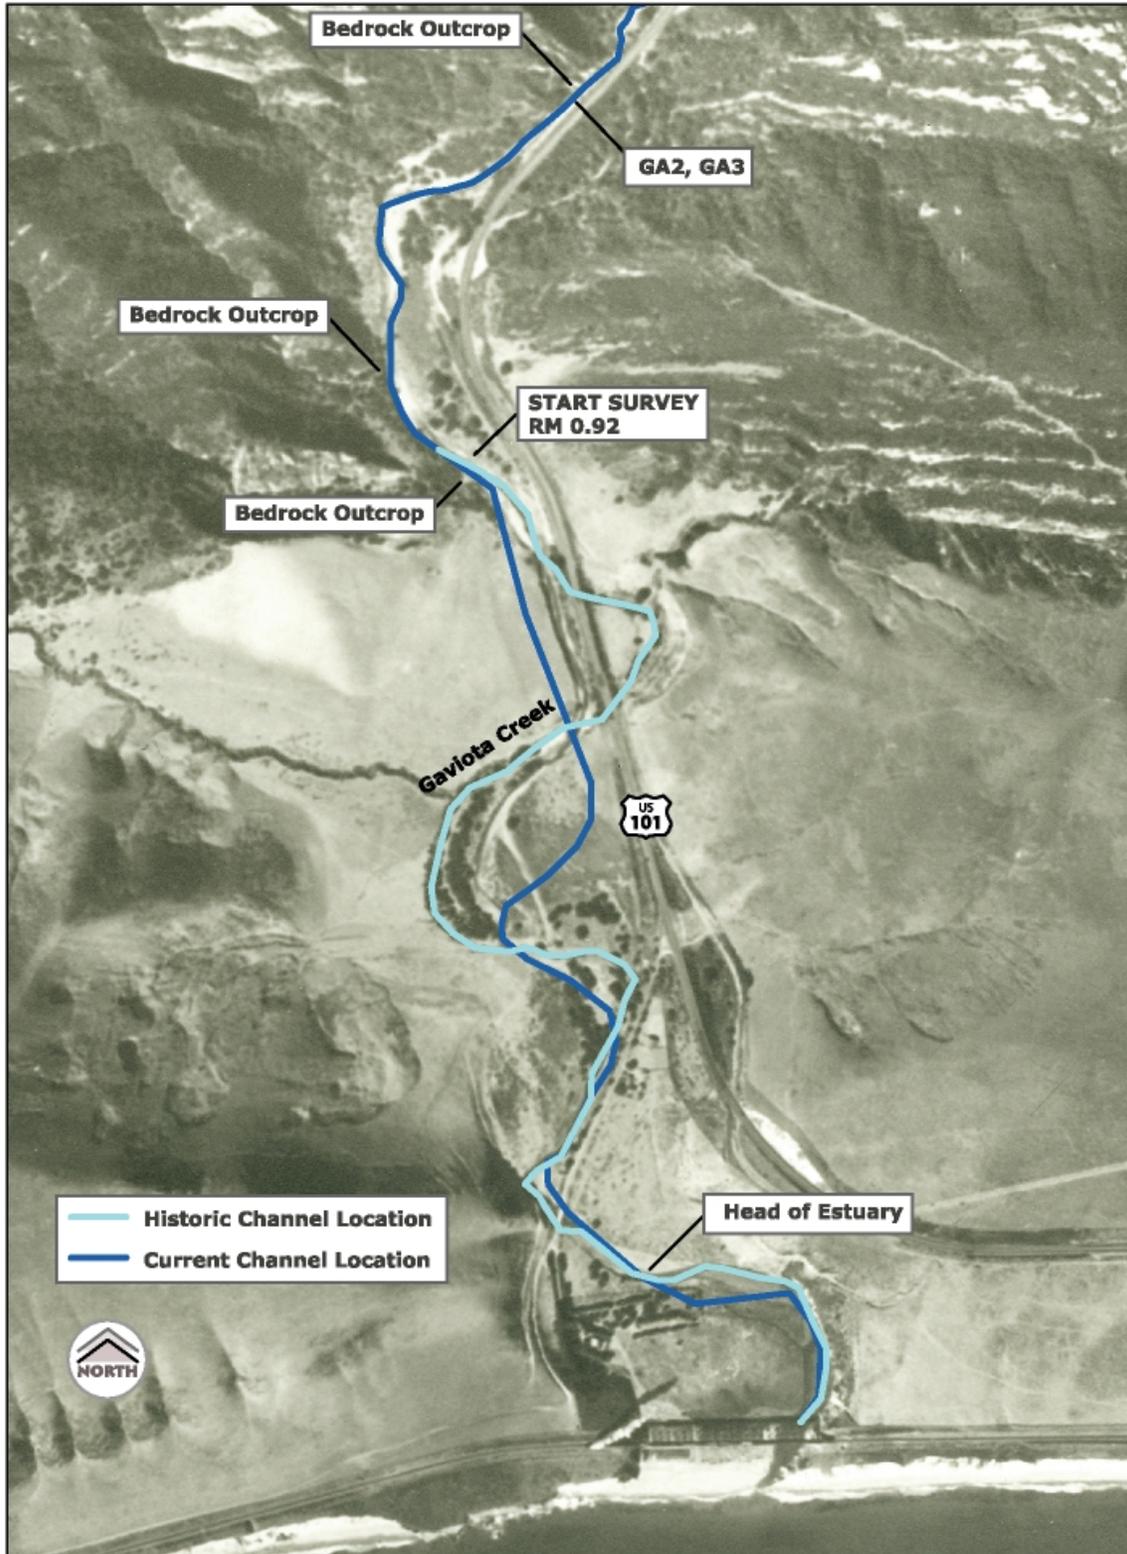
In 1934 a road straightening project between Gaviota and La Honda involved removal of a large meander in lower Gaviota Creek and rerouted the channel along the road embankment, as evident in the 1943 air photo (Figure 5.2). Subsequently, the channel alignment was further altered. In total, changes in channel alignment shortened the channel length by as much as 1,600 feet.

Figure 5.2 – Aerial photograph from 1943 showing current and historic alignment of Gaviota Creek between the ocean and the first set of grade control structures (GA2 and GA3). Current alignment is roughly 1,600 feet shorter than the historic alignment.

Based on a loss of 1,600 feet of channel length and a channel slope of 0.5%, the upstream channel may have experienced up to 8 feet of incision. Incision of the upstream channel bed appears to be partially controlled by exposed bedrock in two distinct locations (Figure 5.5) and possibly by the lower two grade control structures (GA2 and GA3).

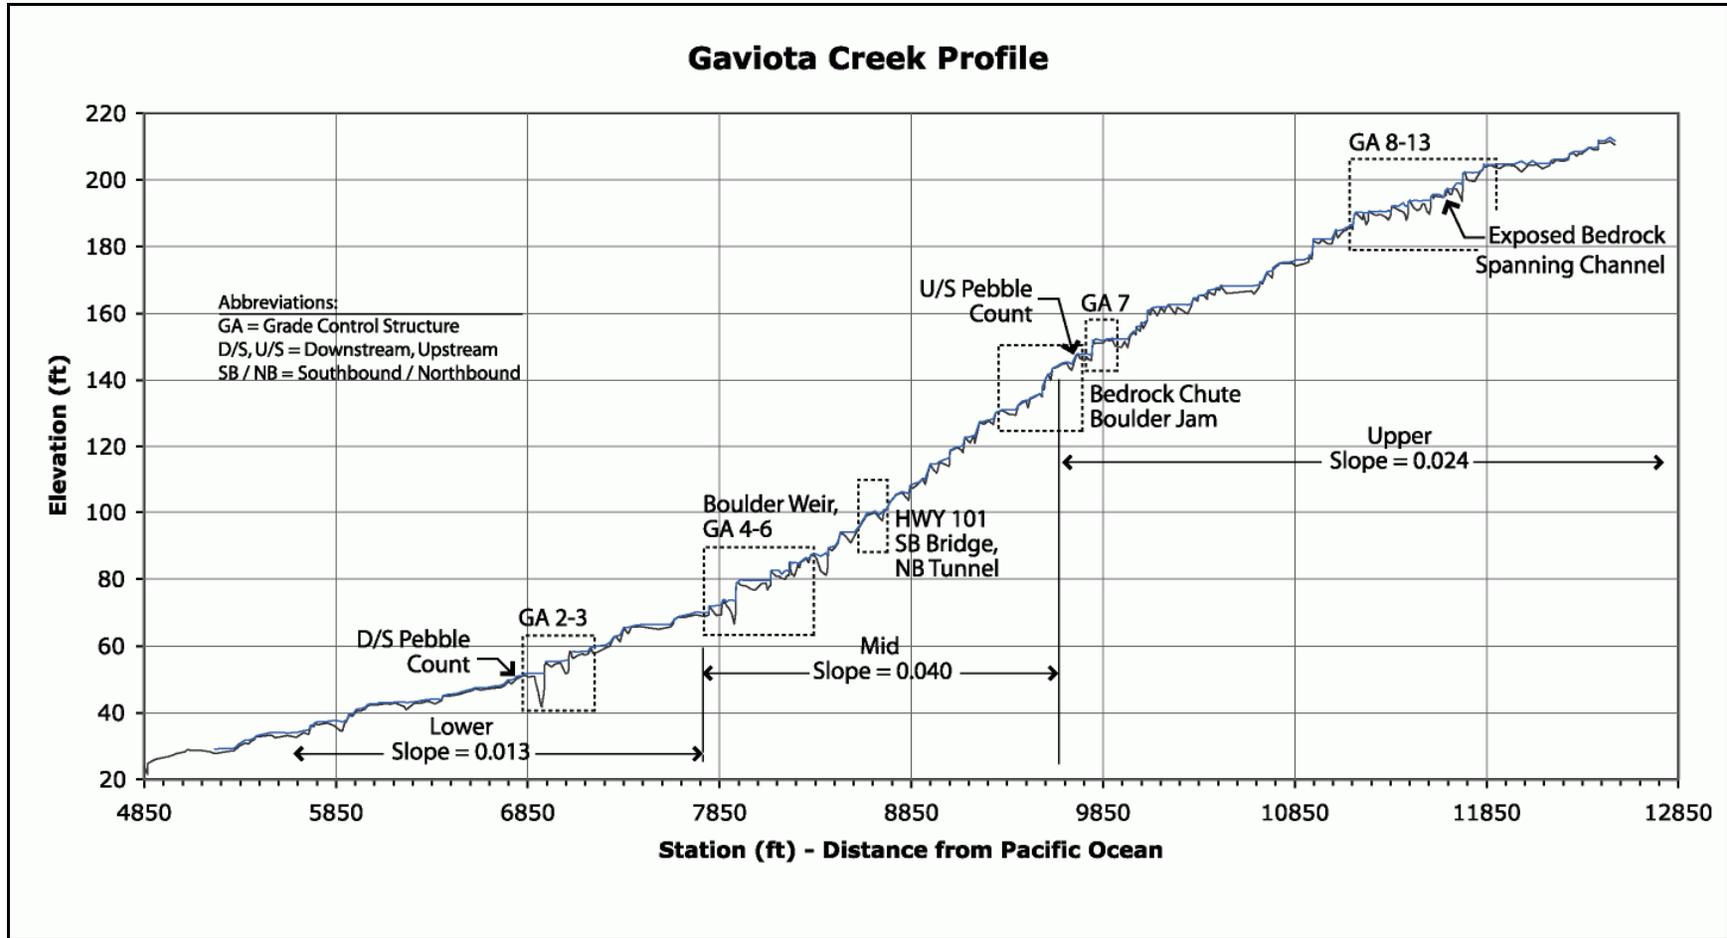
The surveyed channel reach begins 2,200 feet downstream of the first grade control structure (GA2) and extends through the confined sections of Gaviota Canyon to the second southbound 101 bridge crossing, for a total distance of 7,700 feet (Figure 5.3). From GA2 to the second bridge, the channel maintains a steep grade and the channel bed and banks are controlled by a combination of large colluvium, boulder jams, bedrock outcroppings, concrete grade control structures, hardened road embankments, and concrete retaining walls. To assist in defining the existing geomorphic channel characteristics and describing the channel interactions associated with the existing grade control structures, we have categorized the surveyed channel into three reaches: Lower, Middle, and Upper.

Figure 5.3 – Longitudinal Profile of Gaviota Creek Study Reach. 1.45 miles were surveyed from river mile 0.92 (from the ocean) to river mile 2.37.

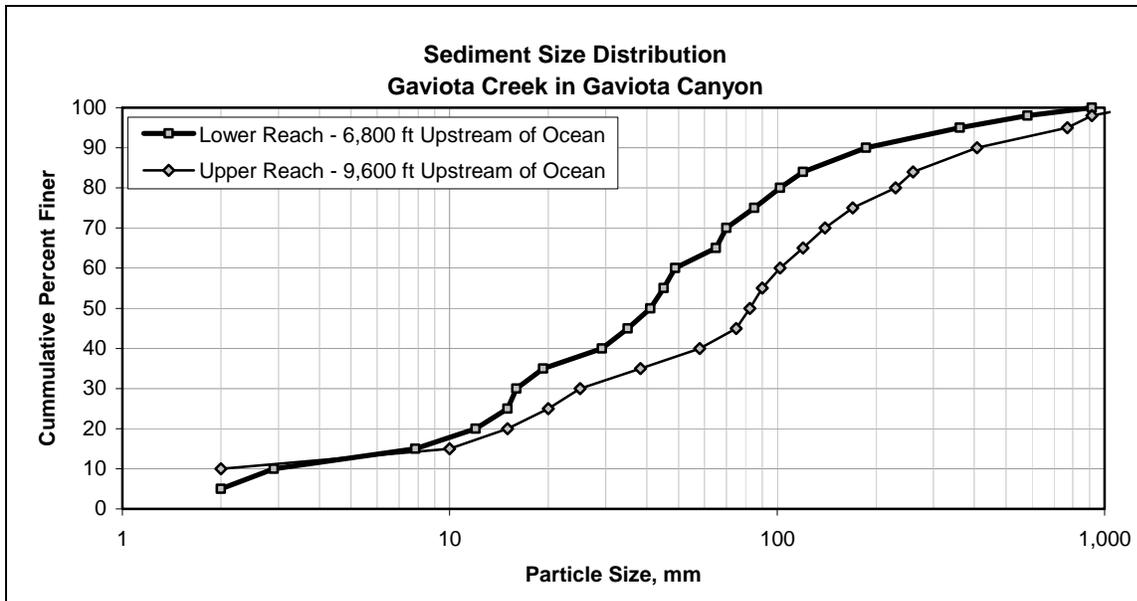
The lower surveyed channel reach begins at the upstream end of the realigned channel (Sta. 48+50) and continues to the base of the boulder weir (BLDR_WEIR) just downstream of grade control structure GA_4 (Sta. 78+00). The reach is 2,950 feet in length and has an average channel slope of 1.3%. A Wolman pebble count was conducted within the reach, just downstream of GA_2, to help classify the surface substrate (Figure 5.4). The substrate is alluvial and the predominate material is gravel (54%), followed by cobble (27%). The reach also contains some large boulders (>3 feet diameter) and sand (Table 5.1).

Figure 5.4 – Size distribution of substrate within Gaviota Creek, measured using a Wolman style pebble count (n = 100). The sample locations were approximately 100 feet downstream of GA2 (Lower Reach) and immediately upstream of the boulder jam (Upper Reach)

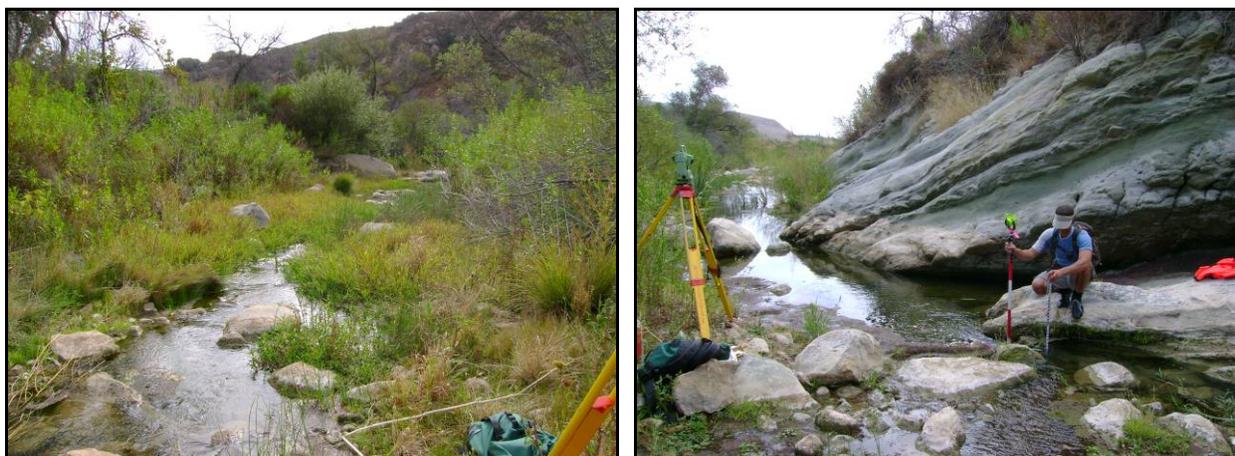
This lower channel reach lacks rhythmic bedforms and is characterized by long stretches of relatively featureless bed. Using the Montgomery and Buffington classification system (1997), the morphology of the lower reach can best be described as a plane-bed alluvial channel.

Throughout the entire reach the right bank of the stream is confined by the hill slope to the west. In several distinct locations bedrock outcroppings protrude into the channel, controlling the grade and forcing pools to form immediately downstream.

Figure 5.5 – The lower reach is predominately a plane-bed stream (left) with bedrock outcroppings (right) along the right bank forcing the formation of pools.
