Gaviota Creek

Fish Passage and Geomorphic Assessment

Prepared for
California Department of Fish and Game
And
Pacific States Marine Fisheries Commission

Prepared by
Michael Love and Associates
PO Box 4477
Arcata CA 95518

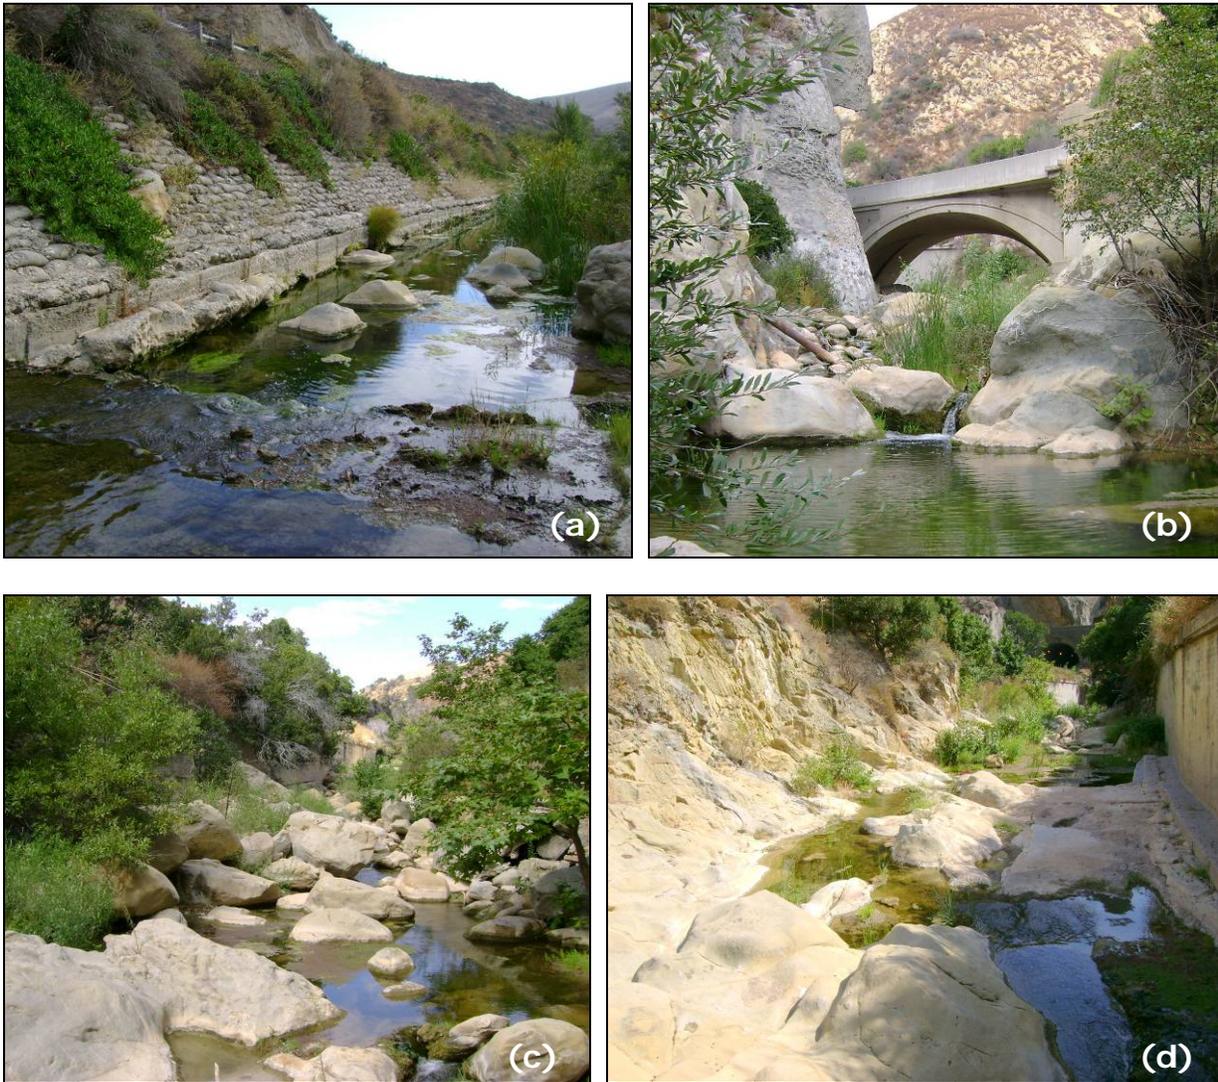
The middle reach begins below the constructed boulder weir (BLD_WEIR) at Sta. 78+00 and ends immediately downstream of the boulder jam (BLDR_JAM) at Sta. 95+25. The average channel slope through this reach is 4.0% and the channel is highly constricted by both the canyon walls and the highway embankments. The channel reach includes boulder cascades, boulder step-pools, and a bedrock chute (Figure 5.6).

Figure 5.6 – Middle reach, from downstream to upstream, consists of (a) four grade controls with long pools in-between, followed by sections of large boulder step-pools and cascades (b and c), and a constricted bedrock channel (d).

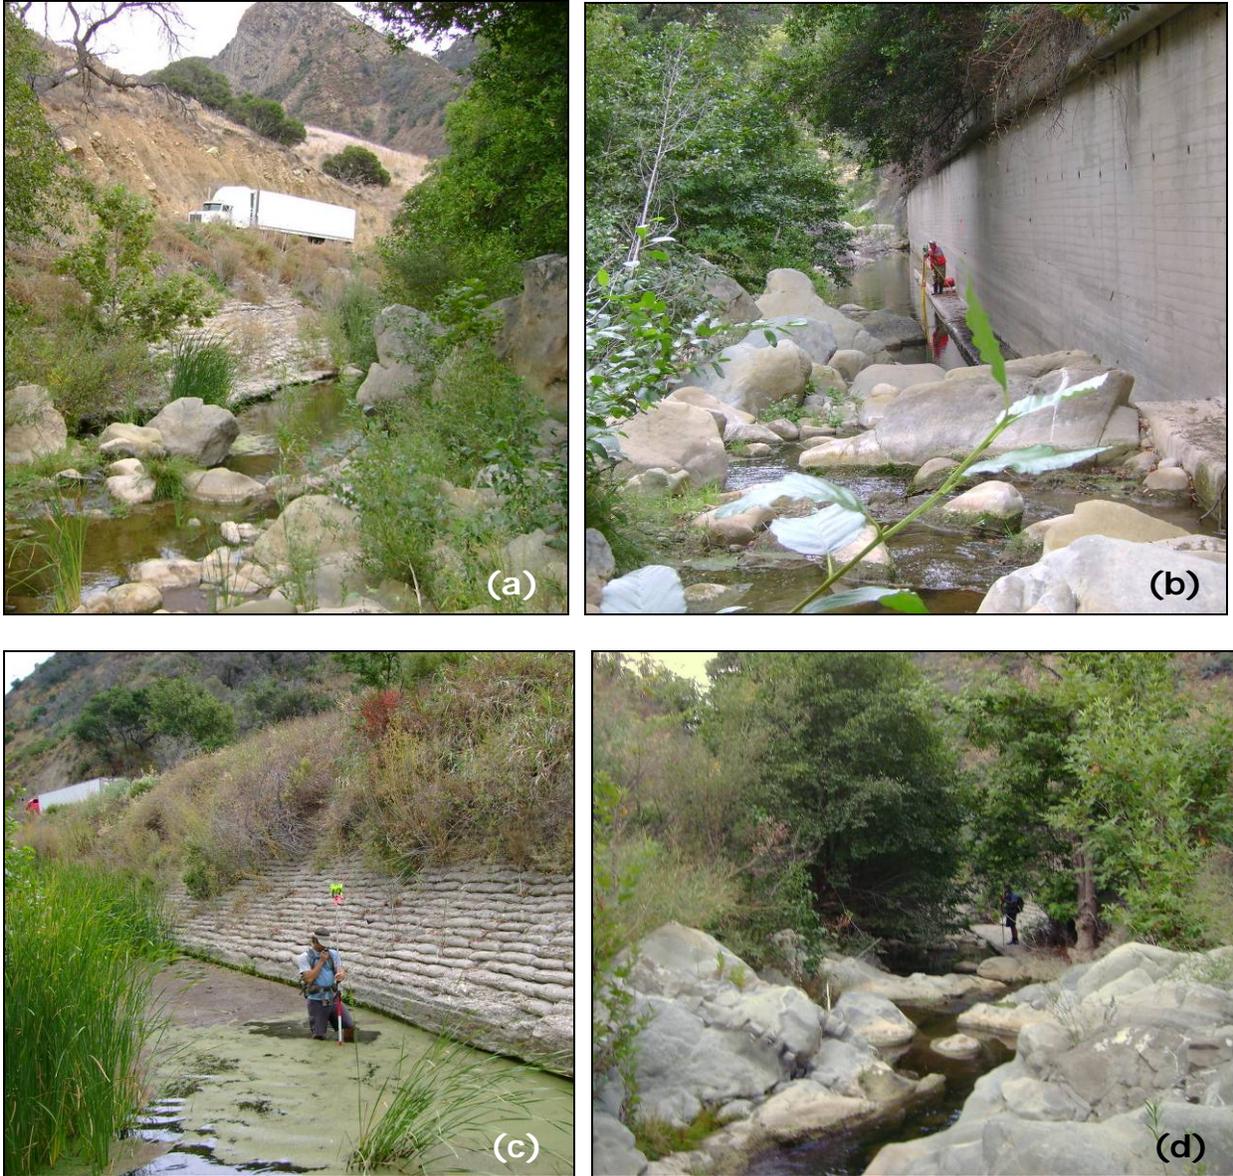
The reach has two distinct sections: from the boulder jam to GA8 and from GA8 to the Highway 101 bridge. Throughout the entire reach the channel is highly incised and constricted by bedrock outcrops, hardened highway embankments, and vertical retaining walls. The channel includes boulder cascades, bedrock dominated step-pools, and long glides. (Figure 5.7).

Figure 5.7 - Upper reach, from downstream to upstream, consists of (a) boulder steps and boulder cascades followed by long glides, highly confined banks due to the proximity of the highway (b and c), followed by a section of channel bed controlled by bedrock (d) and concrete grade control structures.

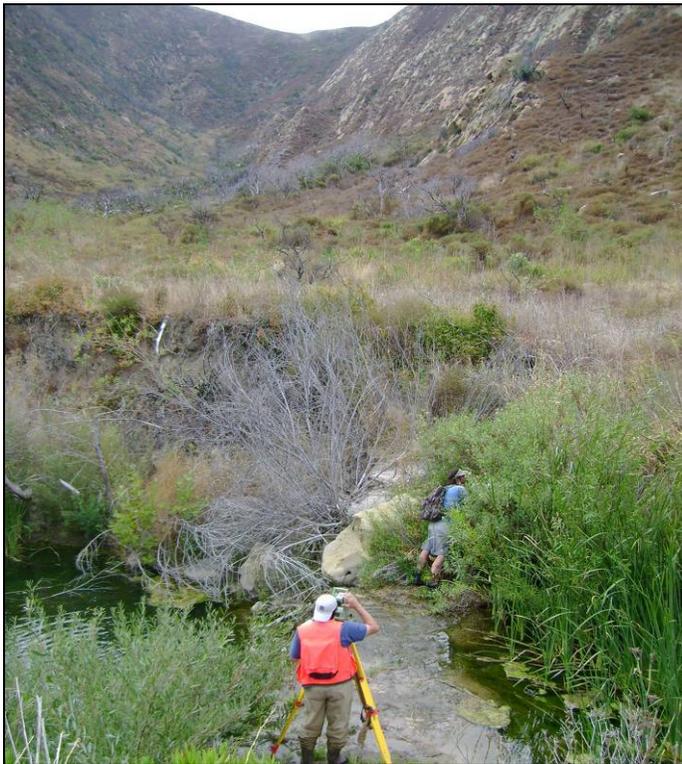
The channel was undoubtedly straightened through this reach. Increasing the length of the channel through this reach would provide more distance to make-up grade. Between about Sta. 76+00 and 81+00, just downstream of GA5, there is a relatively flat alluvial terrace to the west of the existing channel (Figure 6.3). One alternative to explore is moving the channel to the west and away from the highway. This option could add over 100 feet of length to the channel and provide effective fish passage while eliminating problems associated with the stability of the sacrete revetment and confinement of the channel. Within the constructed channel more natural-type grade controlling features could be included. It would also provide an opportunity to enhance the aquatic and riparian habitat of the stream. The new channel would need to reconnect to the existing channel downstream of GA5 due to a bedrock outcropping and end of the terrace. The grade of the new channel could be sufficiently raised to eliminate the barrier at GA5, and possibly at GA6.

Figure 6.3 – The channel could be relocated away from the highway into the alluvial terrace to the west of GA4.

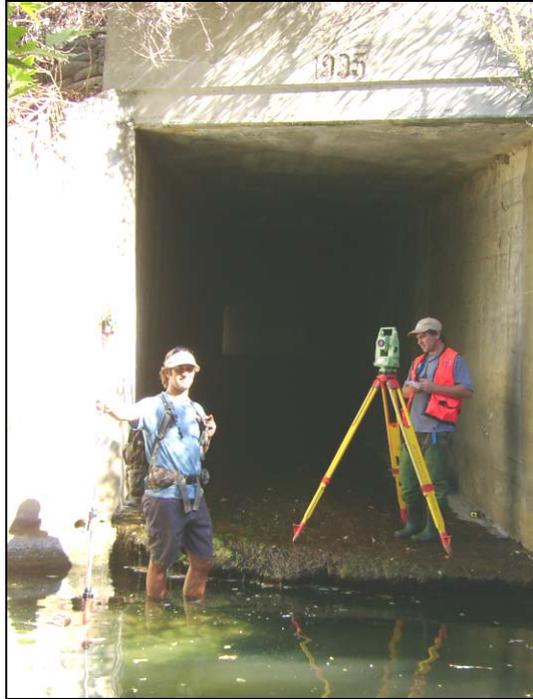
The outlet flows directly into a large tailwater pool (**Figure 5**). There is a 1.24 feet residual drop at the outlet and the tailwater control consists of small boulders accumulated across the channel (**Figure 6**). During the field visit, numerous rainbow trout were observed in the outlet pool, some as large as 5 to 7 inch in length.

Figure 5 – Outlet of Upper Gaviota Creek culvert.

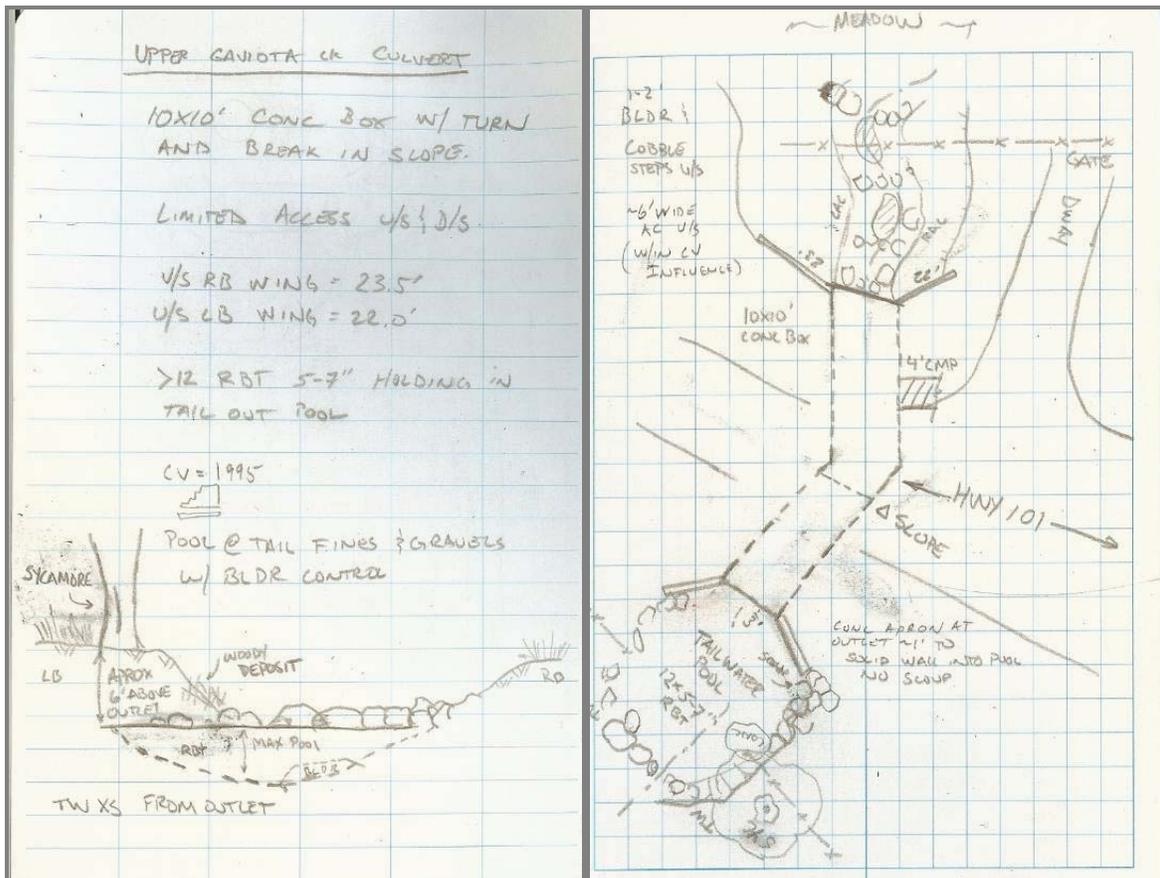
Figure 6 – Site sketches for Upper Gaviota Creek showing tailwater control cross section and plan map of crossing. Survey data was limited to the highway right-of-way.

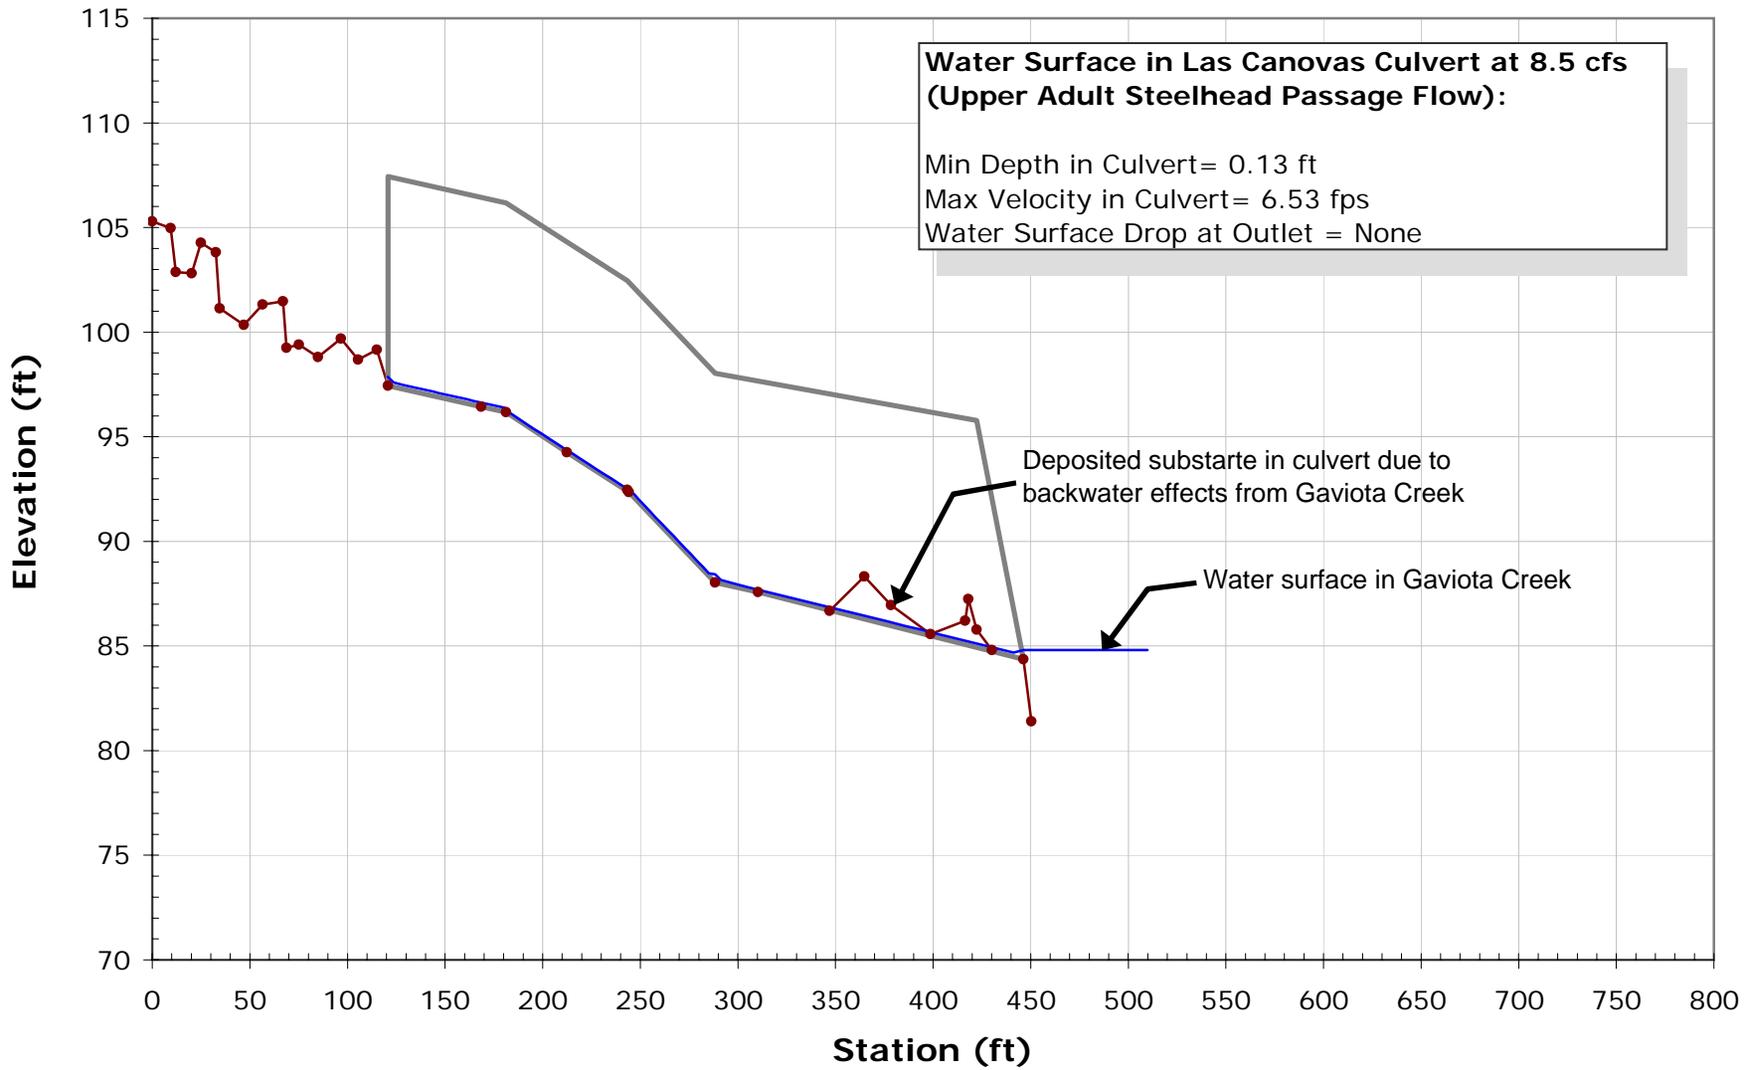
Thalweg Profile - Las Canovas Culvert

The Las Canovas culvert is a barrier to Adult Steelhead, Adult Resident Trout and Juvenile Salmonids at all flows. While there is a small window of acceptable velocity for Adult Steelhead and Trout, the depth is insufficient for an excessive length.
