Technology &
Development
Program

Response of Road- Stream Crossings to Large Flood Events in Washington, Oregon, and Northern California

**USDA Forest Service
Six Rivers National Forest
Pacific Southwest Region**

September 1998

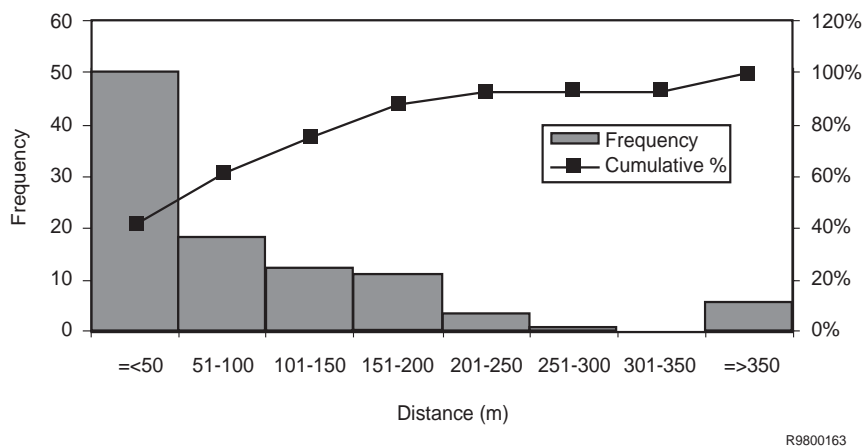
Figure 9—Observed diversion distances at failed stream crossings (n=104).

stream crossings. Diverted streamflow was routed along the inboard ditch, road surface, or often both. Diversion out of the ditch and onto the road surface was often the result of runoff forced out of the inboard ditch, through ditch deposition, failed cross-drains, sharp bends on steep roads, cutslope failure into the ditch, road outsloping, and exceedence of the ditch's hydraulic capacity. Fifty-three percent of diverted streamflows entered adjacent cross-drains or road-stream crossings; the remaining 47 percent either flowed across the road and onto the hillslope or infiltrated the road fill (n = 103). Figure 9 shows the distribution of observed diversion distances.

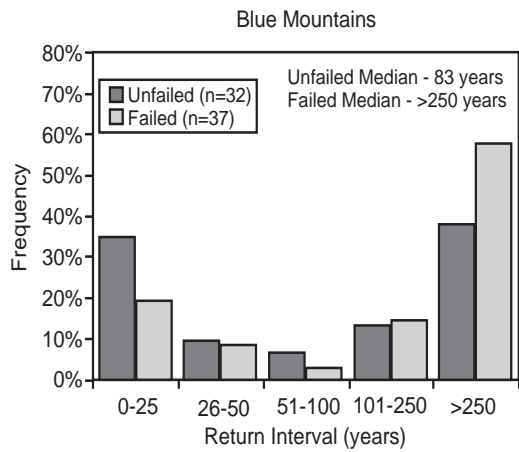
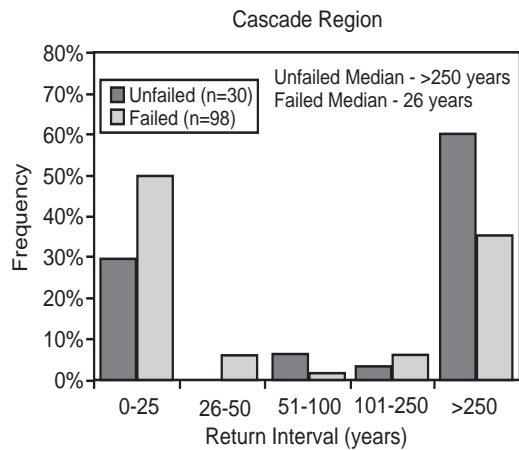
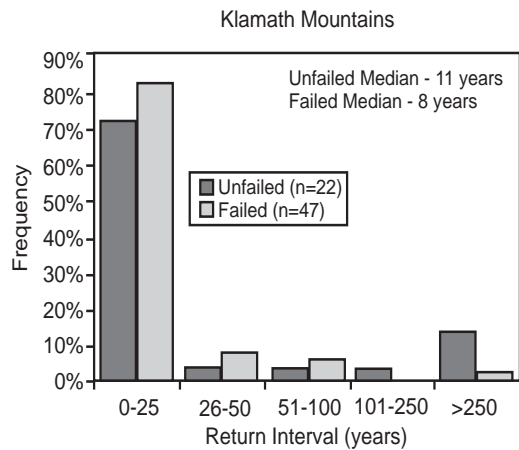
Similar to the observations of Piehl et al. (1988), we found that T_d was distributed bimodally for both failed and unfailed culverts (see Figure 10). The median of T_d in the Cascade Region was greater than 250 years for unfailed crossings but only 26 years for failed crossings. Failures caused by debris torrents were suspected of being unrelated to culvert size. If we neglect debris-torrent failures, the median T_d for failed crossings is only 18 years. The relative frequency distribution in Figure 10 suggests that culverts in the Cascades sized for less than the 25-year peak flow have a higher probability of failure than those sized for greater than the 250-year peak flow. Stream crossings in the Blue Mountains exhibited the opposite trend, with the median of T_d for unfailed crossings less than that of failed crossings. The hydraulic assessment template was not useful as a screening tool in the Klamath National Forest study area because a majority of the sites, both failed and unfailed, had T_d values less than the 25-year peak flow. The survey size in the Coast Range was insufficient for the analysis of the T_d distribution.

Figure 10—The relative frequency of the probability of exceeding culvert hydraulic capacity, expressed as peak flow recurrence interval, T_d , for failed and unfailed stream crossings in the Blue Mountains, Cascade Region, and Klamath Mountains. Within the Cascade Region, failed culverts were more frequently sized for less than the 25-year peak flow (at $HW/D = 1$), while the majority of unfailed culverts were sized for greater than the 250-year peak flow (at $HW/D = 1$). The opposite relationship was found for the Blue Mountains.

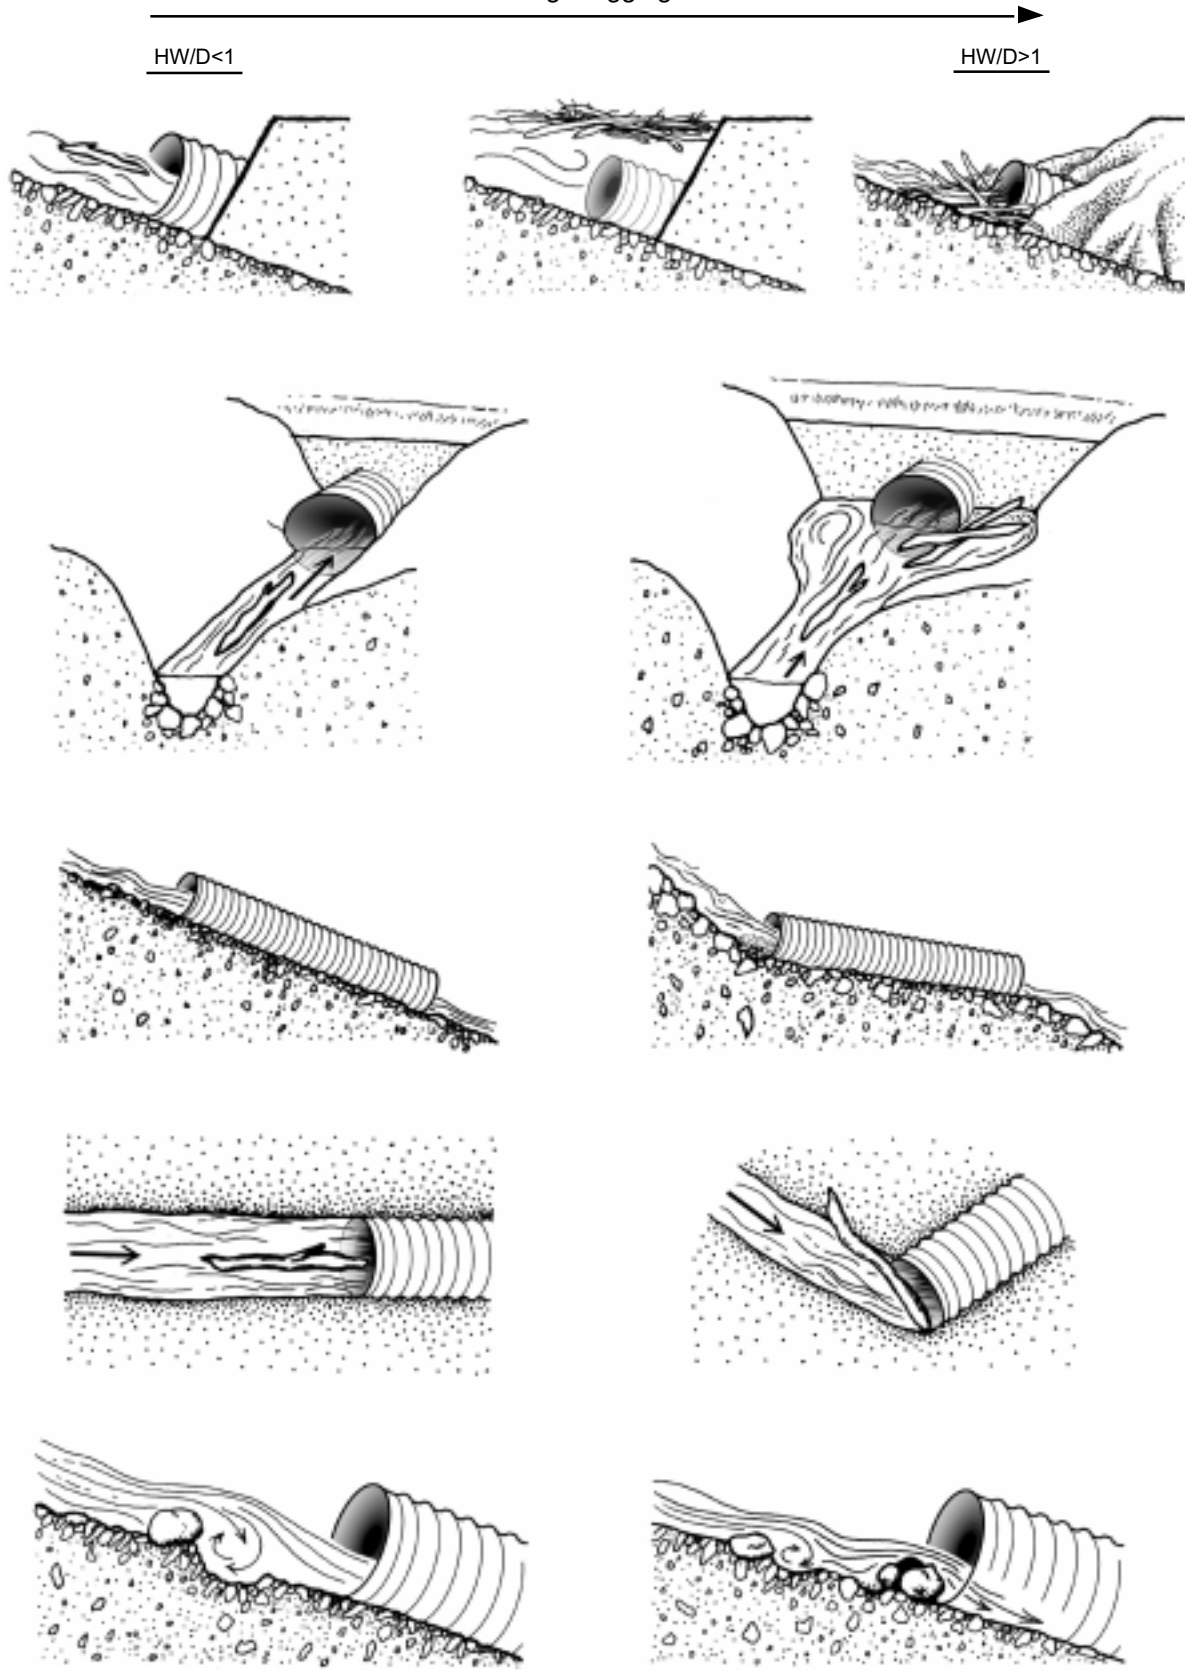
Figure 11—Illustrations of increasing plugging hazard.

Accumulation of headwater (water level above the top of the culvert) at culvert inlets will increase plugging hazard by retarding the passage of floating debris and by decreasing streamflow velocity and the capacity for sediment transport. Ponding at the inlet basin led to the accumulation or "rafting" of woody debris. When the inlet was re-exposed, it was instantly faced with an interlocking raft of wood exceeding the capacity of the inlet, therefore resulting in plugging (Figure 11a).

The behavior of sediment and debris at culvert inlets was crucial to stream-crossing performance. Crossings that presented the least change to channel cross-section, longitudinal profile, channel width, and alignment were most likely to pass sediment and debris (Figure 11b, c, d).

- Increases in channel width immediately upstream of the culvert inlet promoted accumulation of both woody debris and sediment at the inlet. In widened channels, woody debris can rotate and present larger effective widths to the culvert inlet, increasing the likelihood of lodgment, and resulting in reduction or plugging of the inlet. Narrow channels are more likely to present woody debris to the culvert inlet oriented with the flows and the culvert, and thus more effectively entrain and move sediment through the culvert. (Figure 11b). Wider channels also result in flows

- Culverts set at substantially lower gradient than the natural channel will tend to retard sediment transport and promote plugging. Often the crossing creates a depositional reach in a channel that otherwise efficiently transports its sediment loads (Figure 11c).
- Where culverts are not aligned with the channel, stream energy losses and reorientation of entrained floating debris are likely, leading to sediment deposition and lodging of woody debris at the inlet (Figure 11d).
- Larger rocks are often moved downstream by progressive undermining and rolling. When large rocks encounter the edge of a culvert, undermining ceases and rocks can lodge, leading to plugging by sediment and debris (Figure 11e). Flared metal end-sections that have a well-bedded apron seem to be effective in reducing or eliminating this effect.

$HW/D = 0.5$ or 0.67 . We believe this criterion is prudent in any situations where woody debris and sediment must be passed (Figure 11a).
